Geotechnical case studies: emphasis on collapsible soil cases

--Manuscript Draft--

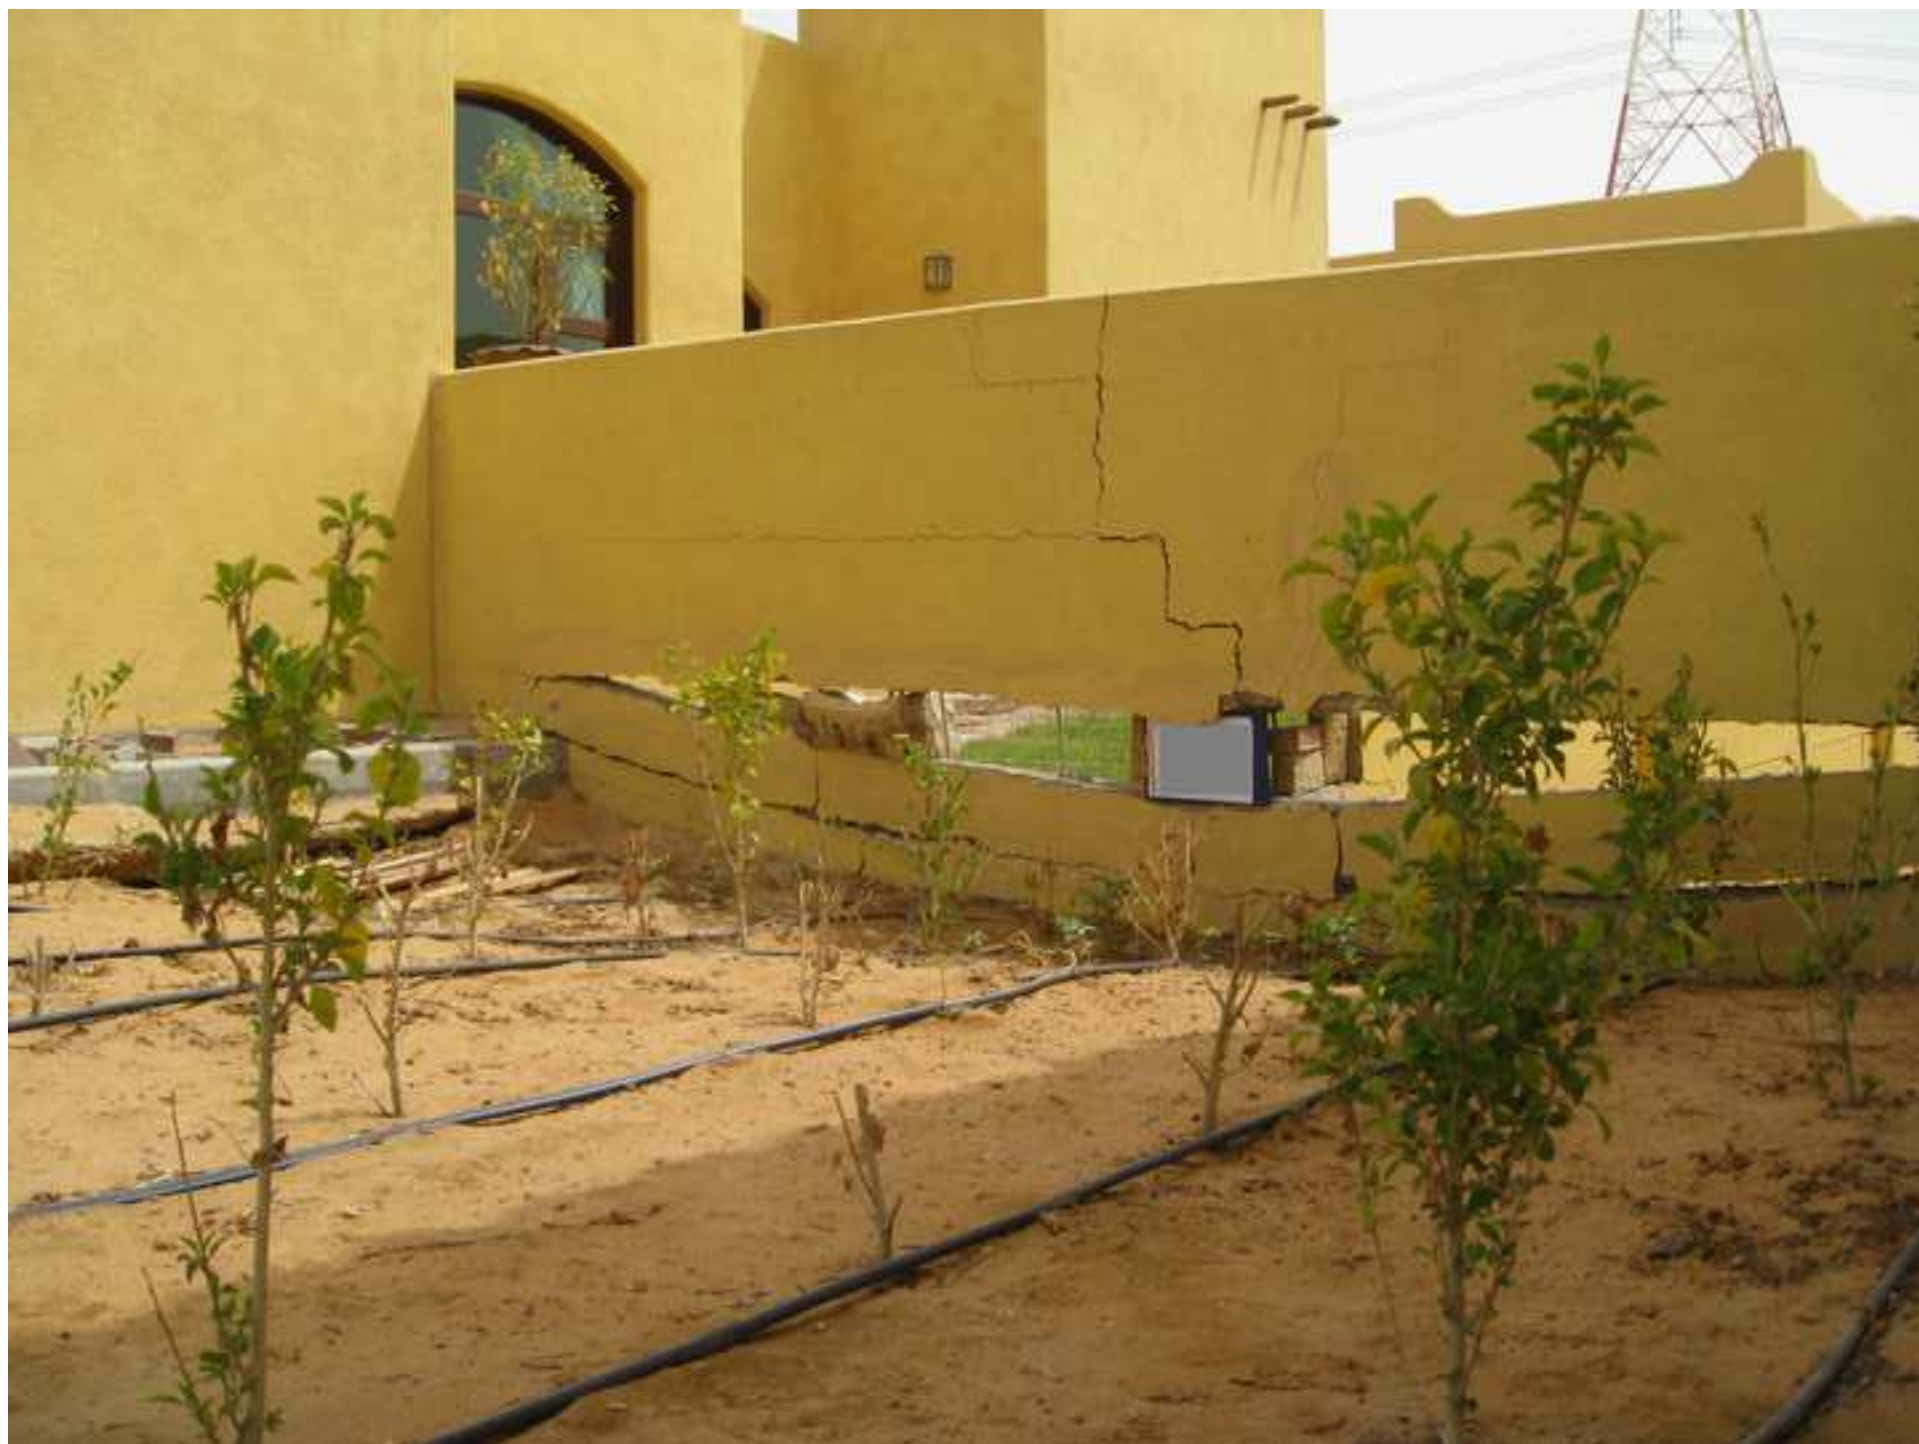
- 3
4 i. Footpaths at locations adjacent to landscaped areas experienced settlements (approximately
5 75 mm) under the effect of continuous water ingress.
6
7 ii. Though several boundary walls had distressed on site, those walls which are located with
8 landscaping on either side had suffered the highest level of distress with settlements
9 approximately 260mm (Figure-4).
10
11 iii. Flexible pavements, particularly those adjacent to open landscaped areas had experienced
12 distress (settled approximately 100 mm) as well. As, stress transfer under flexible pavements
13 is largely limited to 2.0-2.5 m below ground, it was initially thought that very loose to loose soils
14 that are susceptible to collapse due to movement of water were present at shallow depths.
15 This was later confirmed from the low SPT blow counts observed at very shallow depths (1.0-
16 1.5 m) in the drilled boreholes.
17
18 iv. Interestingly it was found that the ground in some green landscaped areas with no structures

58 Figure 4. Cracking and settlement of boundary wall
