# INFRASTRUCTURE DAMAGE DUE TO DEWATERING WITHOUT CONSIDERING LAND USE HISTORY

Geotechnical processes such as subsidence, seepage, scouring, extreme temperatures as well as geological events pose constructional challenges even despite advancements in design codes, ground investigation techniques and numerical analysis. This paper analyses a case record where subsidence and damages to existing structures occurred adjacent to a location where dewatering works were being carried out for a new pipeline. Initially, the damages were thought to be solely linked to the dewatering effects, but it was still a puzzle as to why the problems only occurred at particular locations and not over the entire dewatered area. To solve the puzzle, forensic ground investigation and geophysics were performed. Based on borehole and CPT results, the ground profile was interpreted and compared with results from two parallel geophysical methods. Both of these revealed that the problem area was part of an old channel that had been dredged decades earlier and reclaimed by filling with loose material. This was corroborated by theoretical calculations of ground subsidence, which was found to be consistent with v

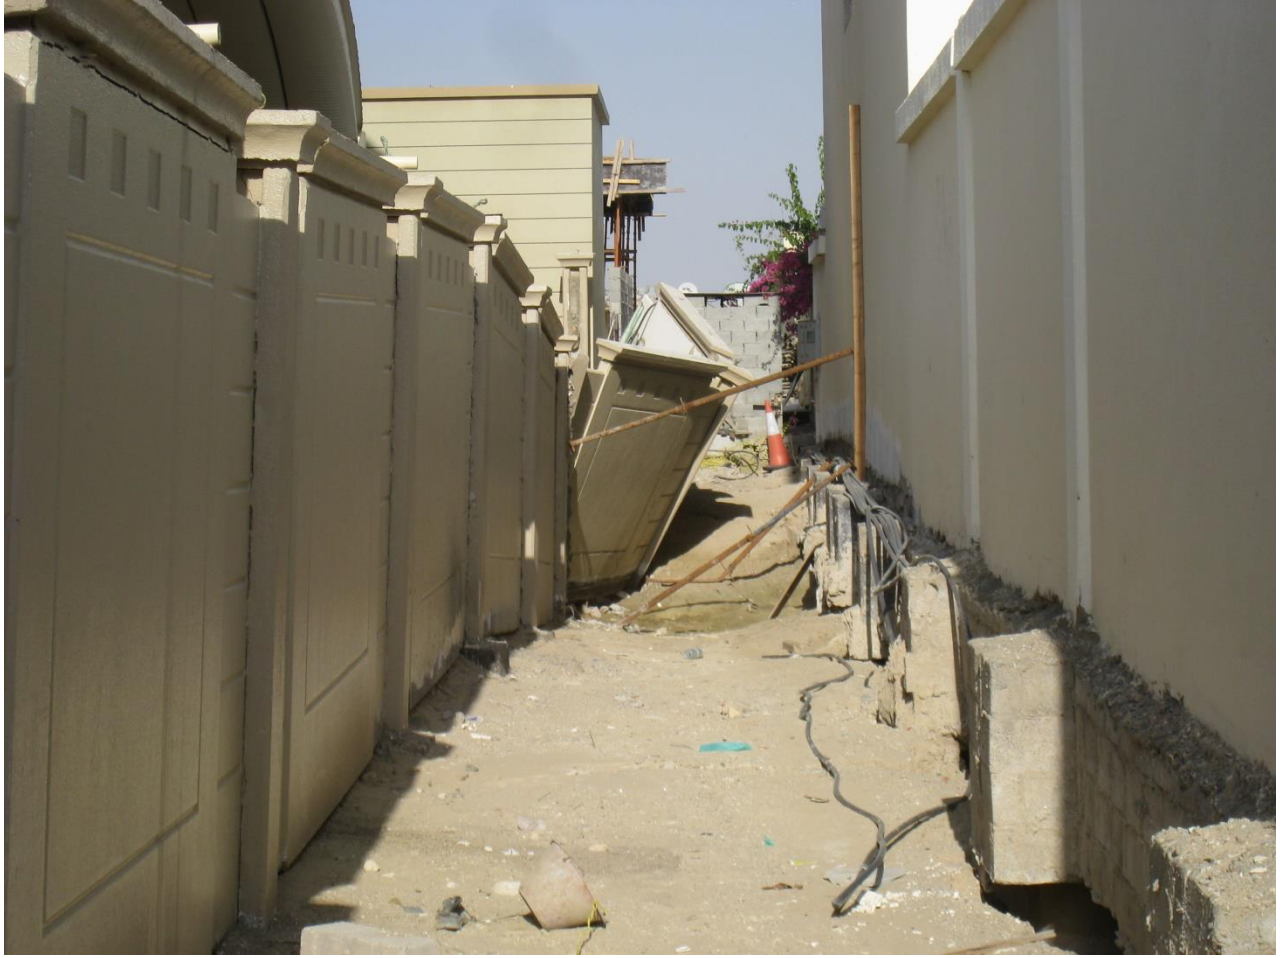
**Fig.1** Overturning of boundary wall of a villa

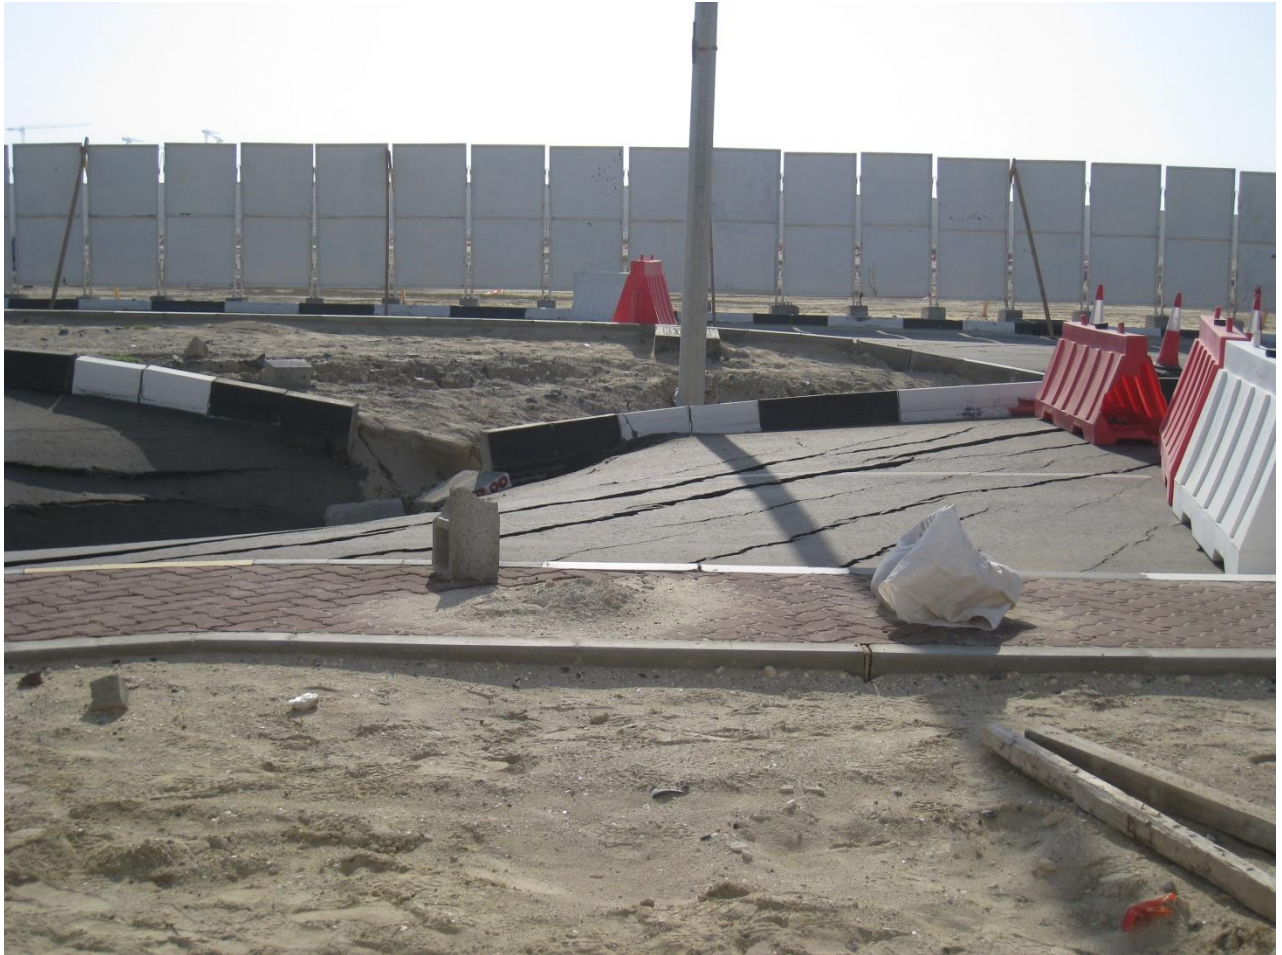
**Fig.2** Cracking and extreme subsidence in pavement (settlement ~600-700mm)

A temporary solution was suggested whereby the damaged sections of the area to be excavated down to the groundwater table, followed by compaction of the underlying soil layers to at least 95% maximum dry

density (MDD), installation of a tough geo-synthetic layer at the sub-grade level and finally reconstruction of the road pavement.

It was recommended to remove the failed parts of the road pavement lying just above the groundwater table, then compact stone layers to refusal followed by compaction (to not less than 95% MDD) above the installed stone layer, laying a tough geo-grid layer on the sub-grade and reconstructing the pavement layers.

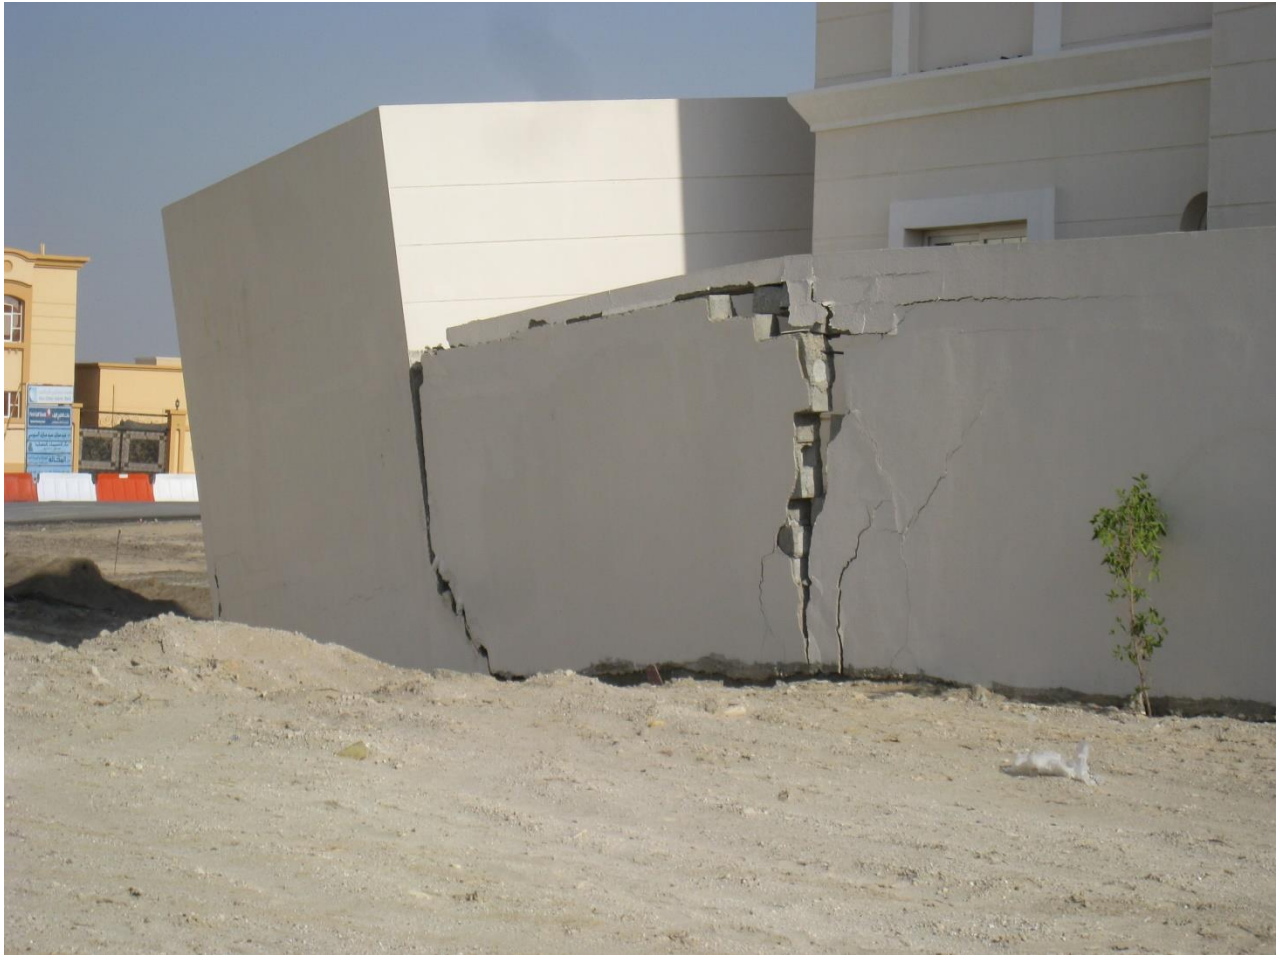
**Fig.3** Tilted building and deformed boundary wall of a villa

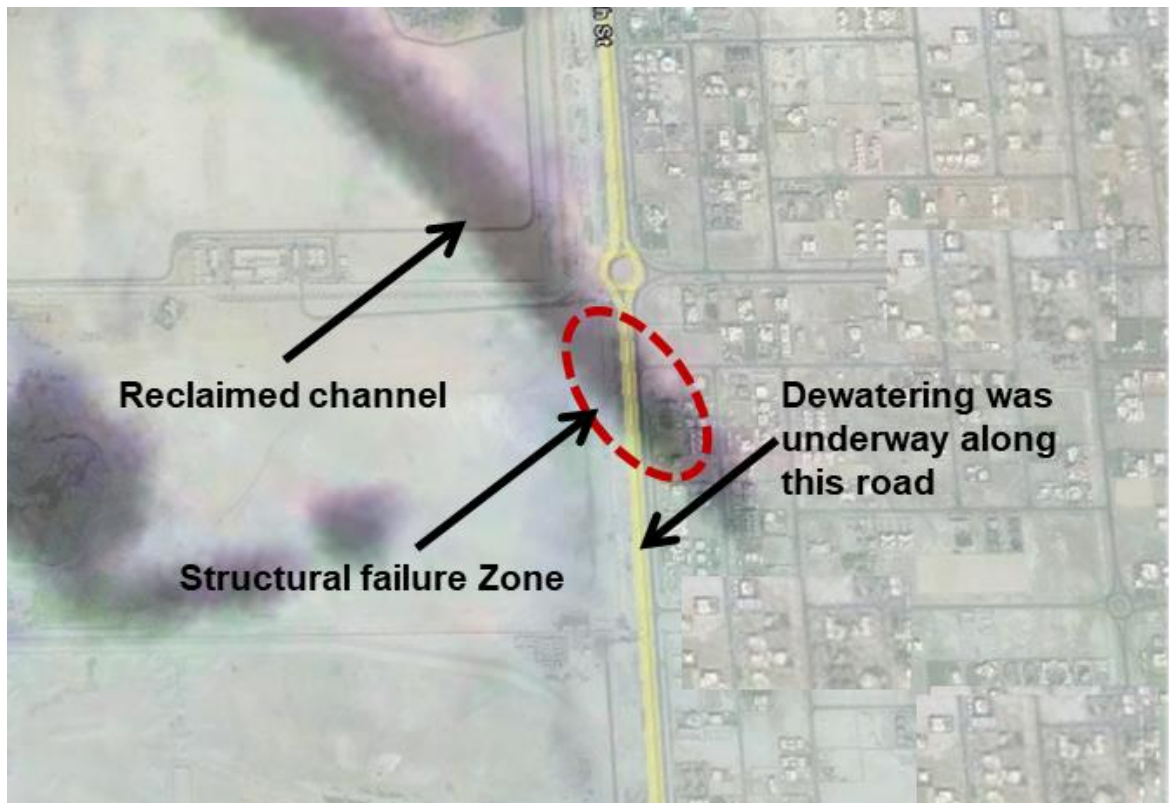
The results interpreted from the ERT survey corroborated well with those from the MASW surveys, hence giving confidence on the validity of the correlations. The zones of anomalies detected by both ERT and MASW surveys coincided remarkably with the structural failure areas. This close match lent credence to the suspicion that the affected site had been reclaimed from a dredged channel several decades in the past and filled with loose sandy soils.

**Fig.4** Historical aerial image of site in the mid 1980s

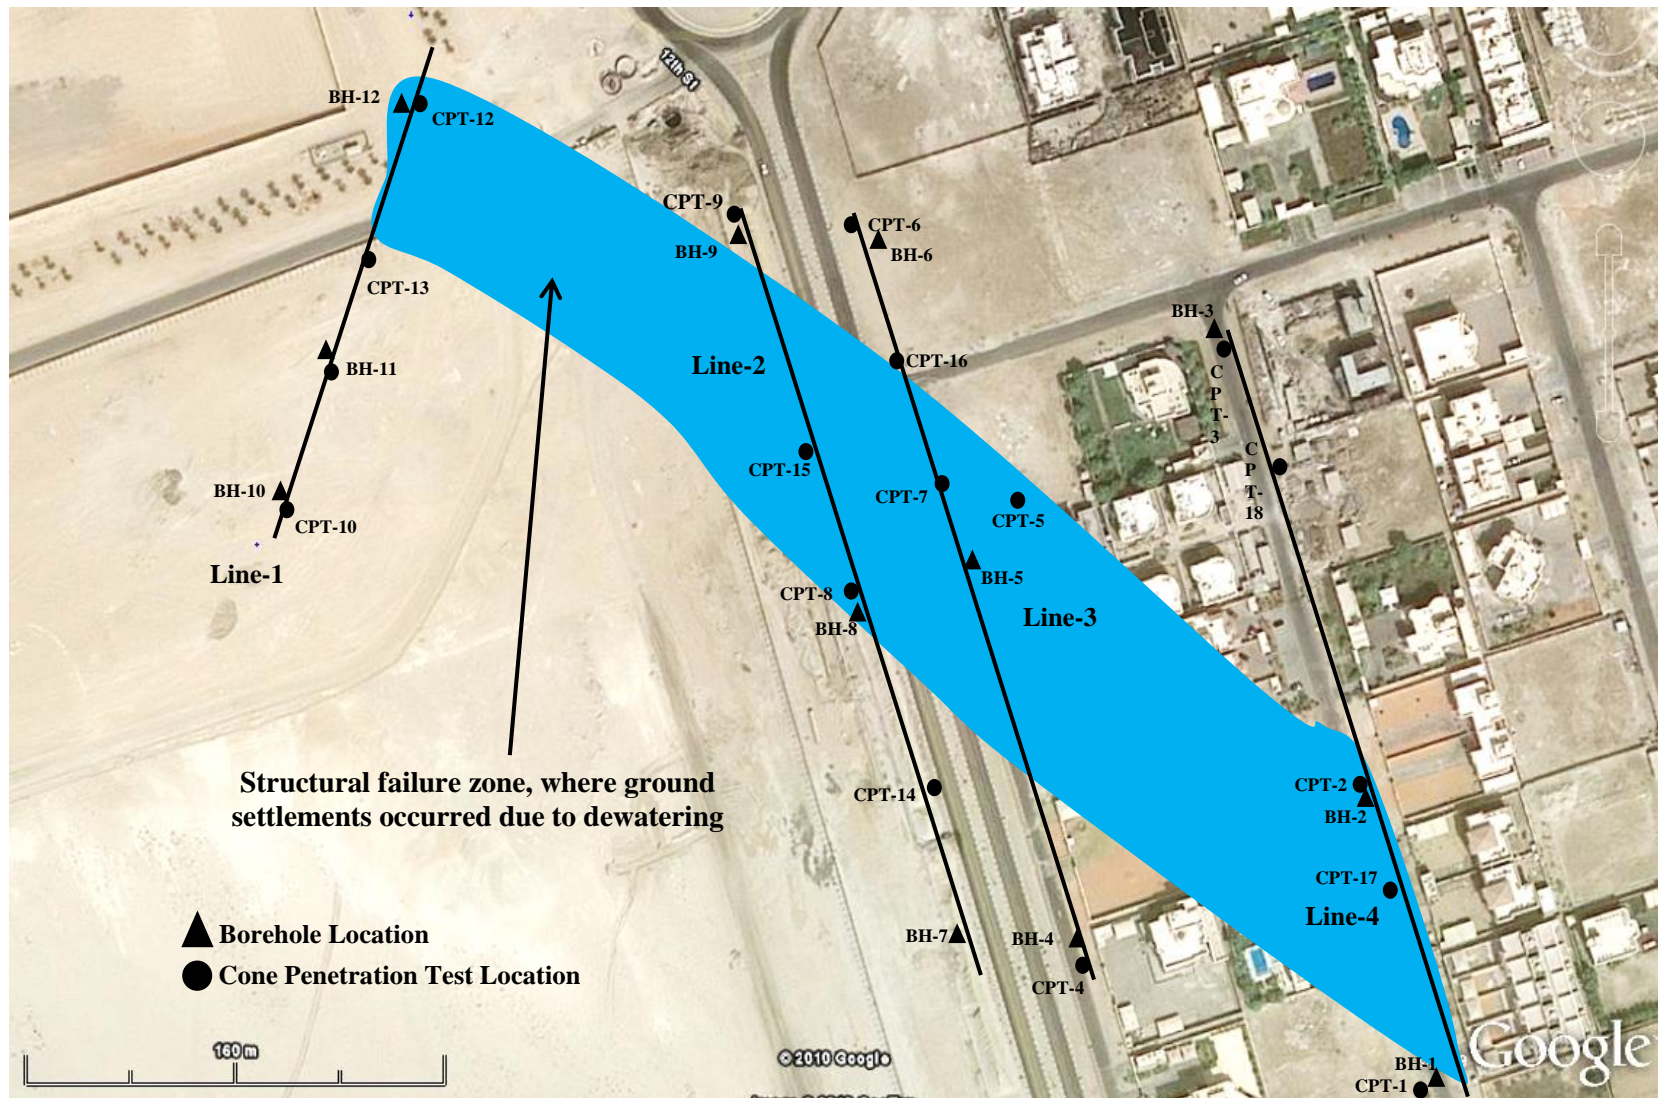
In the geophysical survey, four lines were marked on the ground. Two of the lines were on either side of the structural failure area while the other two lines diagonally crossed the roadway lying over the dewatered area (Fig. 5). Geophysical investigations were carried out on each of the survey lines using two different methods namely Multichannel Analysis of Surface Waves (MASW) method and Electrical Resistivity Tomography (ERT). In the MASW technique, a surface wave was generated on the ground surface to travel through the ground at different depths before being refracted back to the surface. The

**Fig.5** Distressed area and geophysical investigation lines (Lines 1-4)

Given the type of soil and prevailing density values, it was suggested to perform ground improvement using techniques such as vibro-compaction or stone columns. The ground improvement works was to cover the 'right of way' of the road traversing the structural failure area and extending to a minimum of 25 m beyond the edges of the structural failure area. The improvement was to target a minimum RD of 70%, confirmed by proof tests at randomly selected points, during the improvement process. It was further recommended:

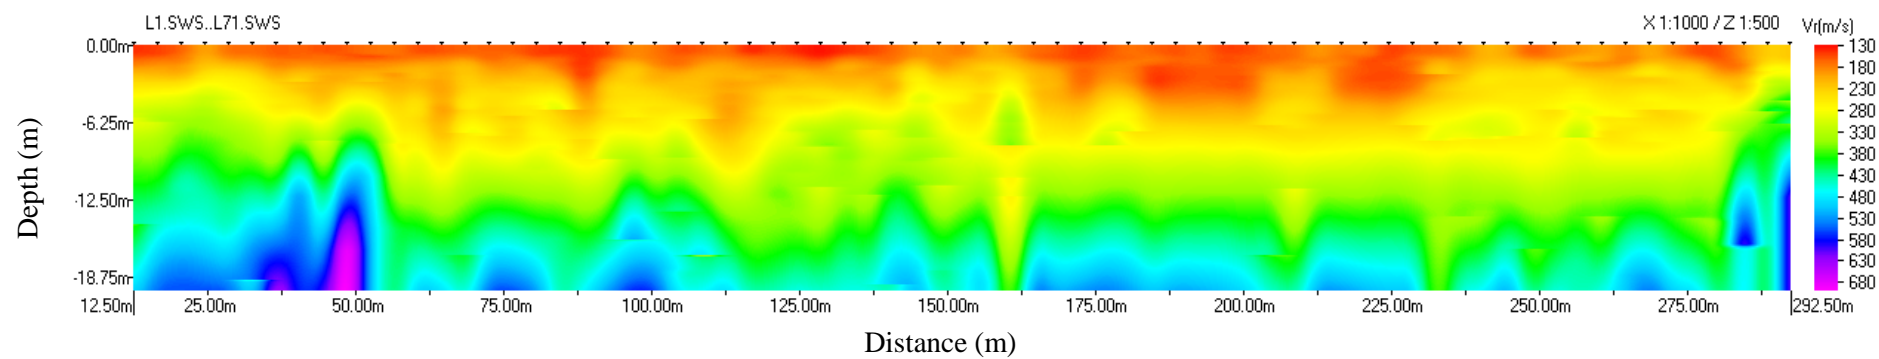
In general, the MASW survey results showed distinct anomalies equating to relatively low shear wave velocities  $\leq 200$  m/s for depths down to 3.0m below the existing ground level. At this depth, the principal stratum was identified to be weak Sabkha soil. At particular locations within the structural failure area, the anomalies extended deeper (7.5m - 8.5m below ground surface) suggesting a possible correlation between the failures and the anomalies detected in the survey. A typical result of a survey line can be seen in Fig. 6.

**Fig.6** MASW survey result (Line 4)

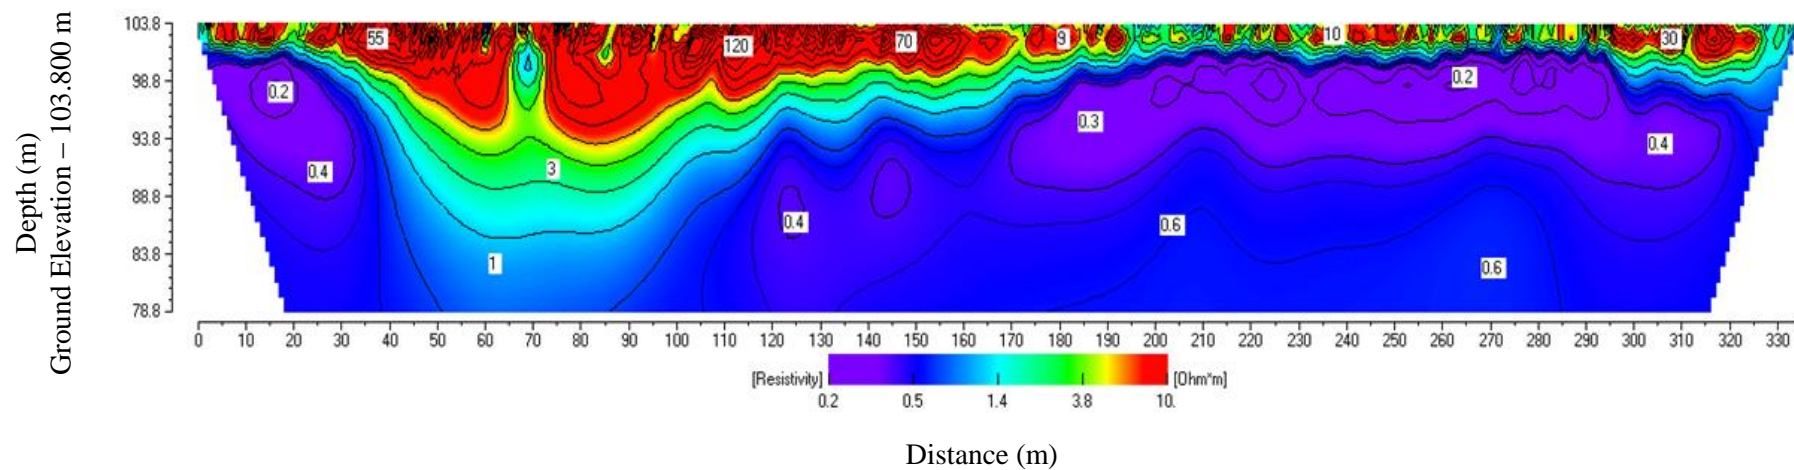
**Fig.7** ERT survey result (Line 4)

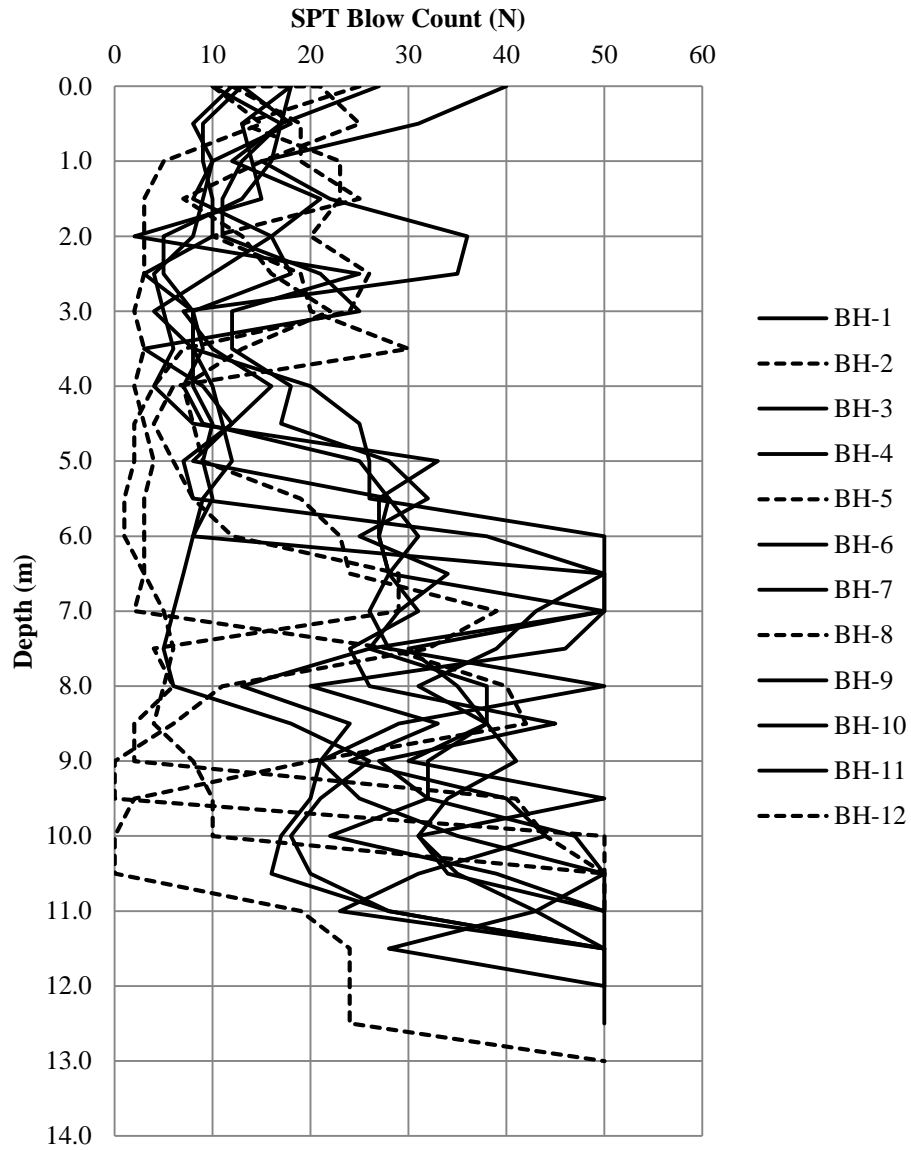
Very loose to loose soils, typically characterized by  $N < 10$  and  $q_c < 10$  MPa, were encountered at various locations (Table 3) both inside and outside of the structural failure area. Generally CPT results showed low  $q_c$  values from 3.0 m to 4.0 m depths and also from 6.0 m to 7.0 m depths (this deep zone of low  $q_c$  being consistent with the MASW and ERT results depicting the anomalies). Therefore, there was strong consistency between the results of different tests, all of which support the suspicion as to the genesis of the settlements and structural failures occurring in the area. In order to demonstrate the strata differences between areas inside and outside the predicted location of the dredged channel, values of SPT N and CPT  $q_c$  were plotted against depth as shown in Figs. 8 and 9. These show that the thickness of the very loose to loose soils to be apparently larger within the structural failure area than outside of it. In addition, borehole

logs showed that the thickness of the sandy fill material was considerably greater within the structural failure area than outside of it.

**Fig.8** SPT blow counts versus depth  
 (----- within structural failure zone; ——— outside structural failure zone)

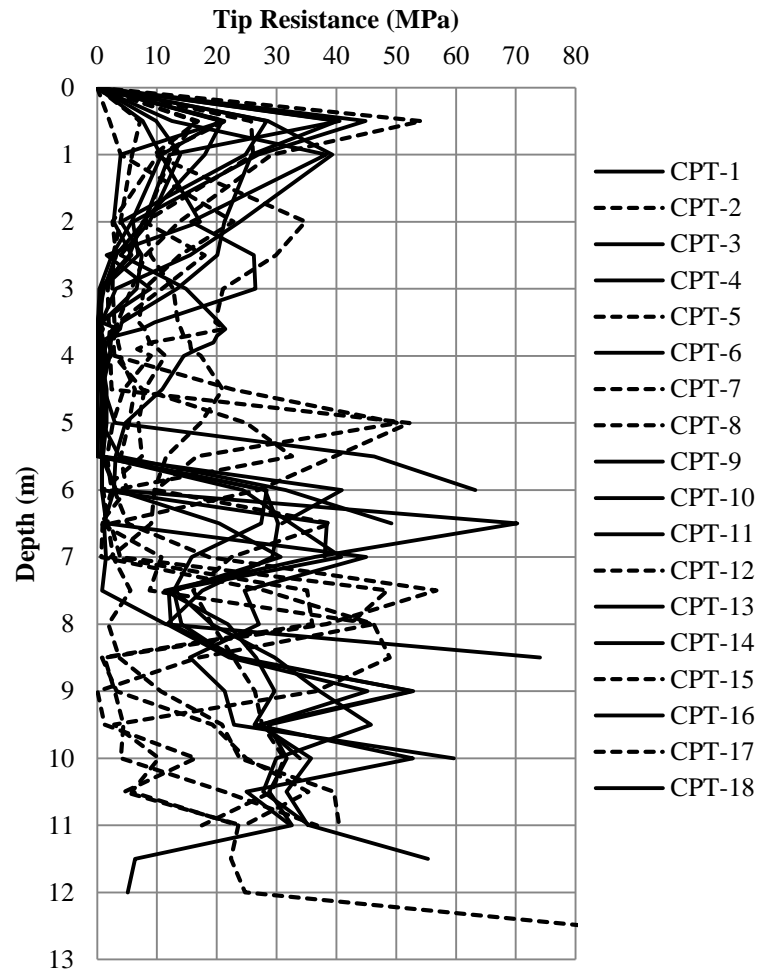
**Fig.9** Cone tip resistance versus depth  
 (----- within structural failure zone; ——— outside structural failure zone)
