# Landslides in the Lower Greensand Escarpment of South Kent

Anna Hopper

A thesis submitted in partial fulfilment of the requirements of  
Kingston University  
for the degree of Doctor of Philosophy

December 2000

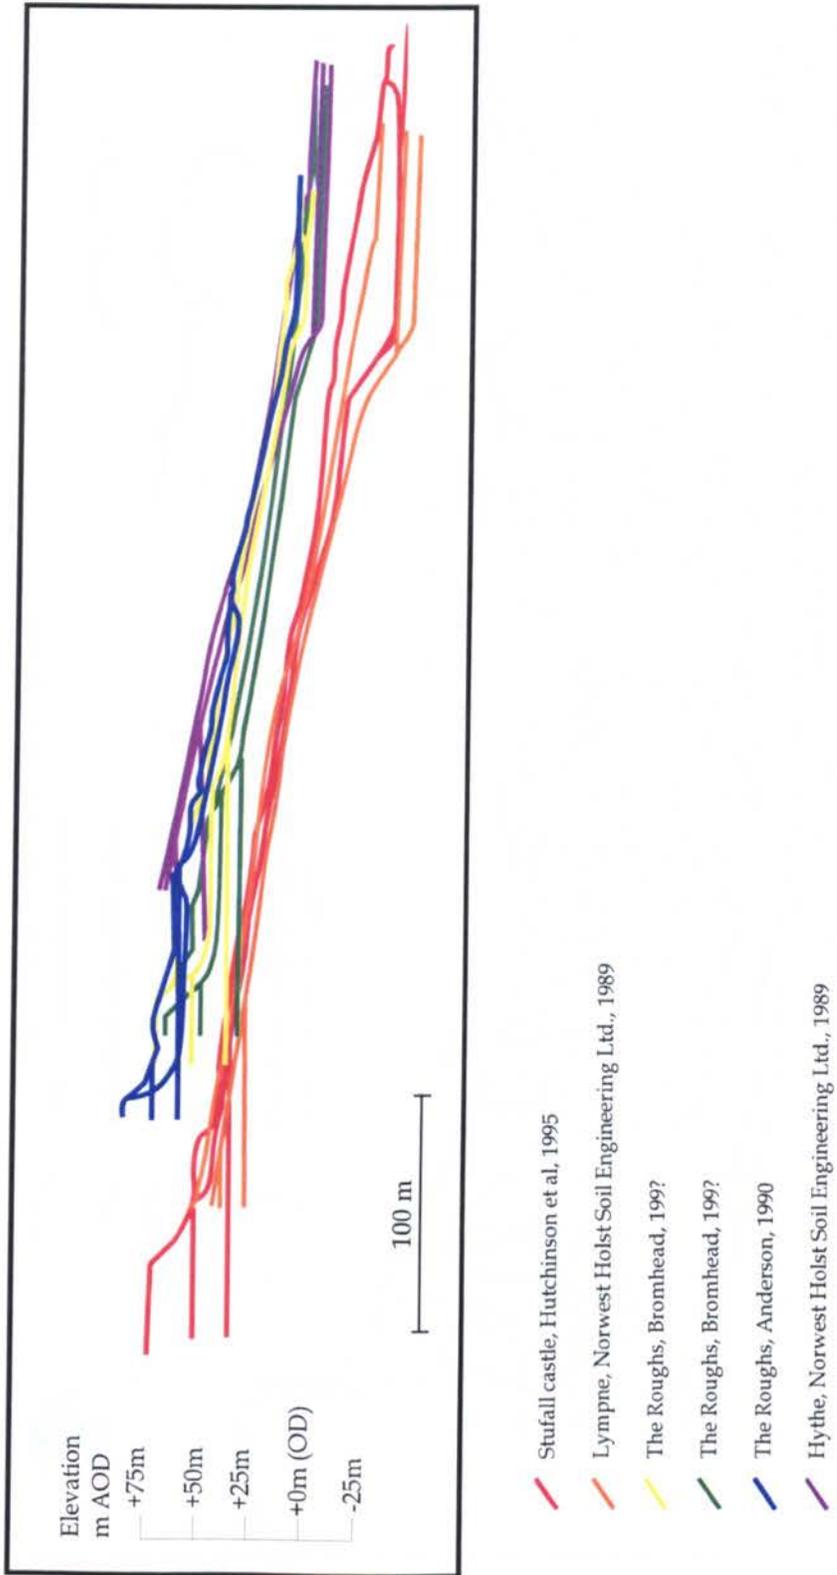
Figures 3.5 (top), 3.6 (middle) and 3.7 (bottom). Geological sections through the Lympe Escarpment, from west to east.

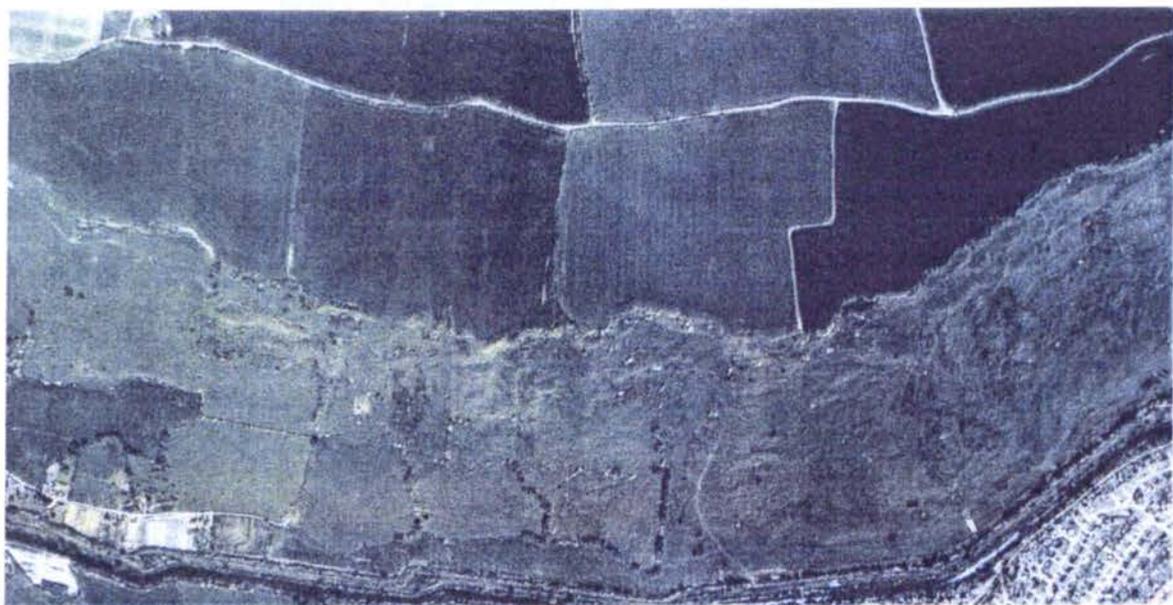
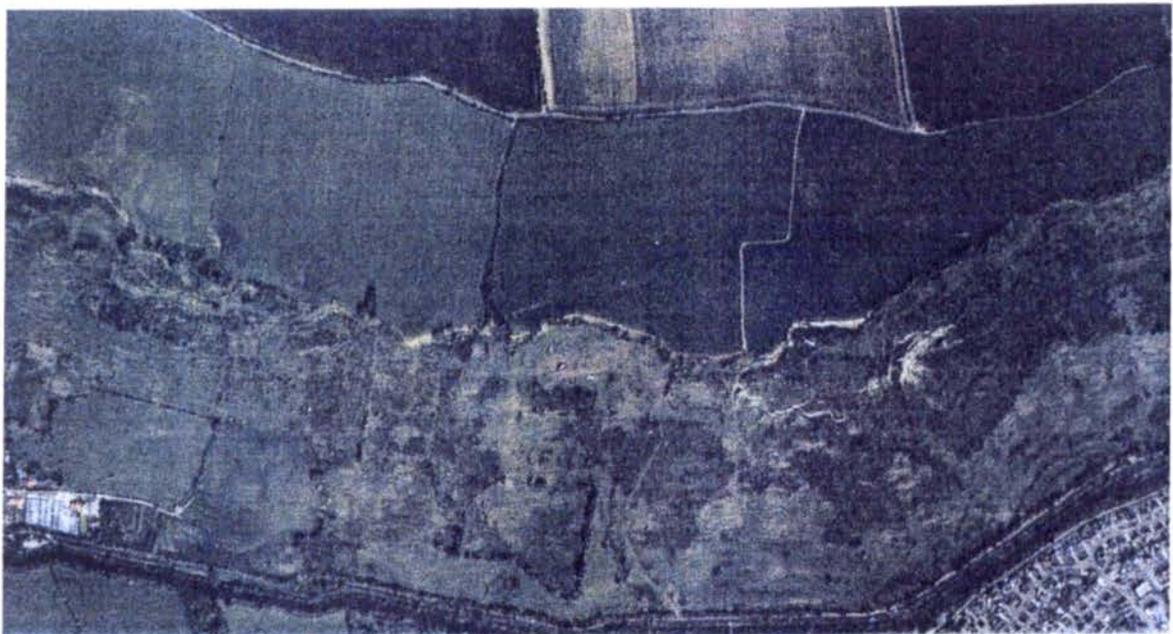
Plate 3.1 (Above). Aerial photograph of The Roughs taken in 1985, before reactivation of the landslides.

Plate 3.2 (Below). Aerial photograph of The Roughs taken in 1990, after reactivation of the landslides.

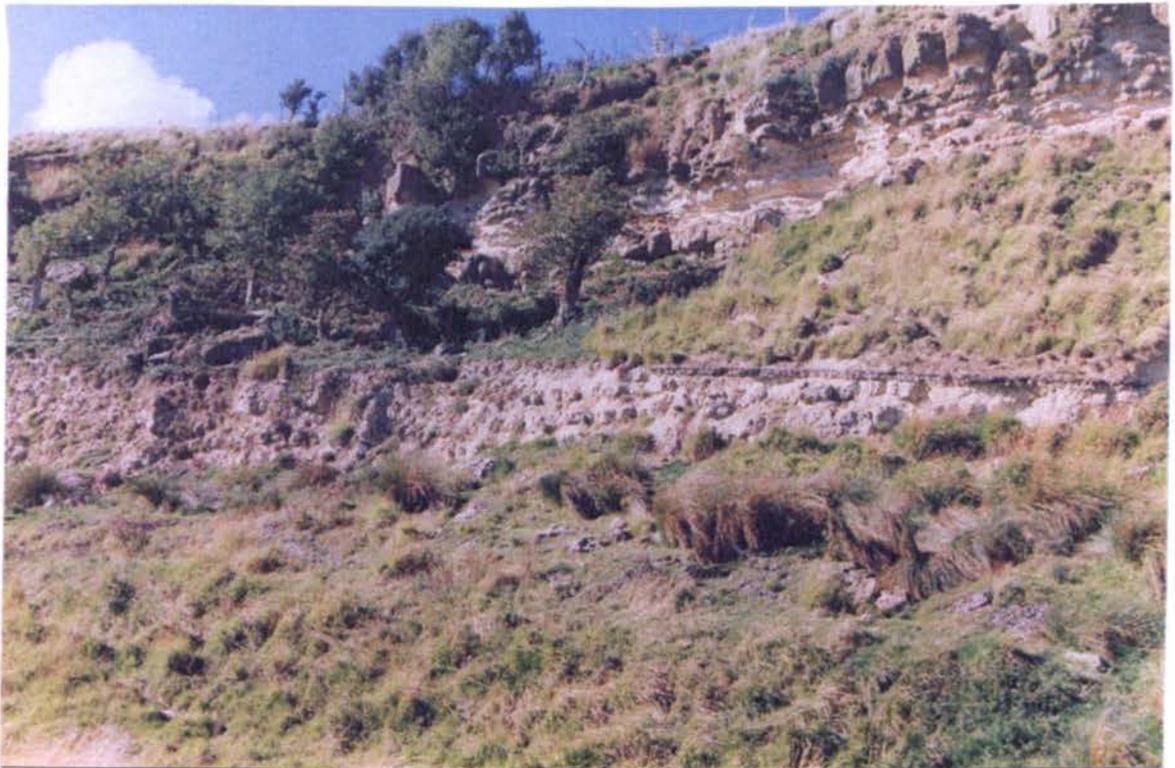
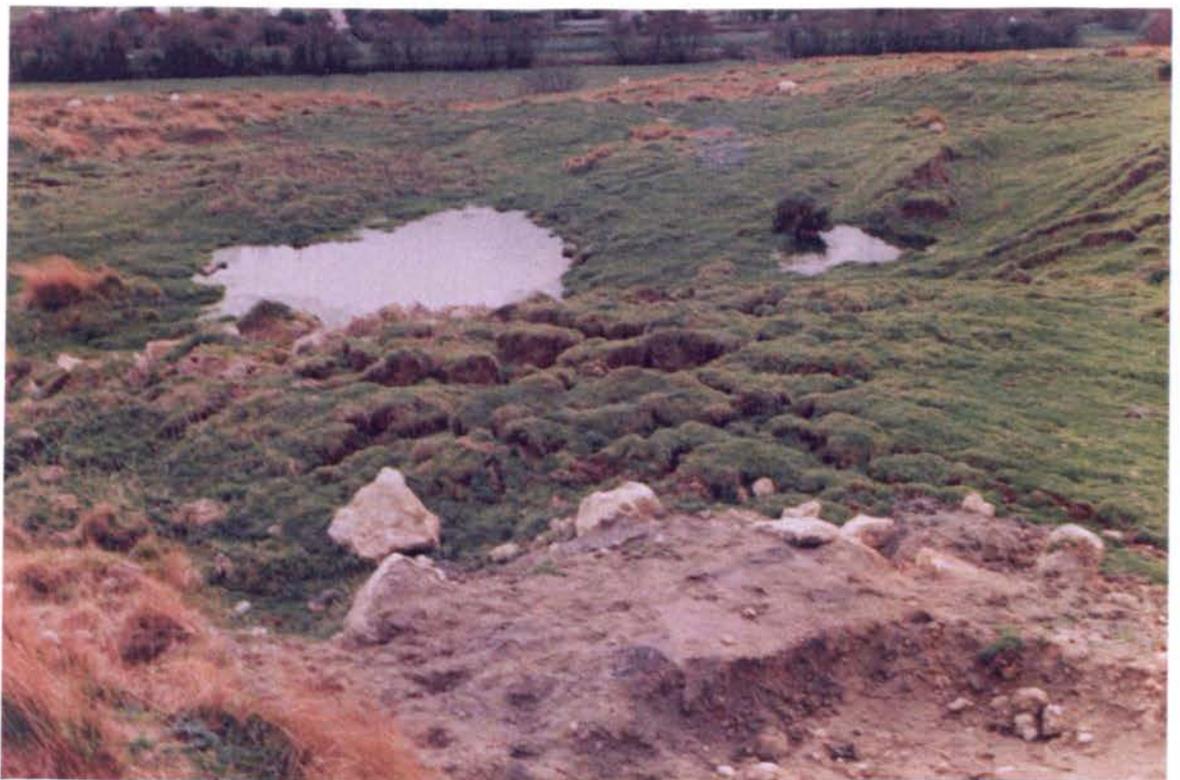
Plate 3.3 (Above). An example of ponding on The Roughts  
Plate 3.4 (Below). The remains of the access road to the Acoustic Research Centre, in the Hythe Beds.

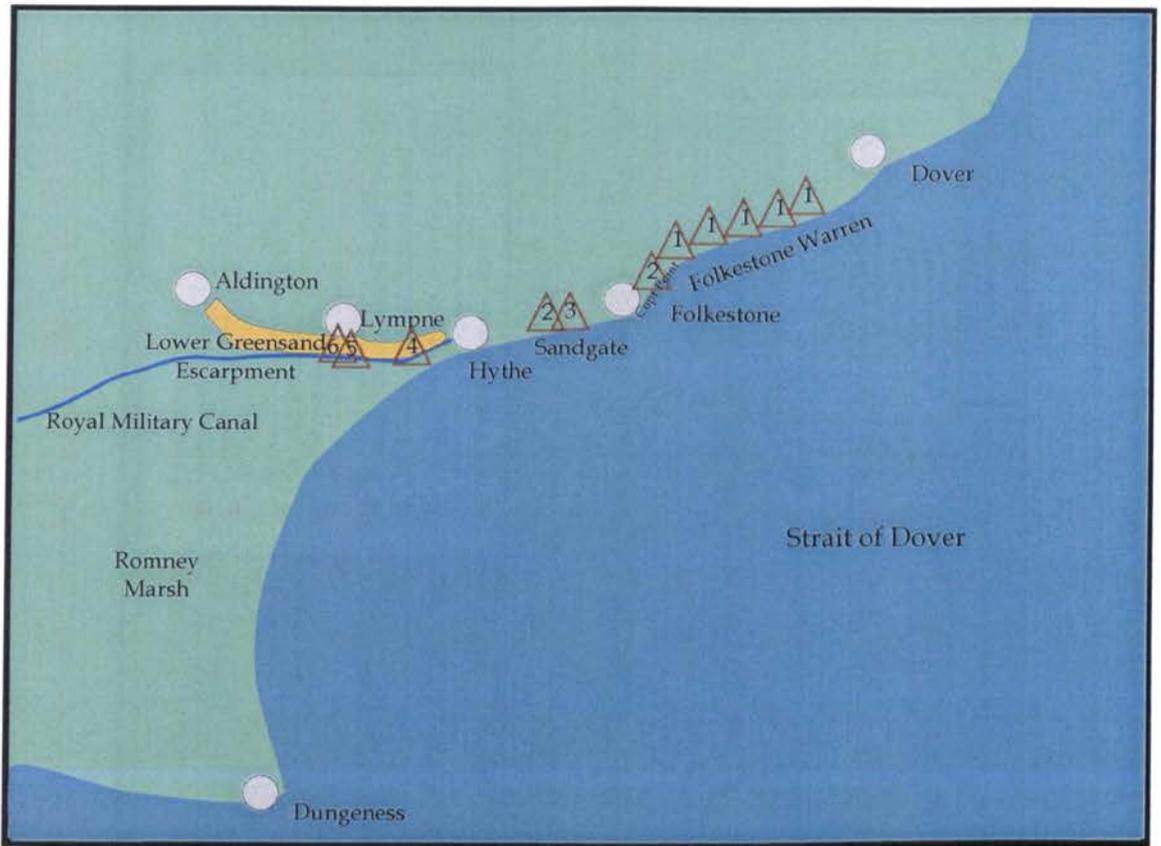
Figure 4.1. Location of landslides in the vicinity of The Roughts.

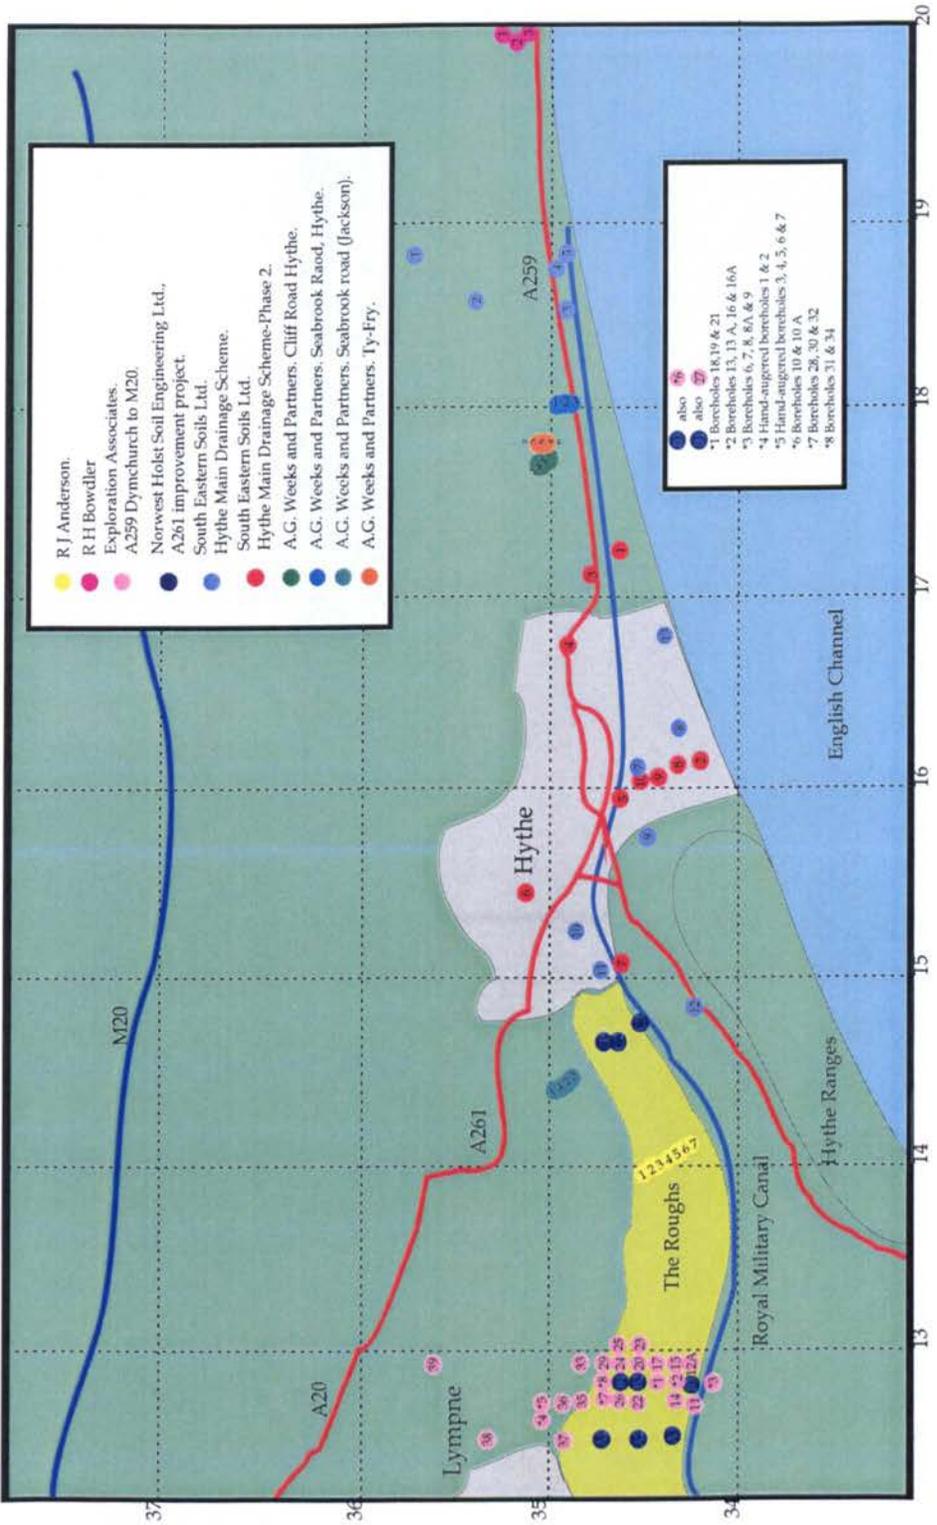
Figure 4.2. Location of boreholes in the vicinity of The Roughs.

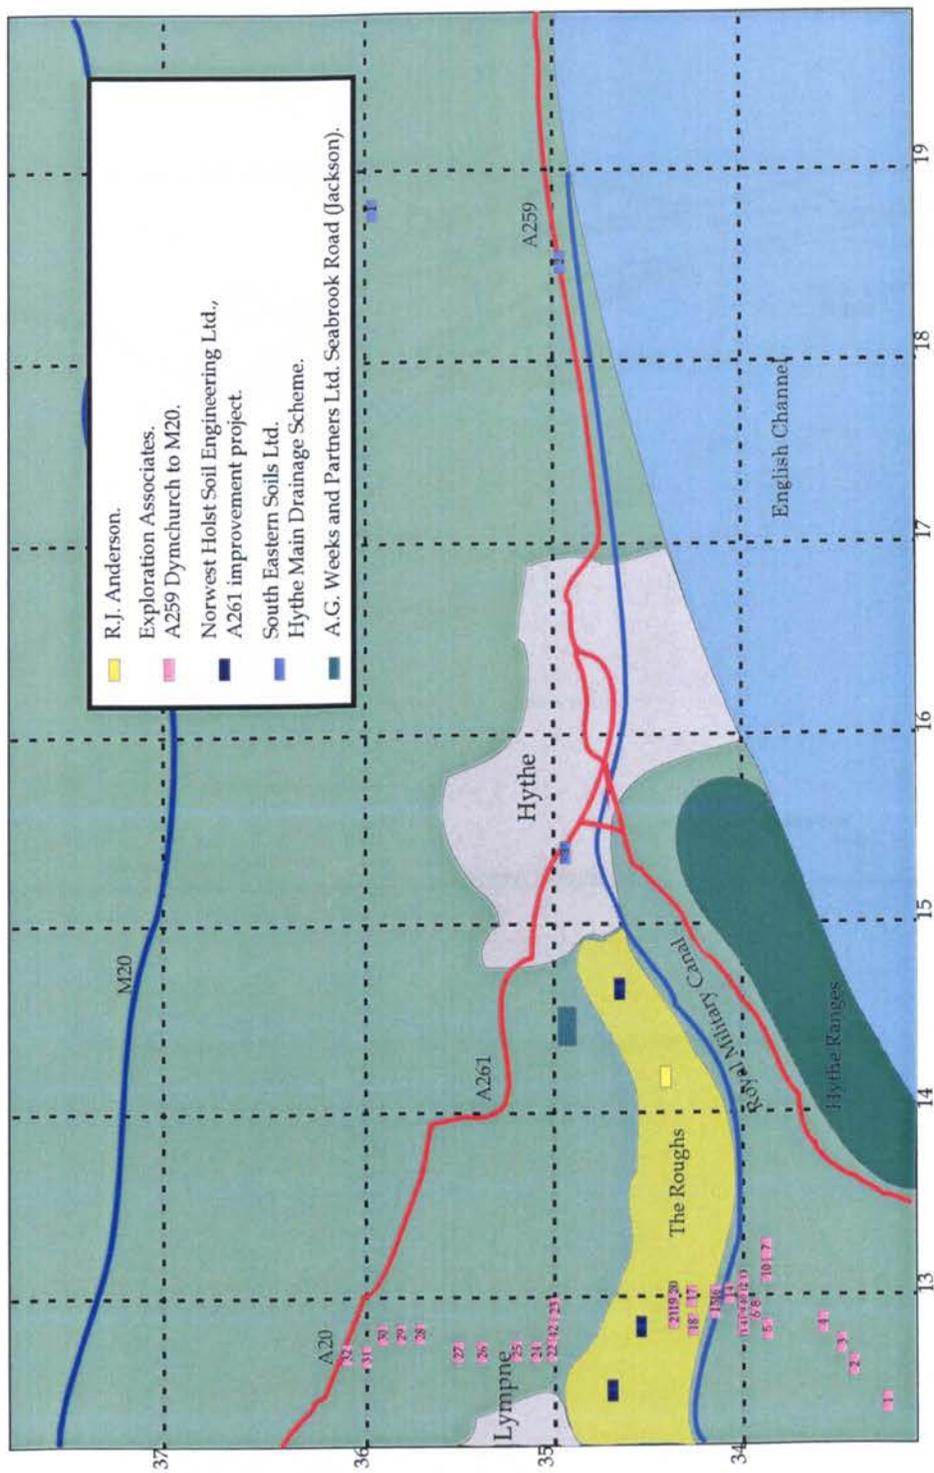
Figure 4.3. Location of trialpits in the vicinity of The Roughs.

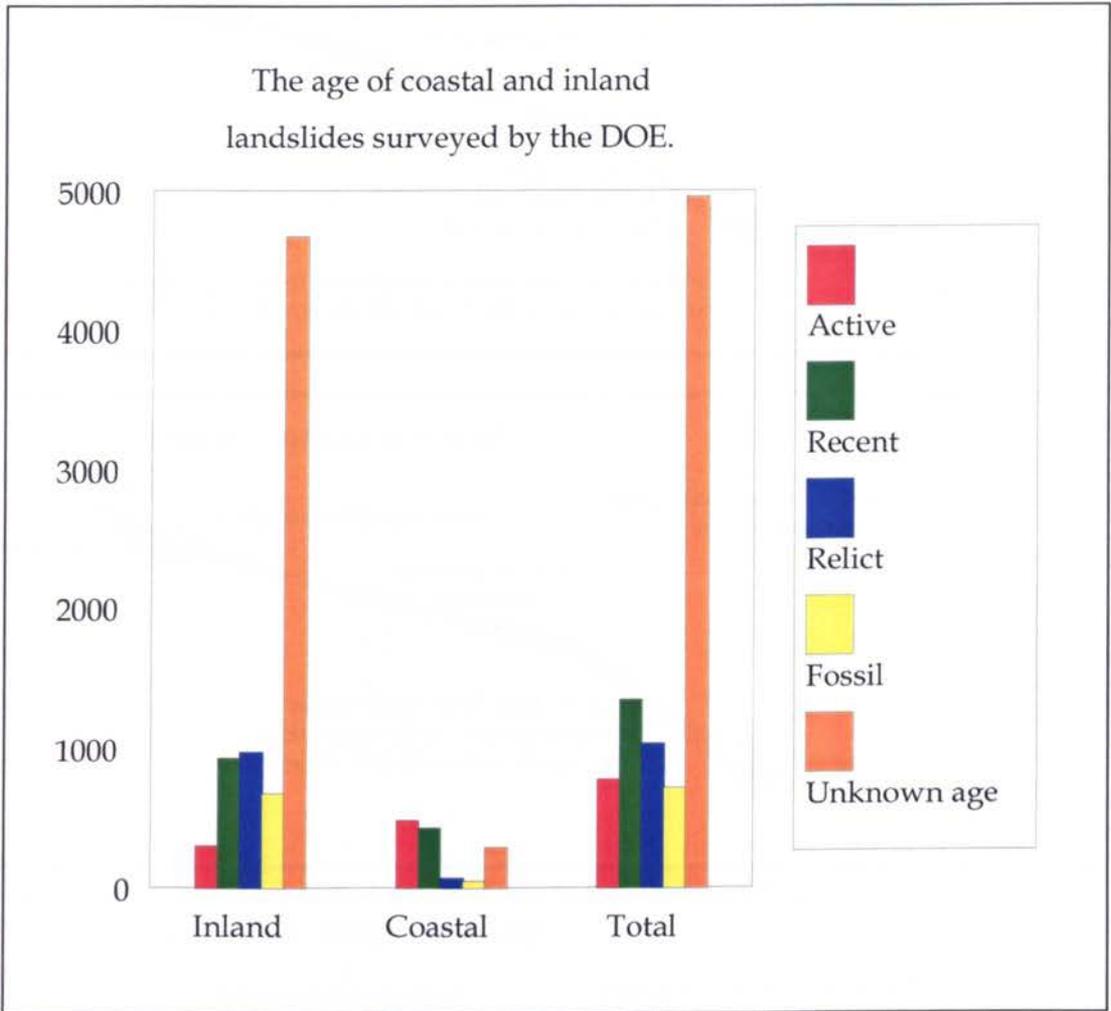
Figure 5.2. Bar chart showing the numbers of coastal and inland landslides in each age category specified by the DOE.

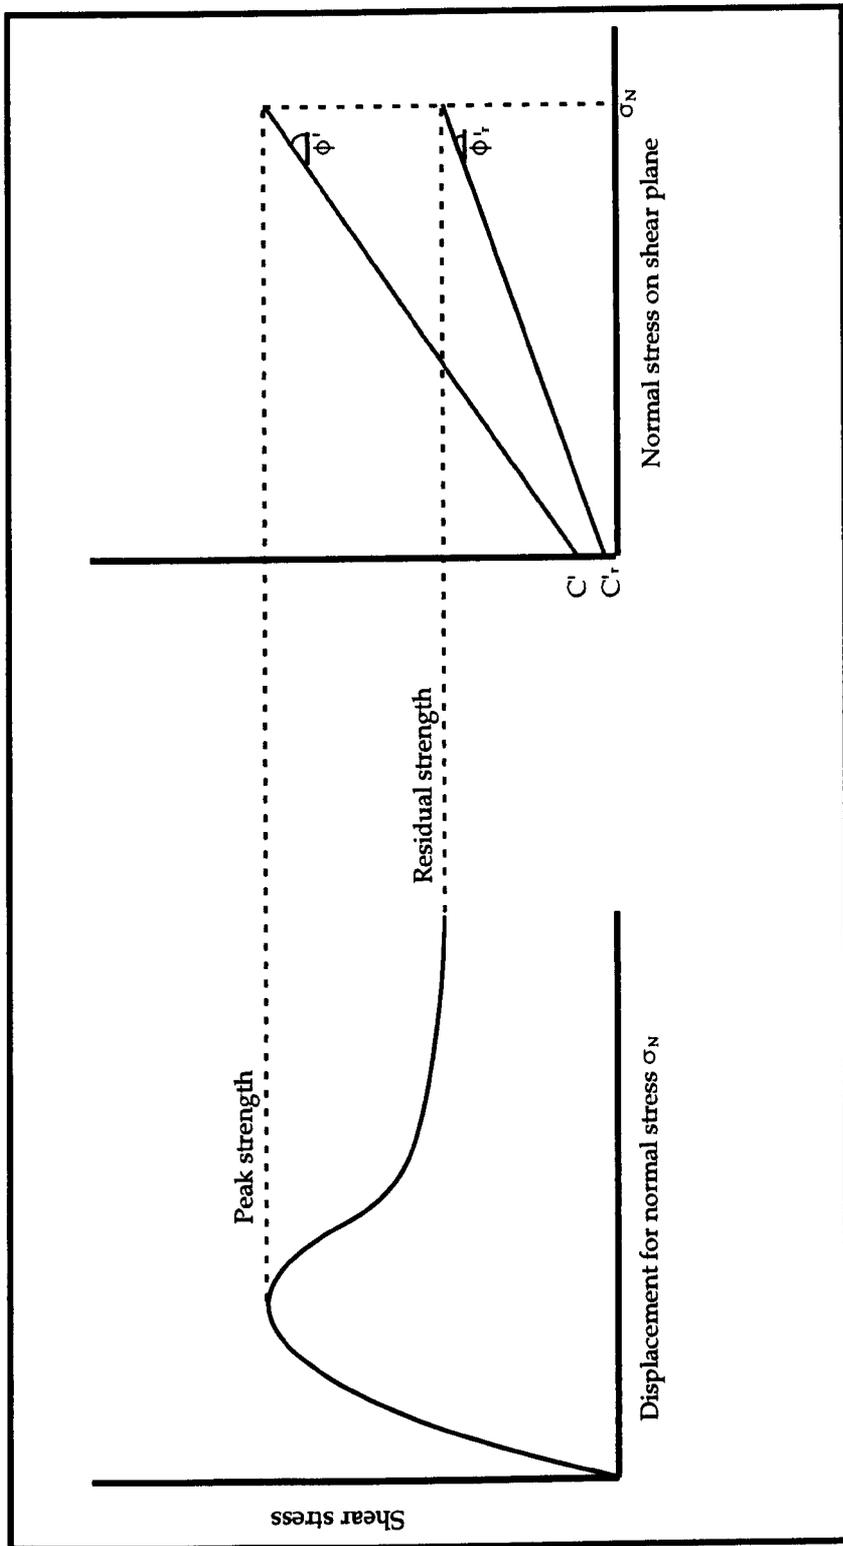
Figure 5.6. Graphs showing the relationship between shear strength and both stress and strain for an overconsolidated clay.

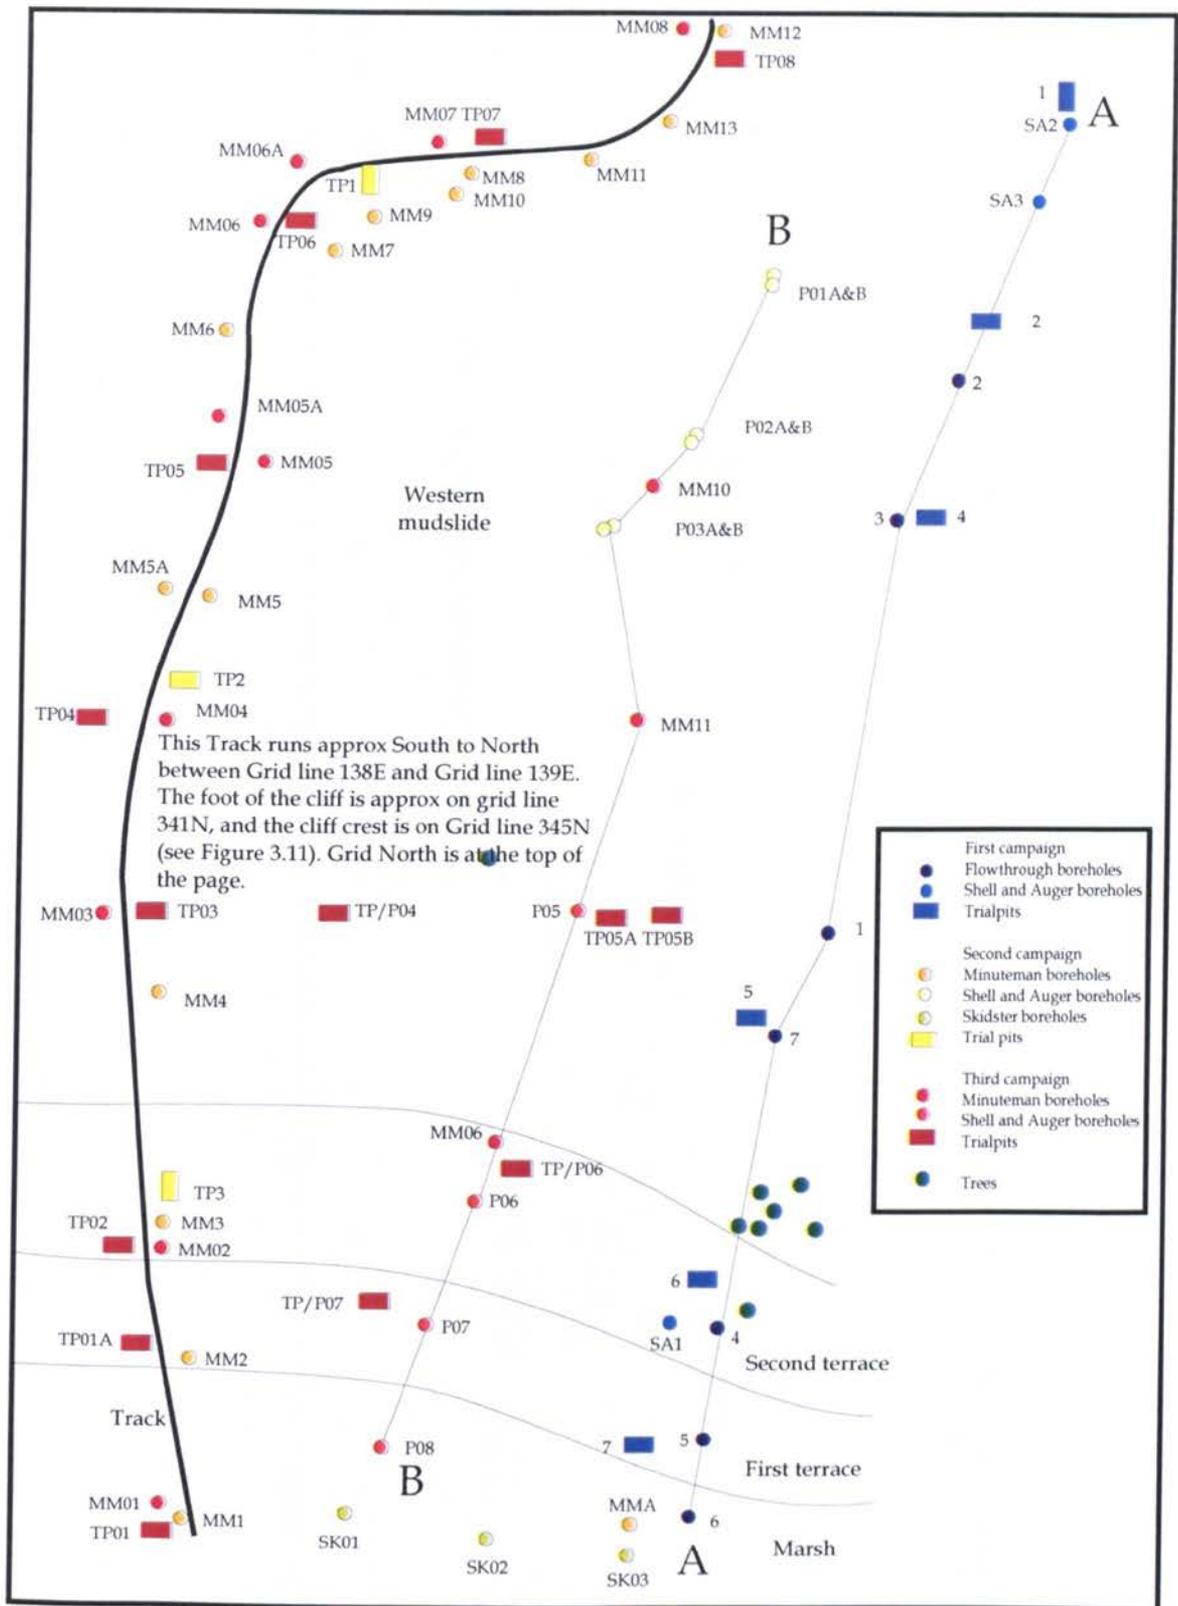
Figure 6.1. Sketch map of The Roughs showing the position of boreholes and trialpits.

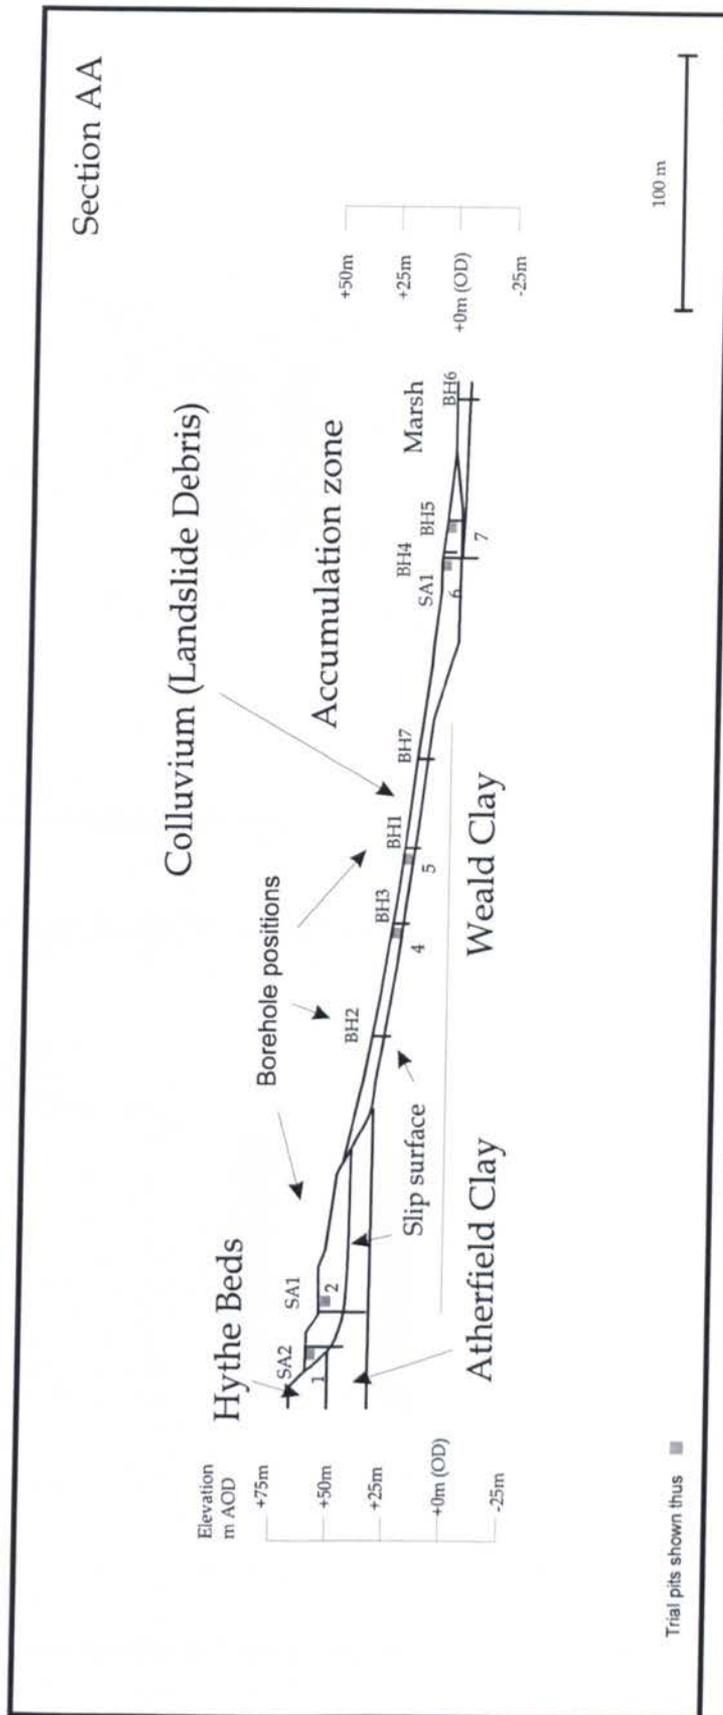
Figure 6.2. Section AA through The Roughs.

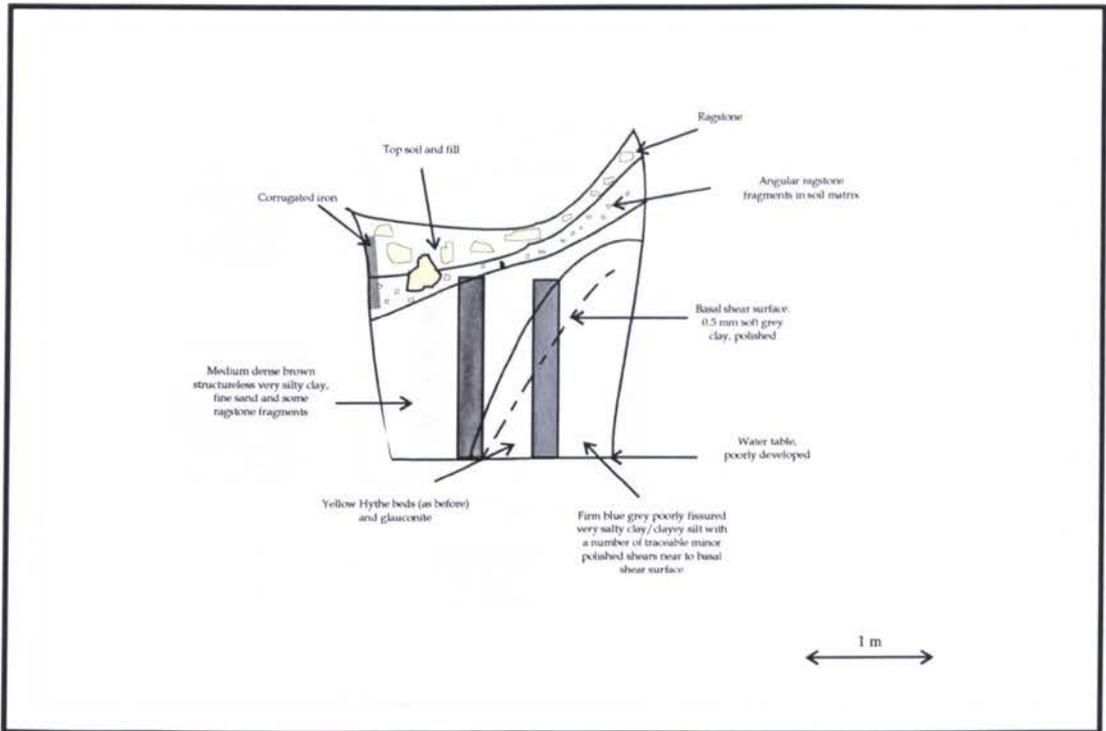
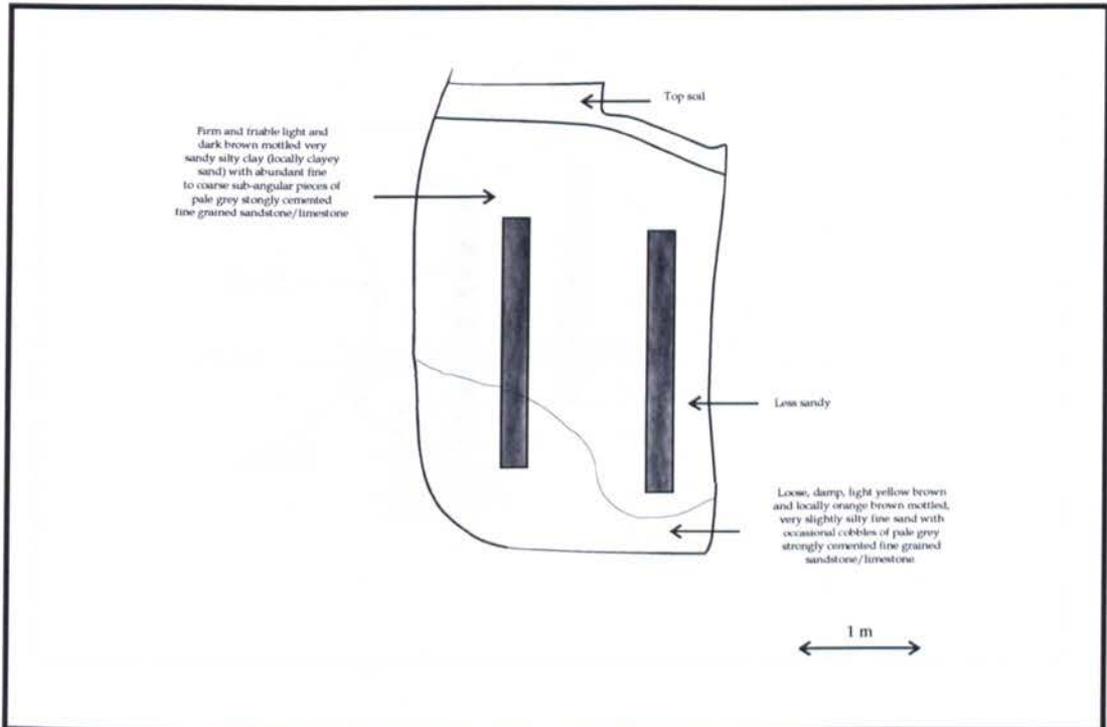
Figure 6.3 (above) and Figure 6.4 (below). Diagrams depicting western face of Trialpit 1 and eastern face of Trialpit 2, respectively.

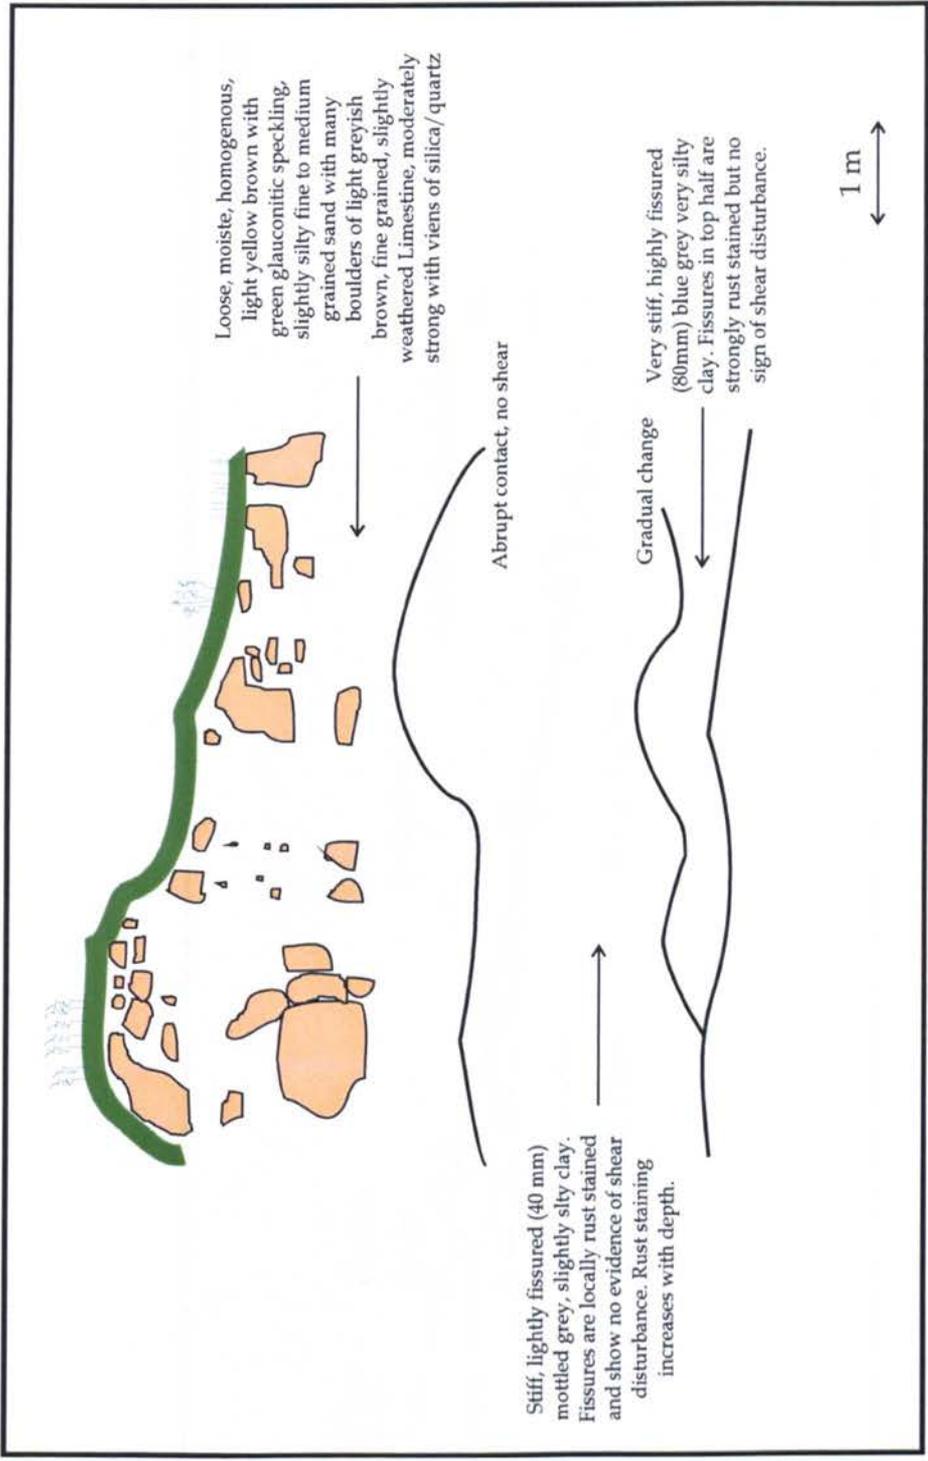
Figure 6.9. Diagram depicting the cleared face of scarp east of western mudslide.

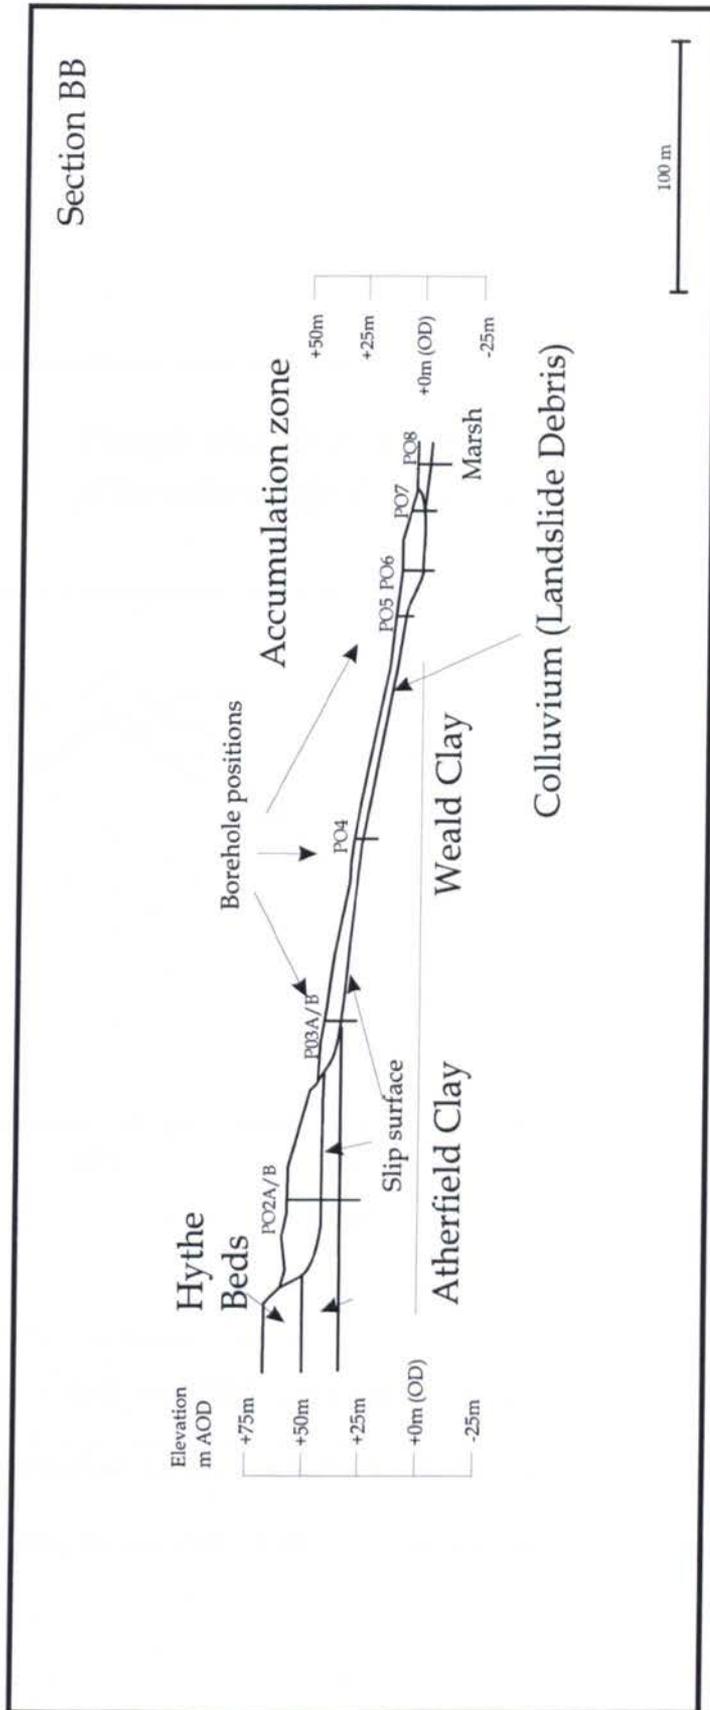
Figure 6.10. Section BB through The Roughs

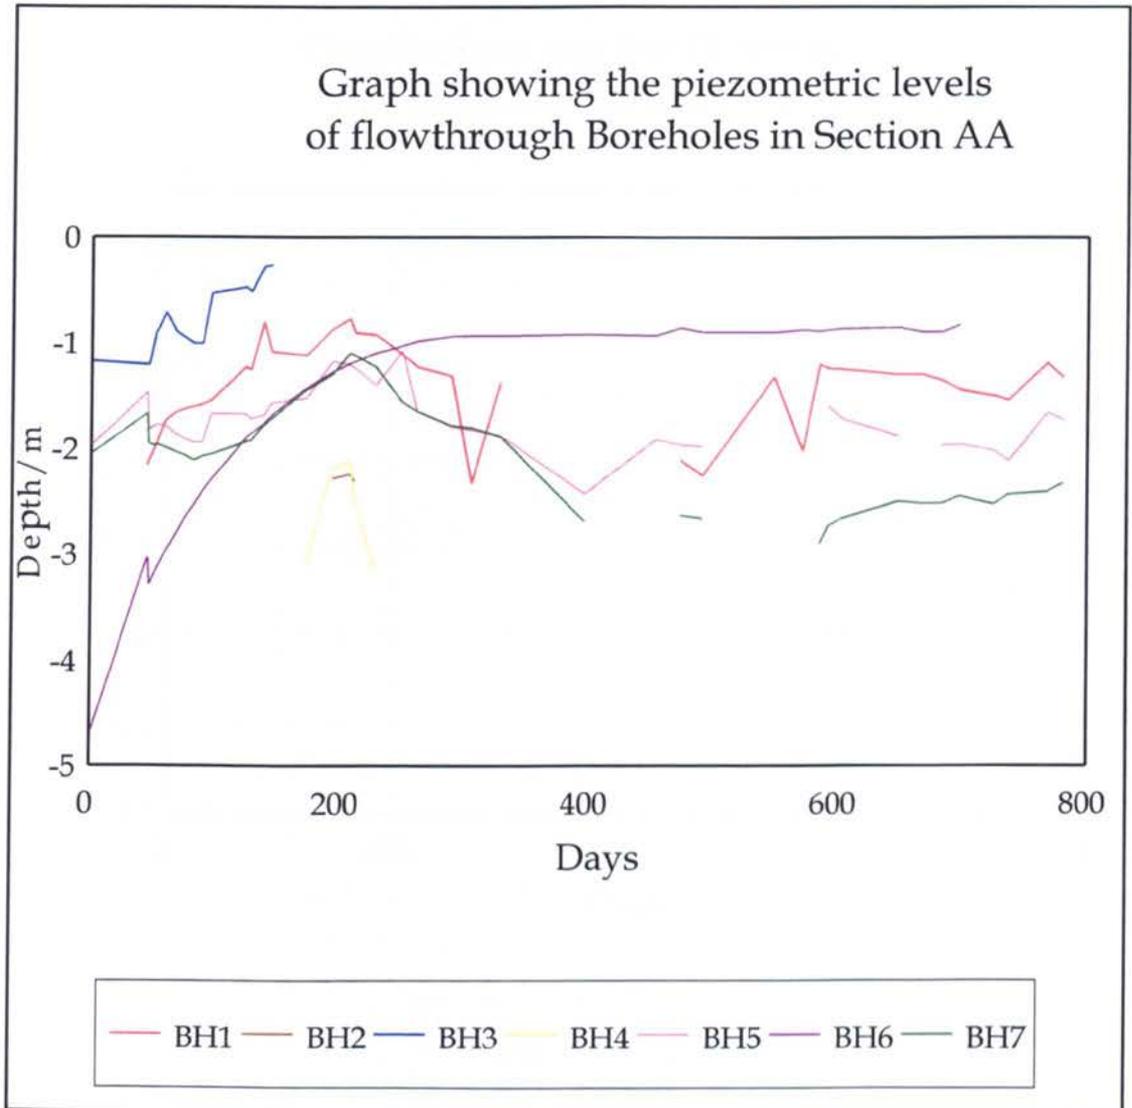
Figure 6.11. Graph showing the piezometric levels of flowthrough boreholes in Section AA.

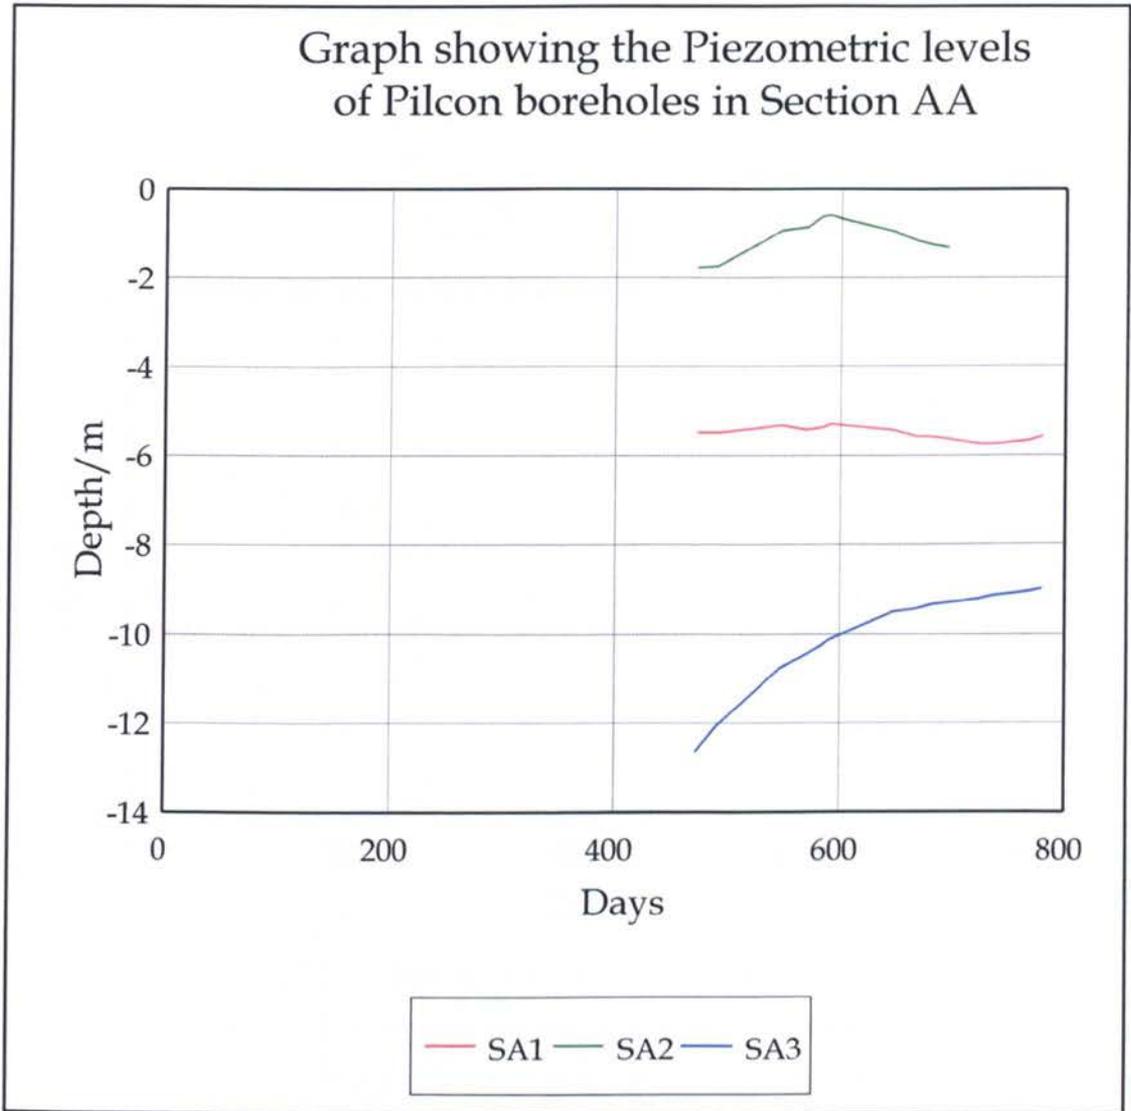
Figure 6.12. Graph showing the piezometric levels of pilcon boreholes in Section AA.

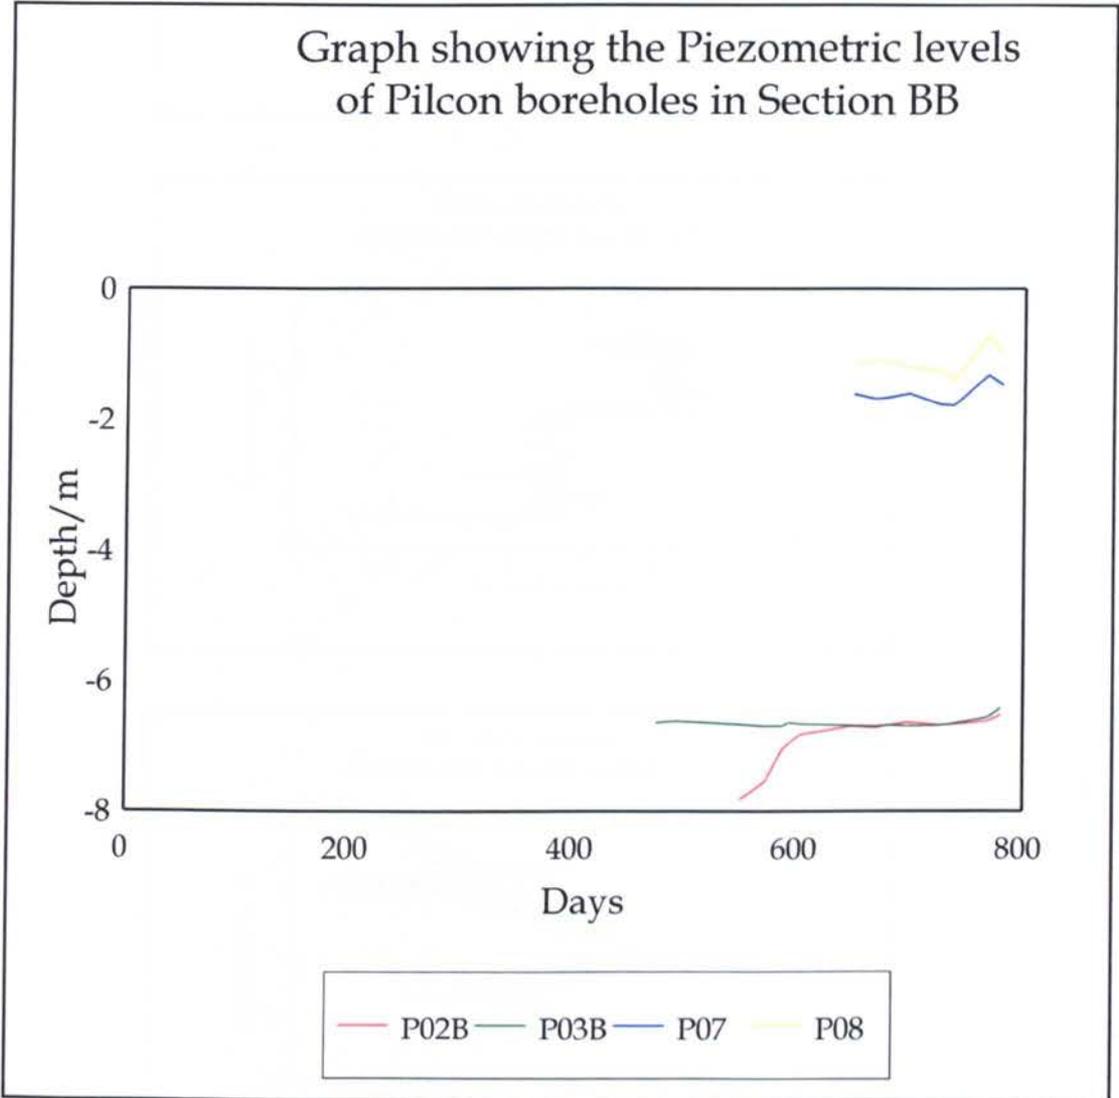
Figure 6.13. Graph showing the piezometric levels of pilcon boreholes in Section BB.
