# Landslides in the Lower Greensand Escarpment of South Kent

Anna Hopper

A thesis submitted in partial fulfilment of the requirements of  
Kingston University  
for the degree of Doctor of Philosophy

December 2000

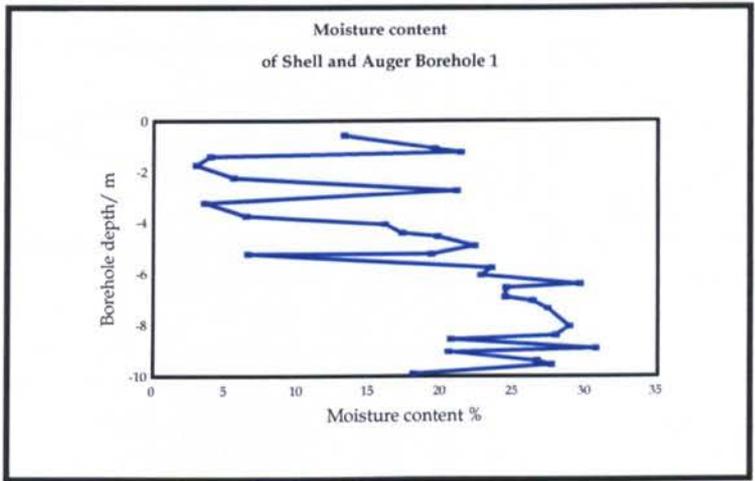
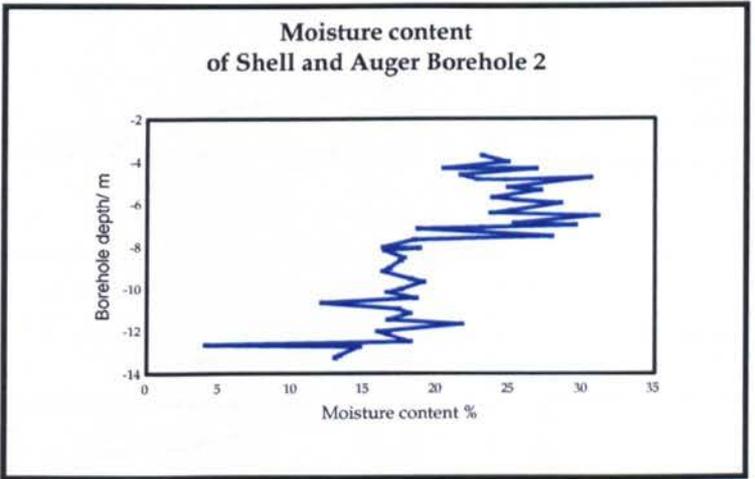
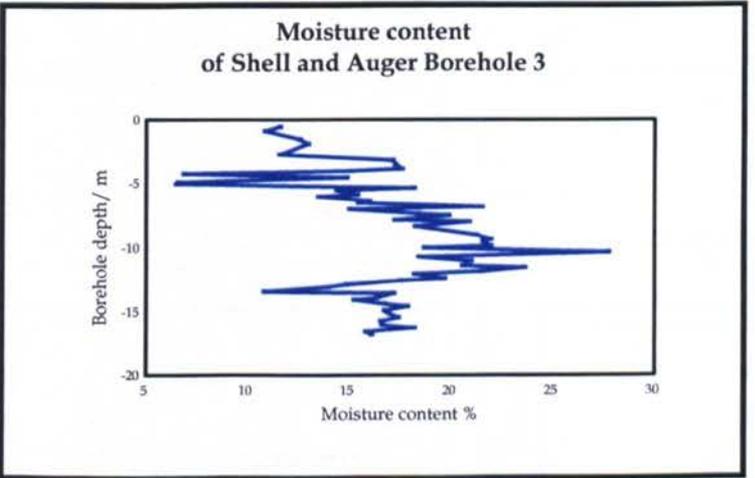
Figure 6.14. Graphs showing the variation of moisture content with depth for the pilcon boreholes in Section AA.

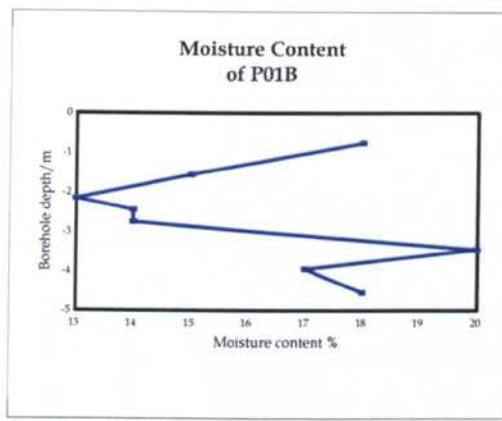
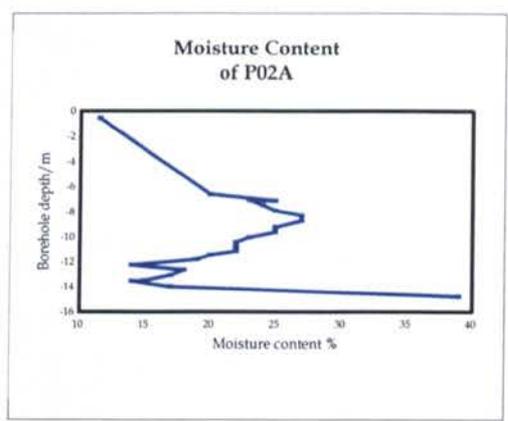
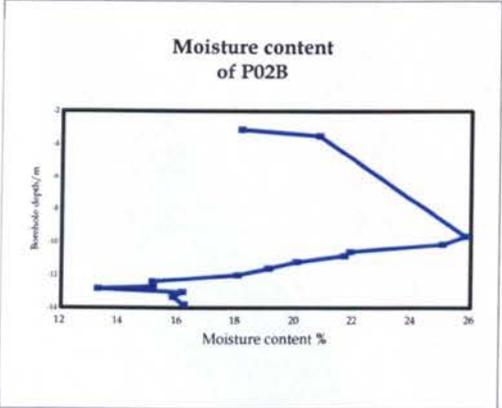
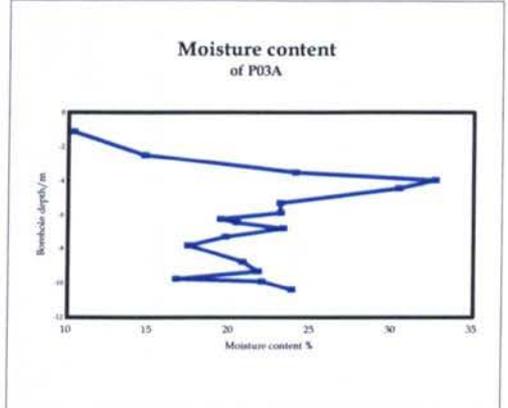
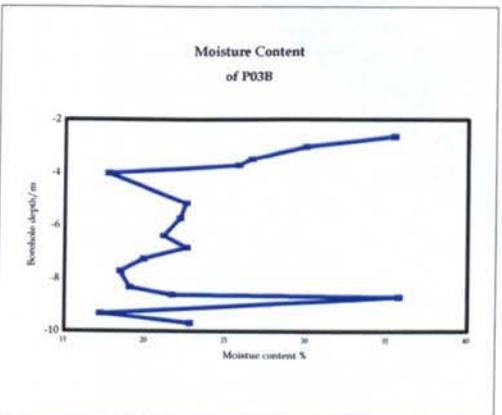
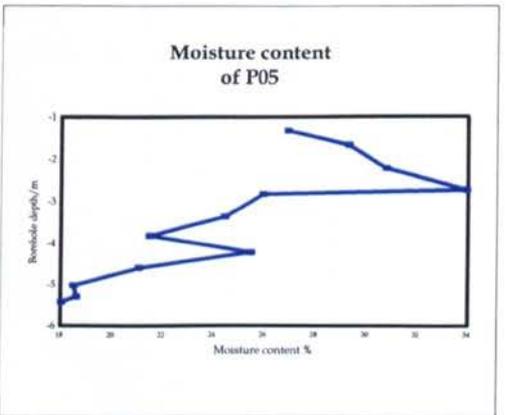
Figure 6.15. Graphs showing the variation of moisture content with depth for the pilcon boreholes in Section BB.

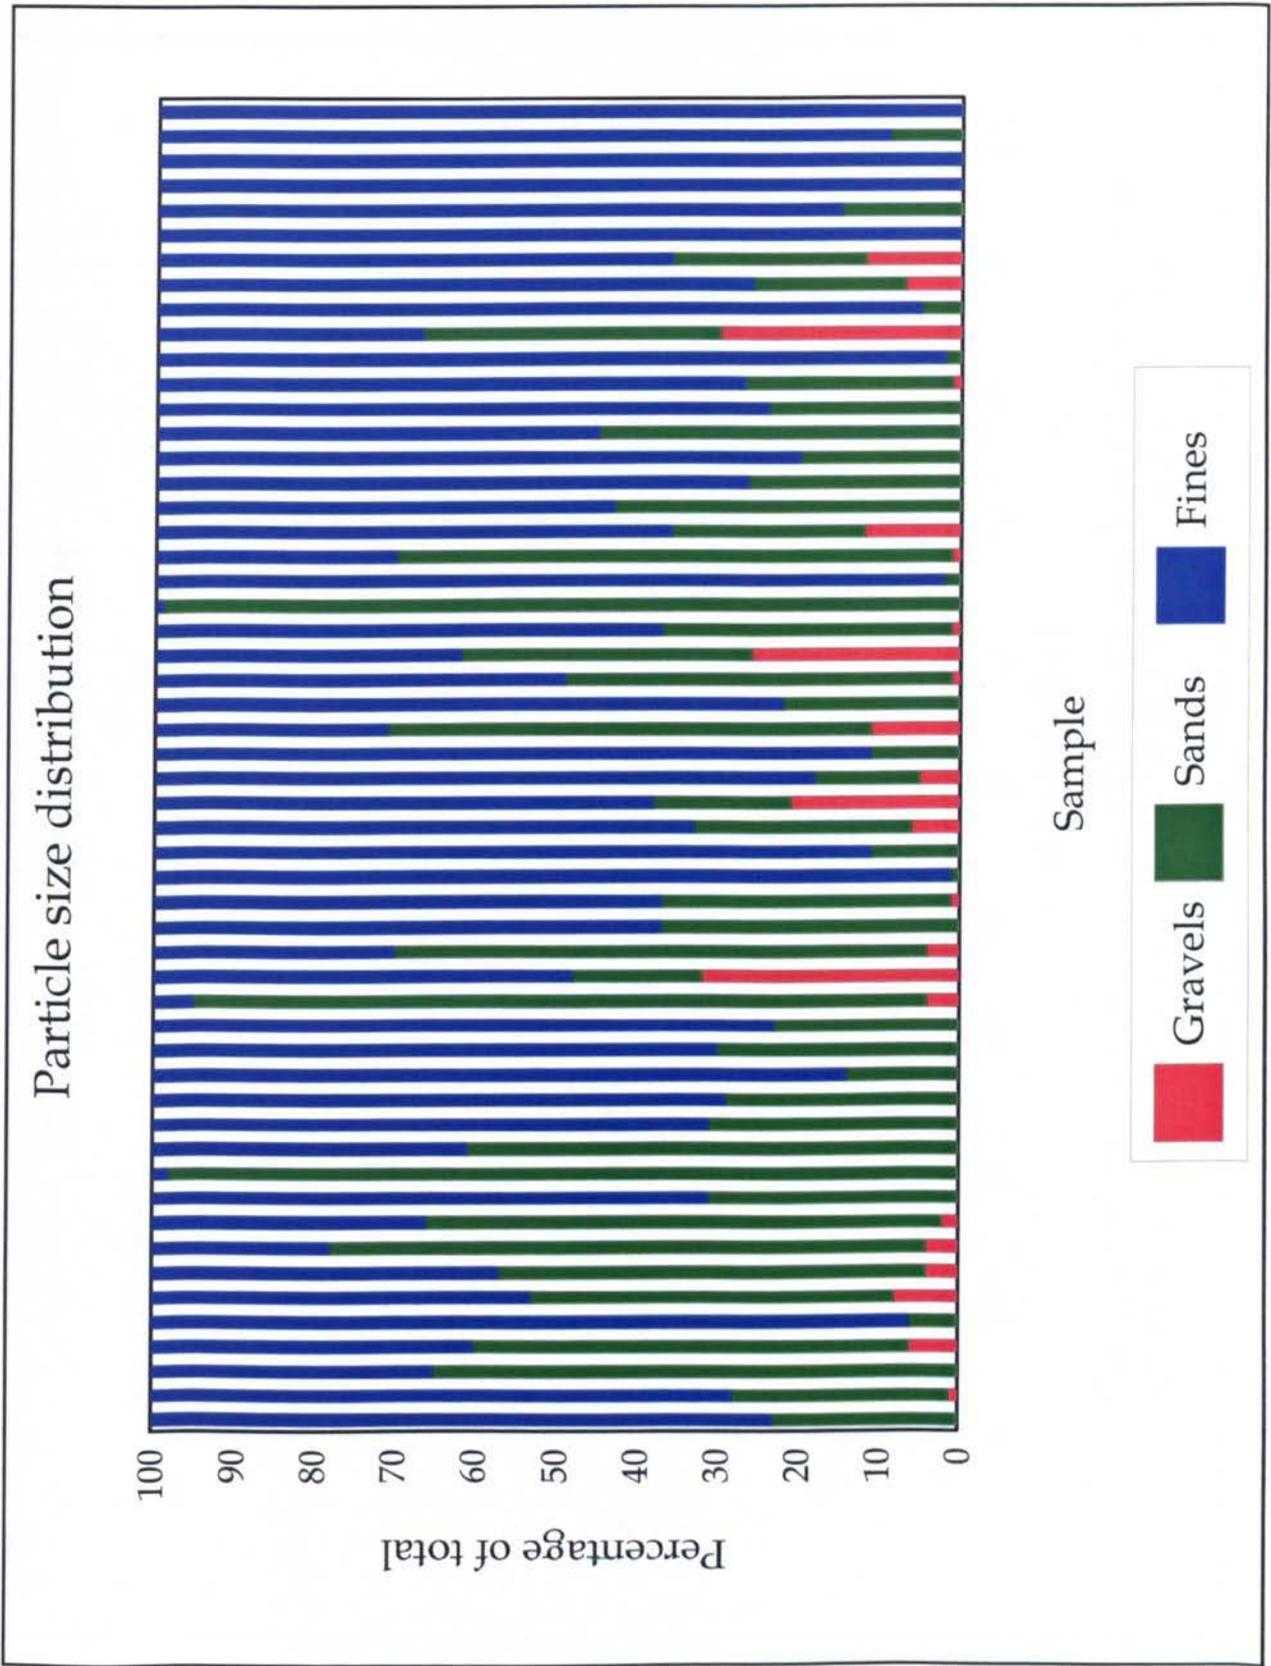
Figure 6.17. Bar chart showing the particle size distribution in samples from The Roughs.

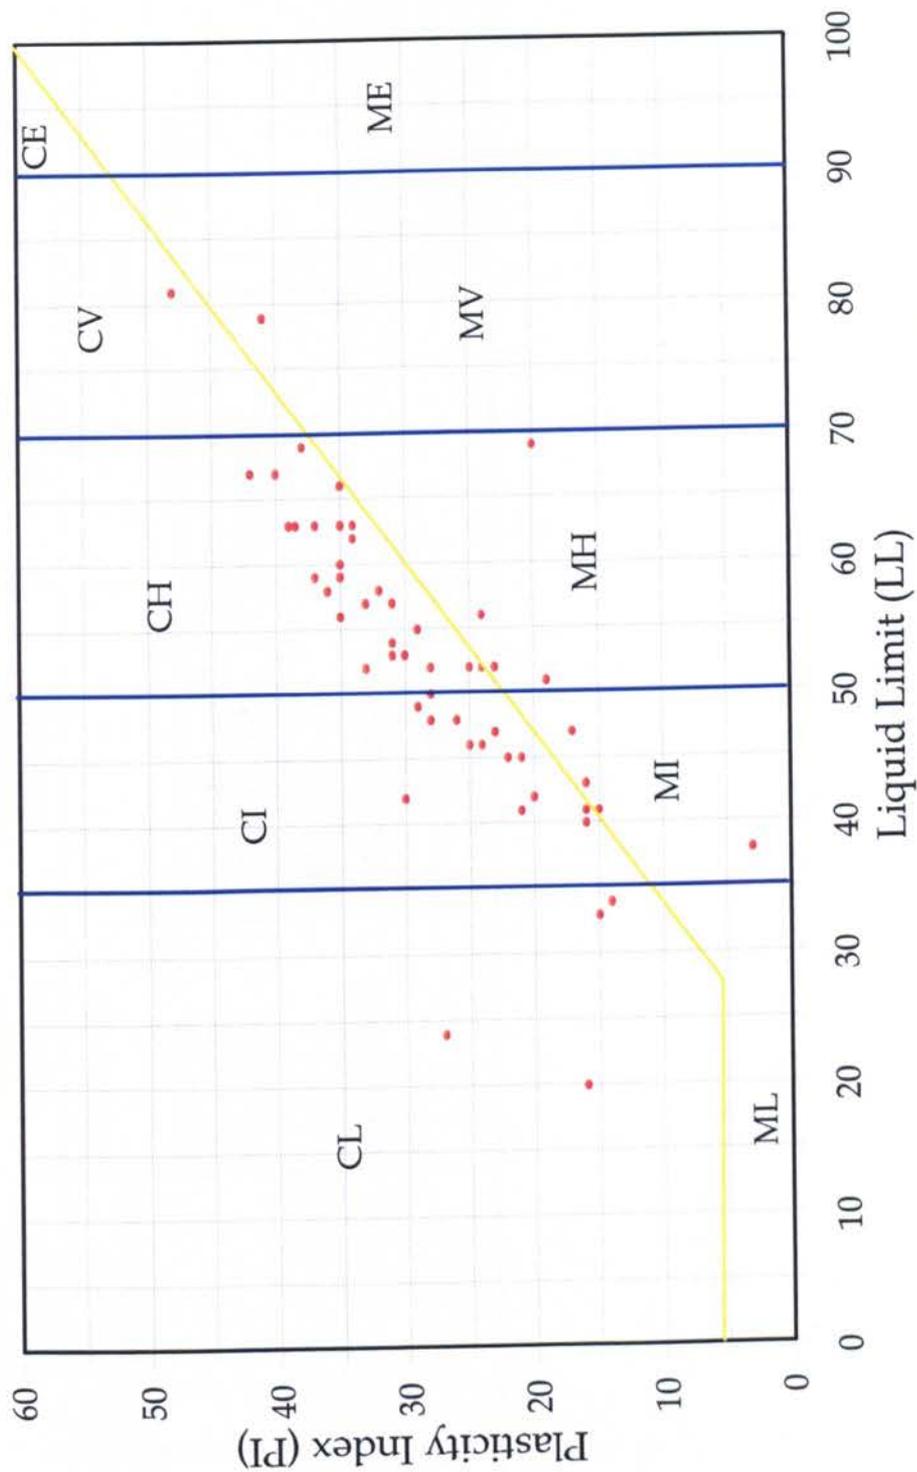
Clay plasticity CL low CI intermediate CH high CV very high CE extremely high  
 Silt plasticity ML low MI intermediate MH high MV very high ME extremely

Figure 6.18. Cassagrande plasticity chart.

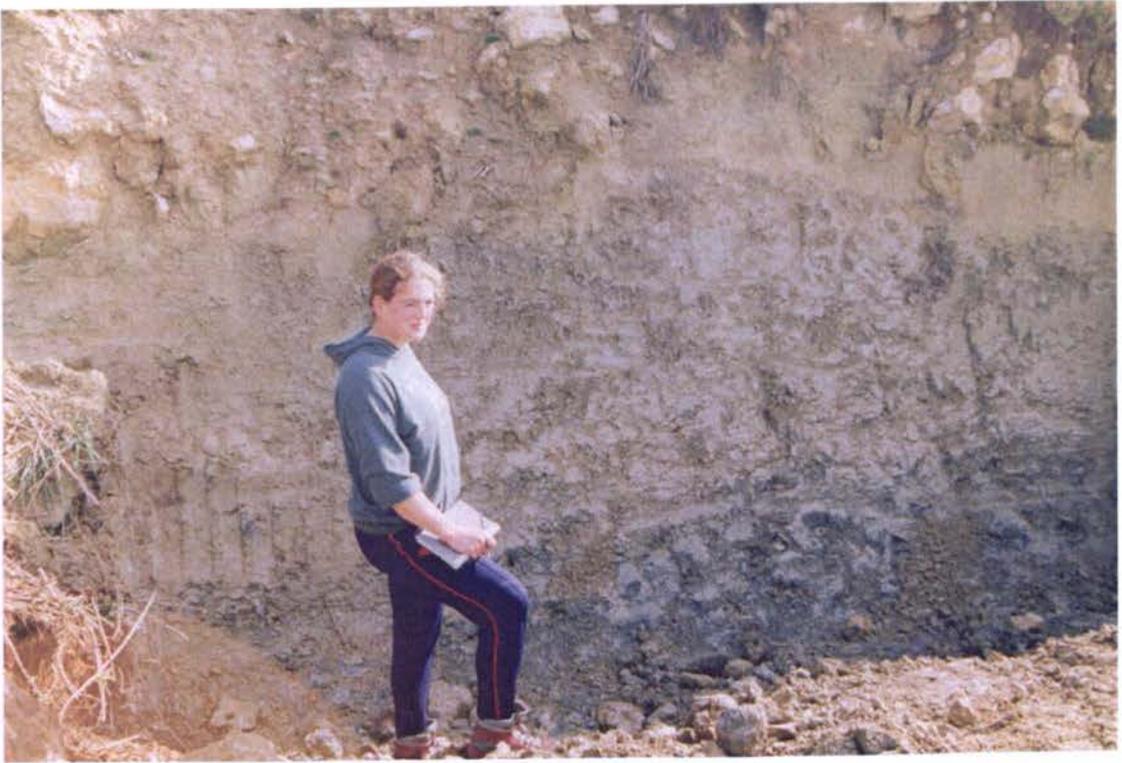
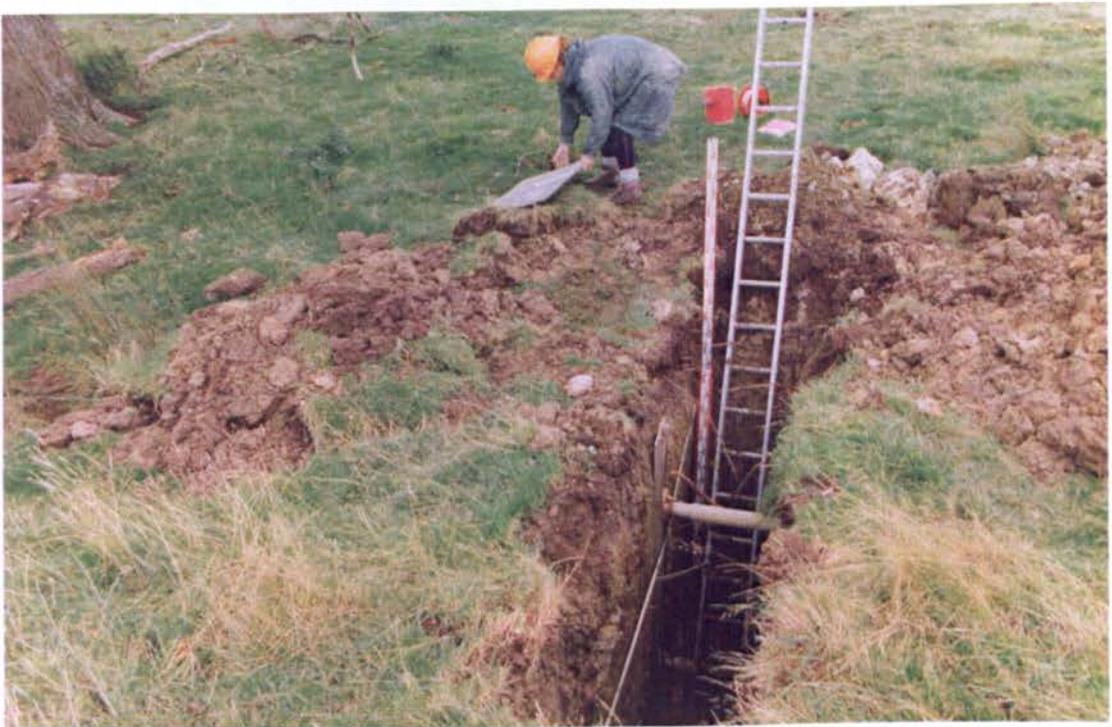
Plate 6.3 (Upper). Trial pit.

Plate 6.4 (Lower). The rear scarp in the Hythe Beds.

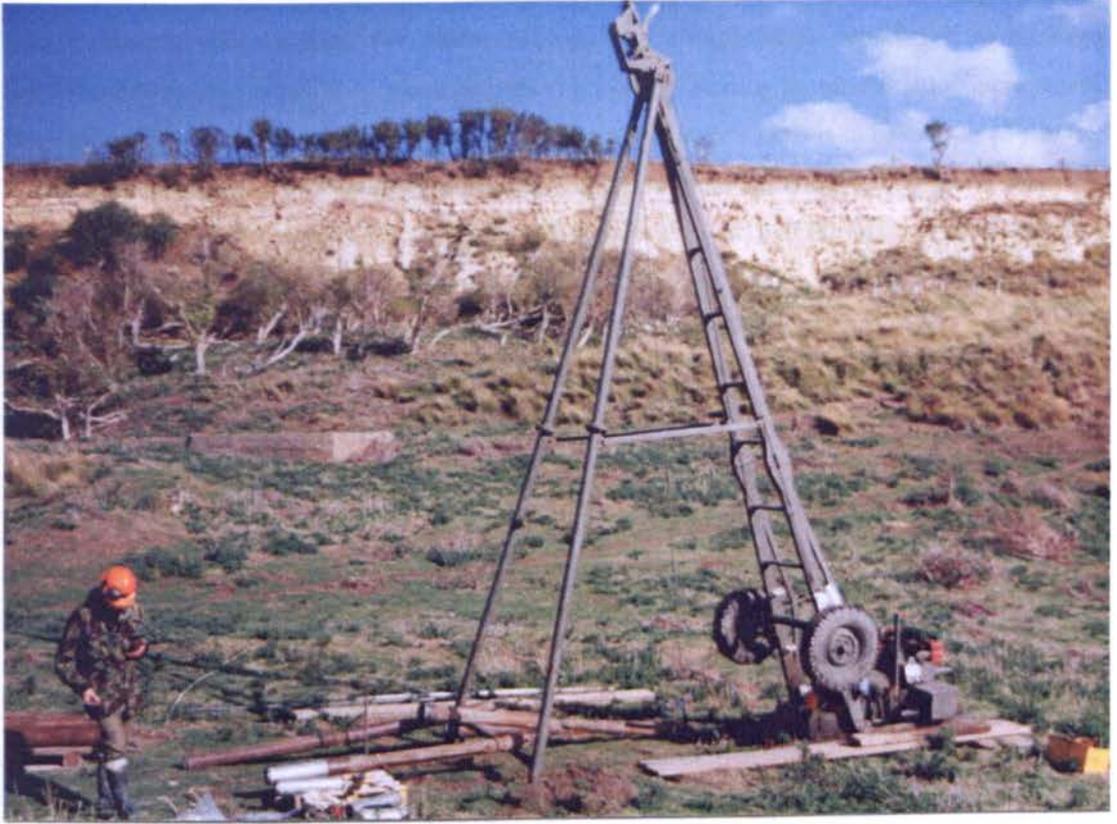
Plate 6.5. The pilcon cable percussion rig.

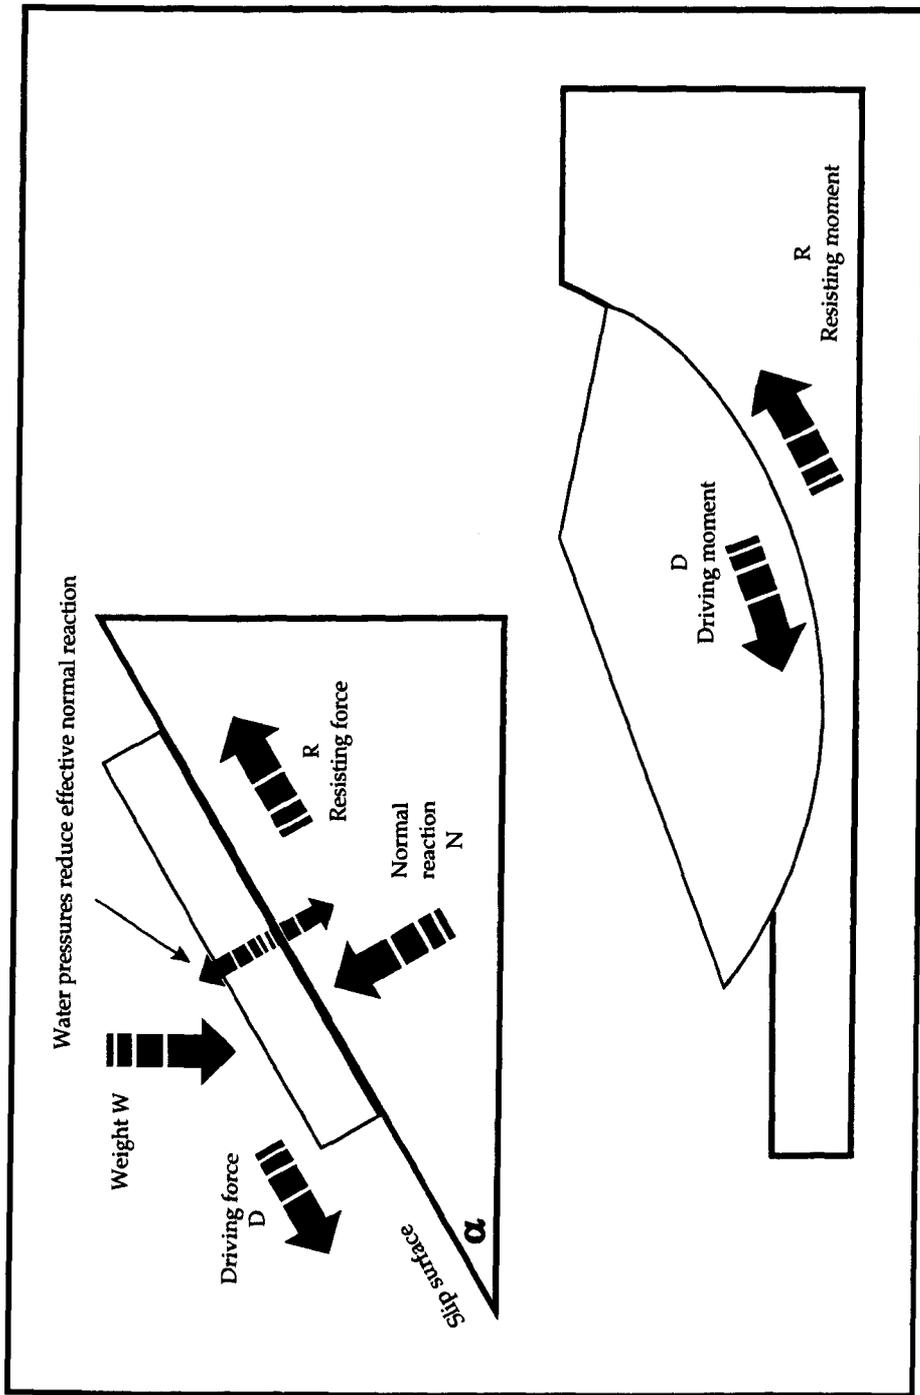
Figure 7.1. Summary of forces acting on a simplified landslide.

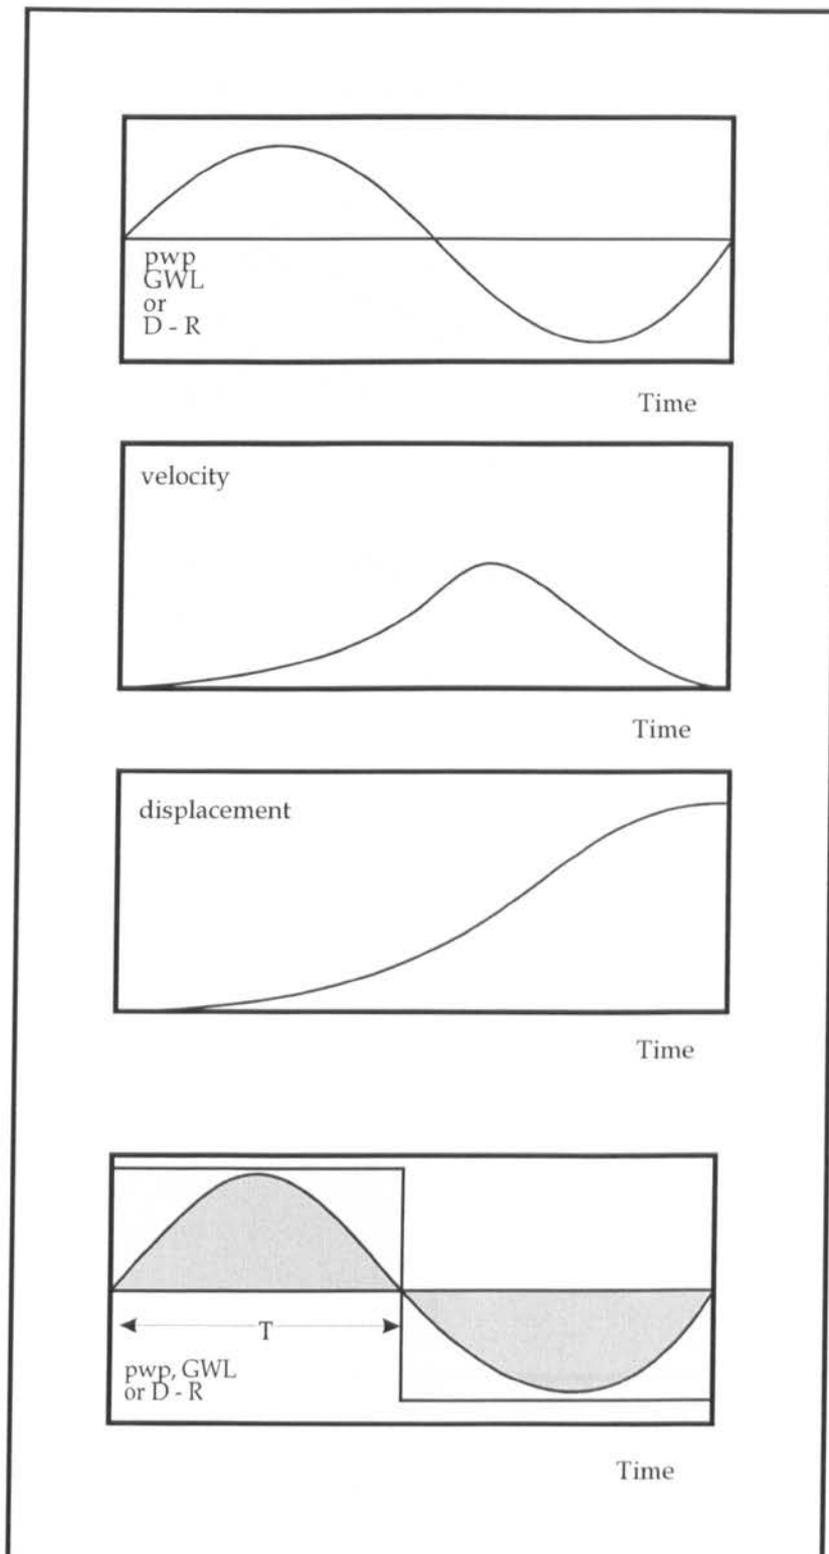
Figure 7.2. Diagrammatic representation of velocity and travel profiles as a function of the time for which a destabilized situation exists.

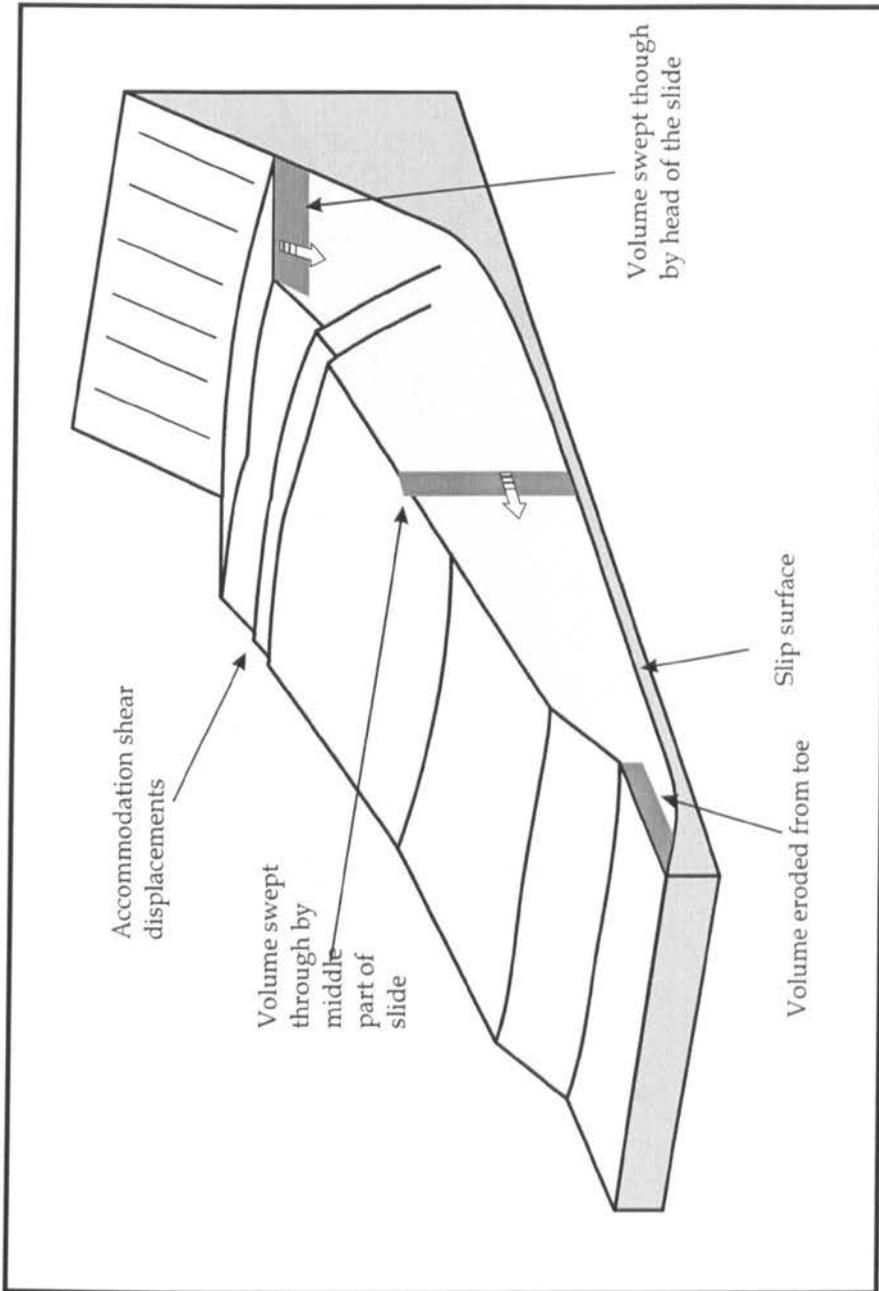
Figure 7.3. Coastal landslide subject to foreshore toe erosion. The movements of different parts of the landslide following a removal of a small part of the toe may be in various directions, and of varying amounts, but they return the slide to perfect equilibrium.

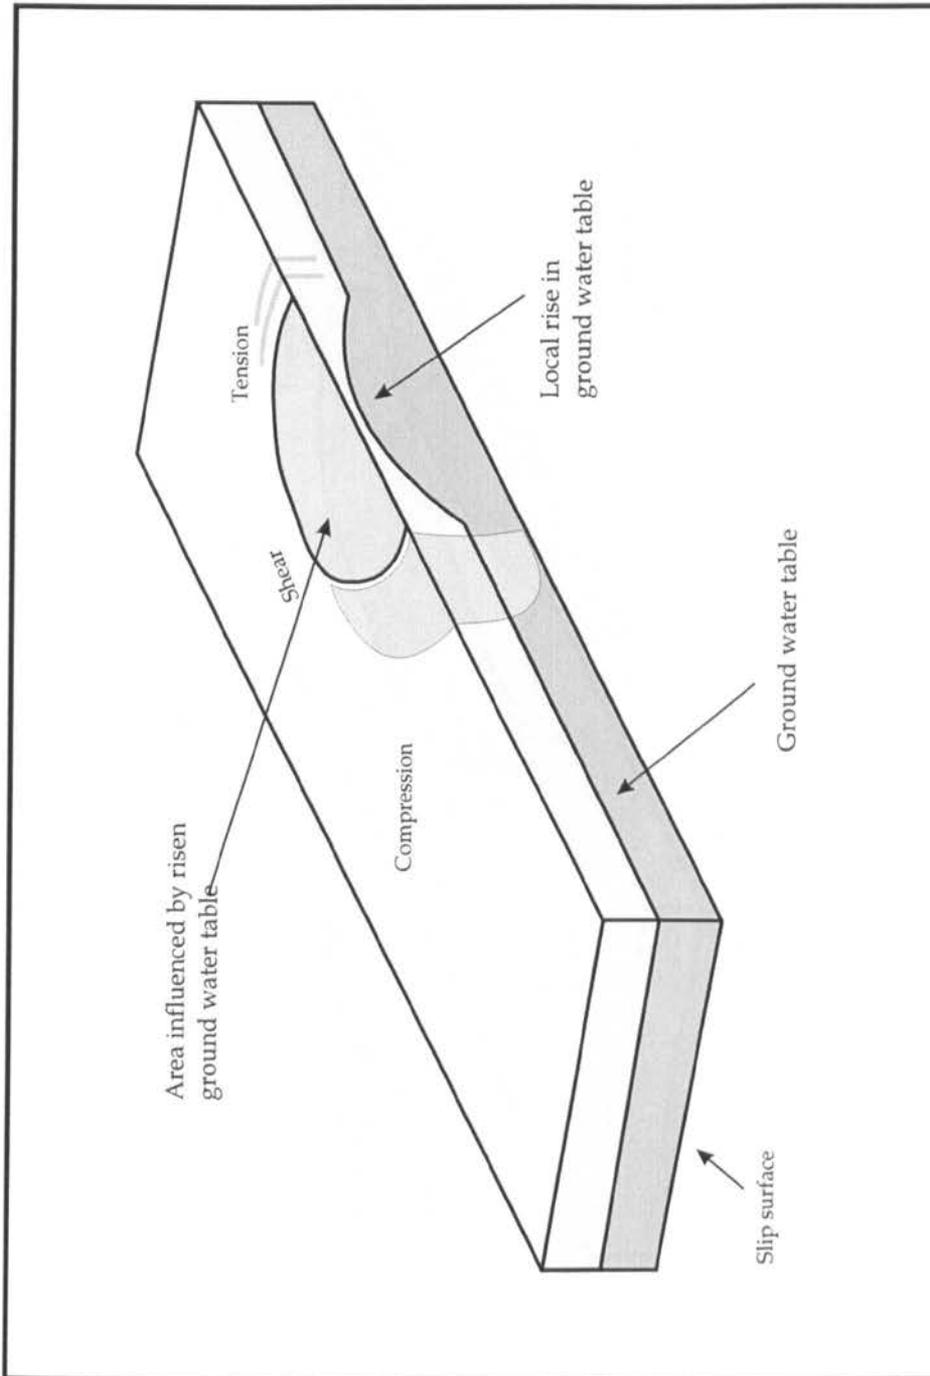
Figure 7.4. In a slab-type landslide mass, a finite area may have a local Factor of Safety less than 1, but be unable to "break out", and as a result, causes deflections in its locality.

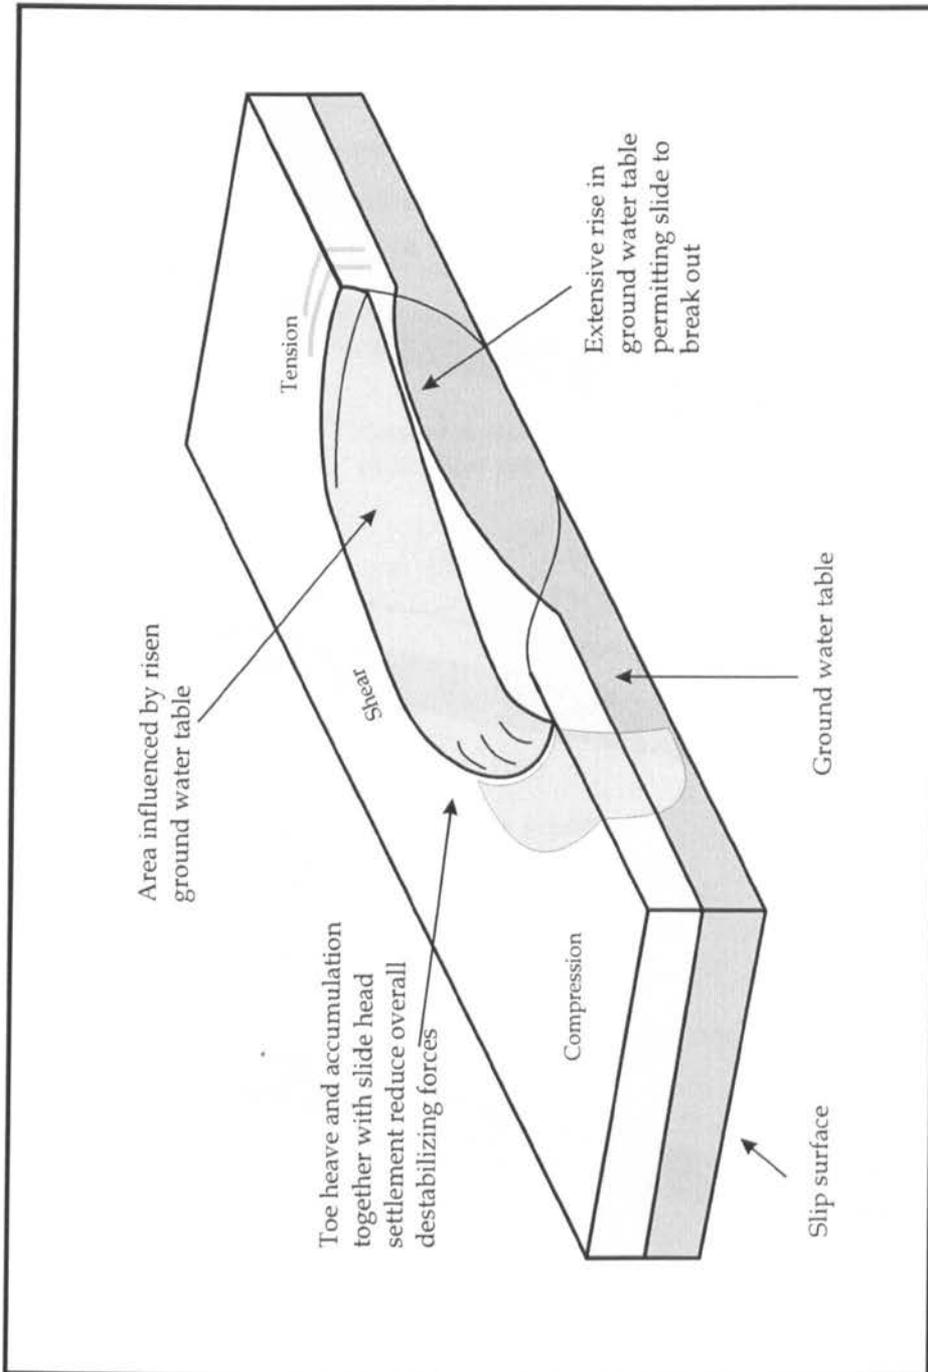
Figure 7.5. In this slab-type landslide mass, a large enough area may have a local Factor of Safety less than 1, to be able to "break out", and as a result, a "new" landslide is seen.

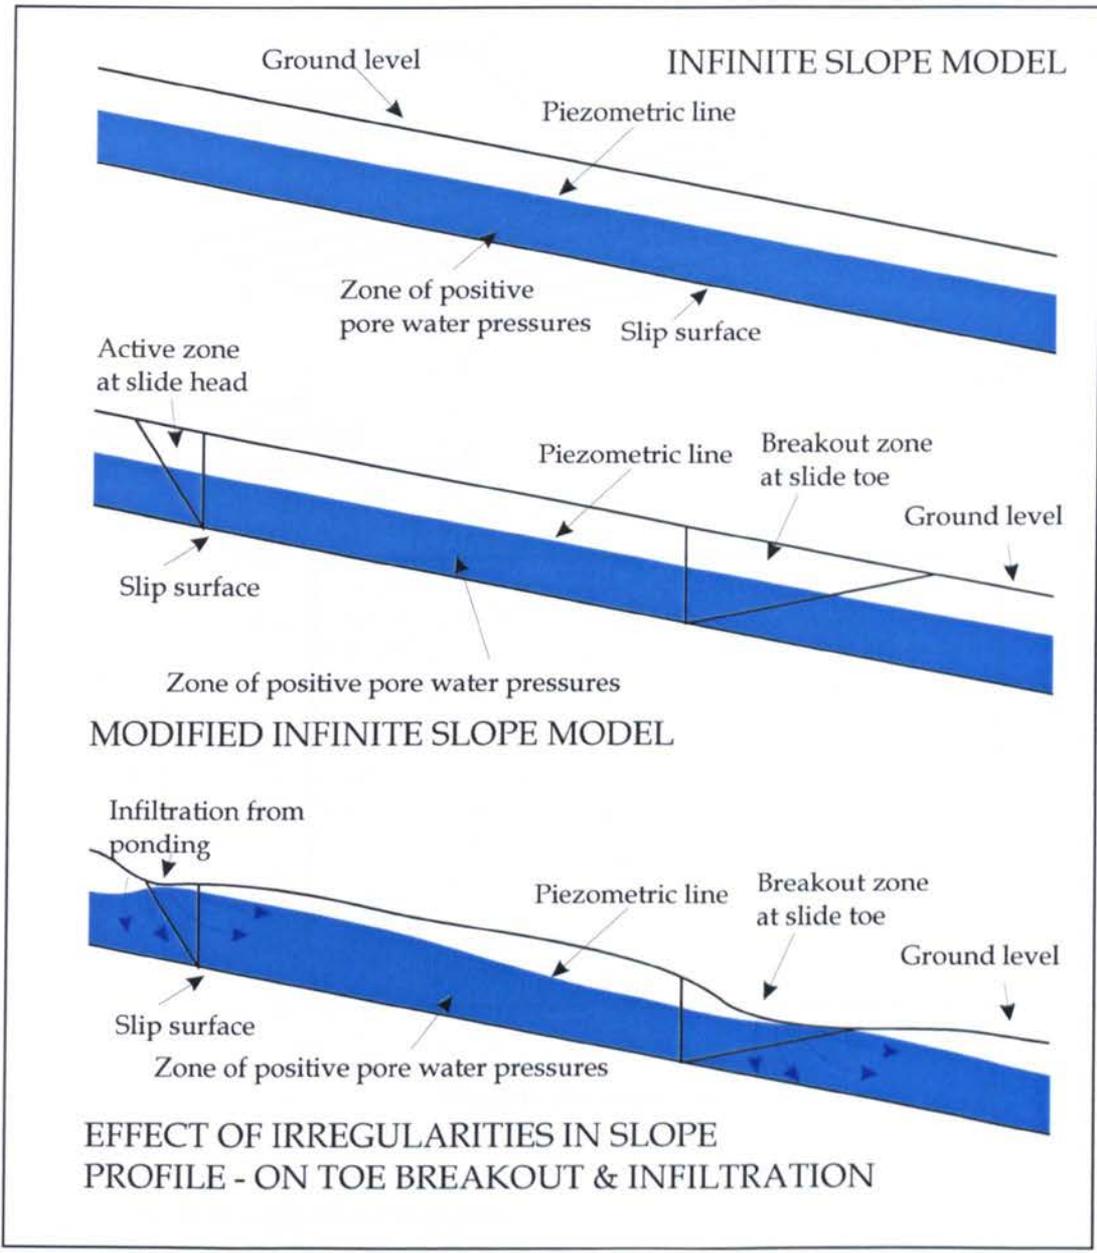
Figure 7.6. Haefeli's (1948) Infinite Slope model (top) assumes that conditions are identical throughout the length of the slope. It expressly neglects (centre) the head wedge (actually has only small impact) and the toe break-out wedge (significant). The occurrence from time to time of small movements creates slope profile irregularities which account, in part, for non-uniform ground water tables during and immediately after rainfall (lower).

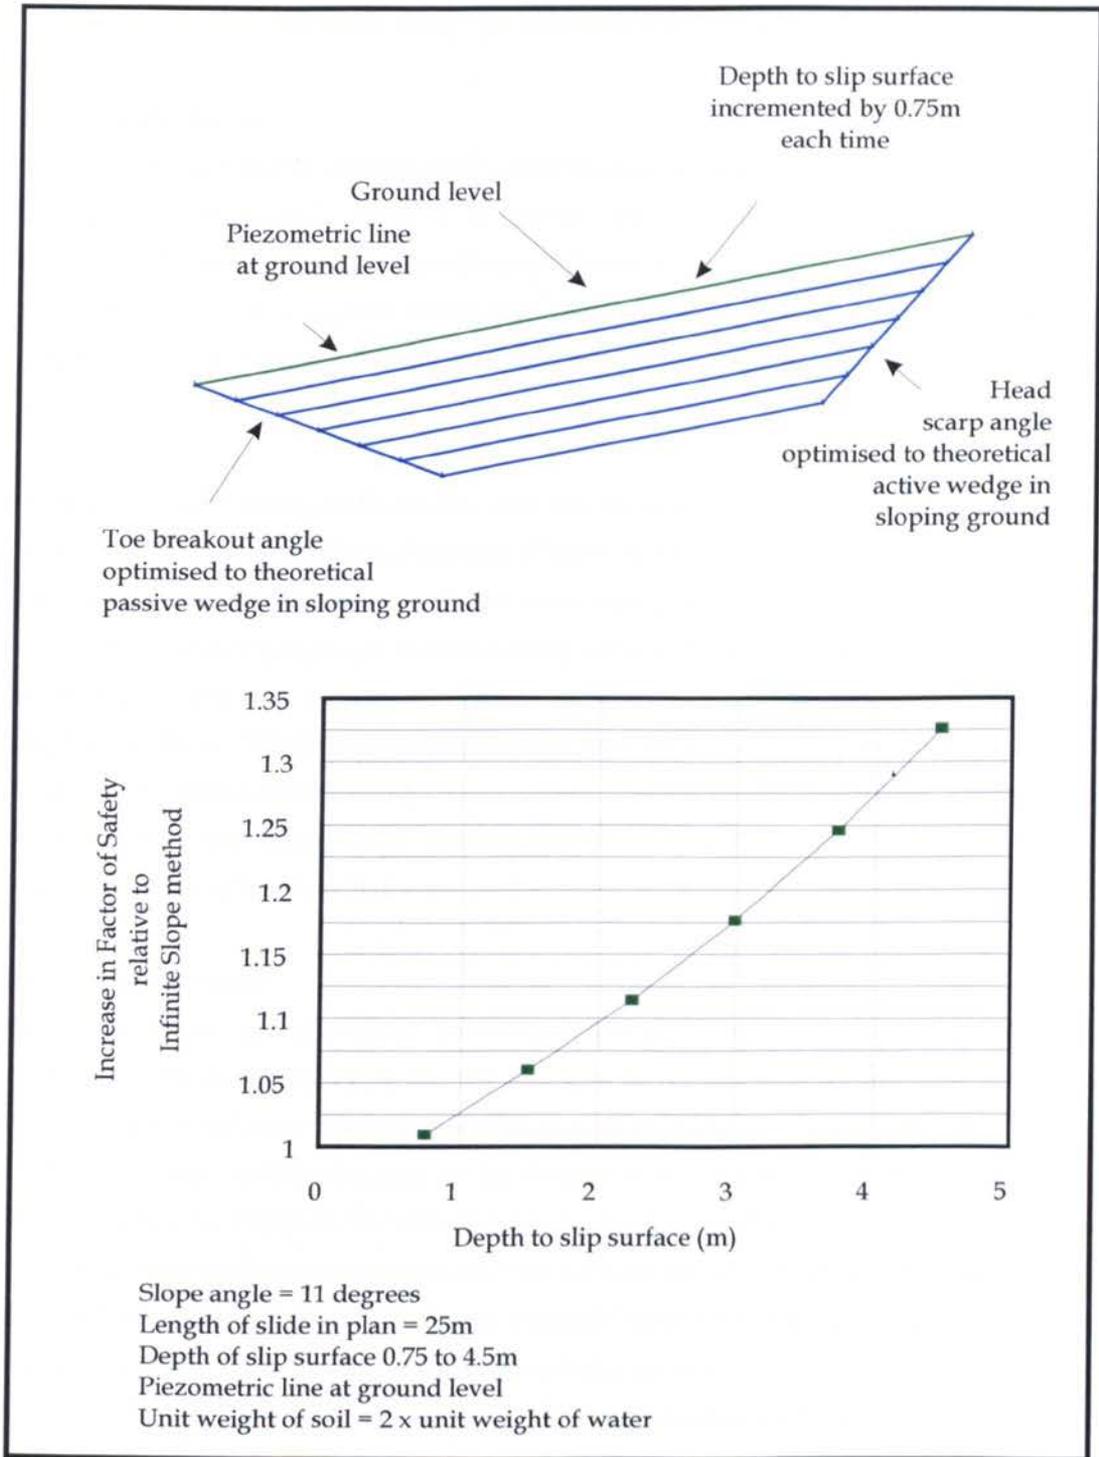
Figure 7.7. Typical case of effect of toe breakout wedge on the stability of what is otherwise the "Infinite Slope" case.

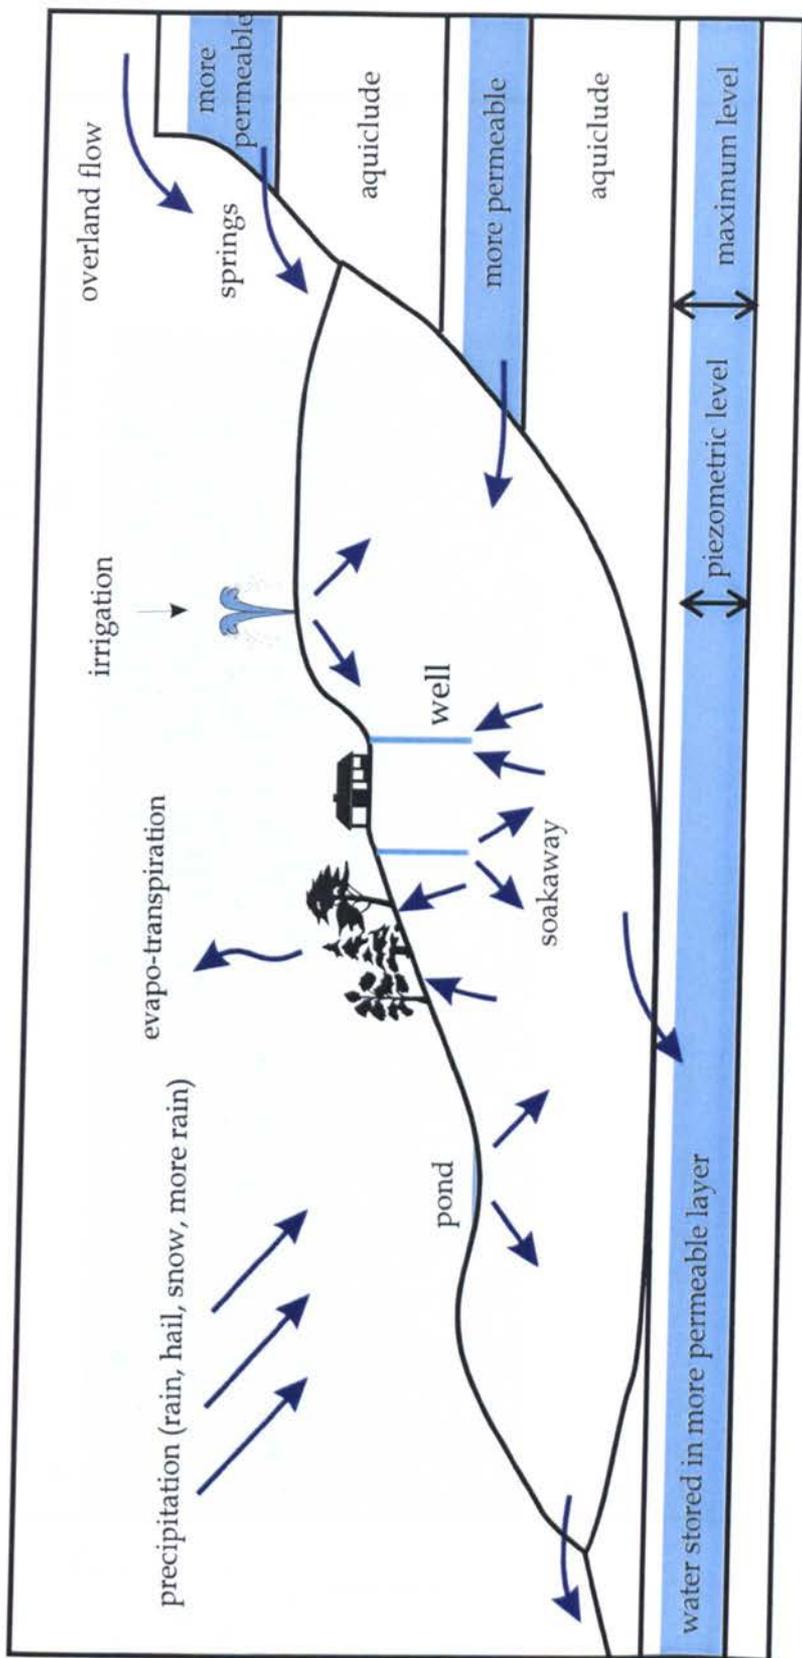
Figure 8.1. Diagram of typical hillslope hydrological cycle.

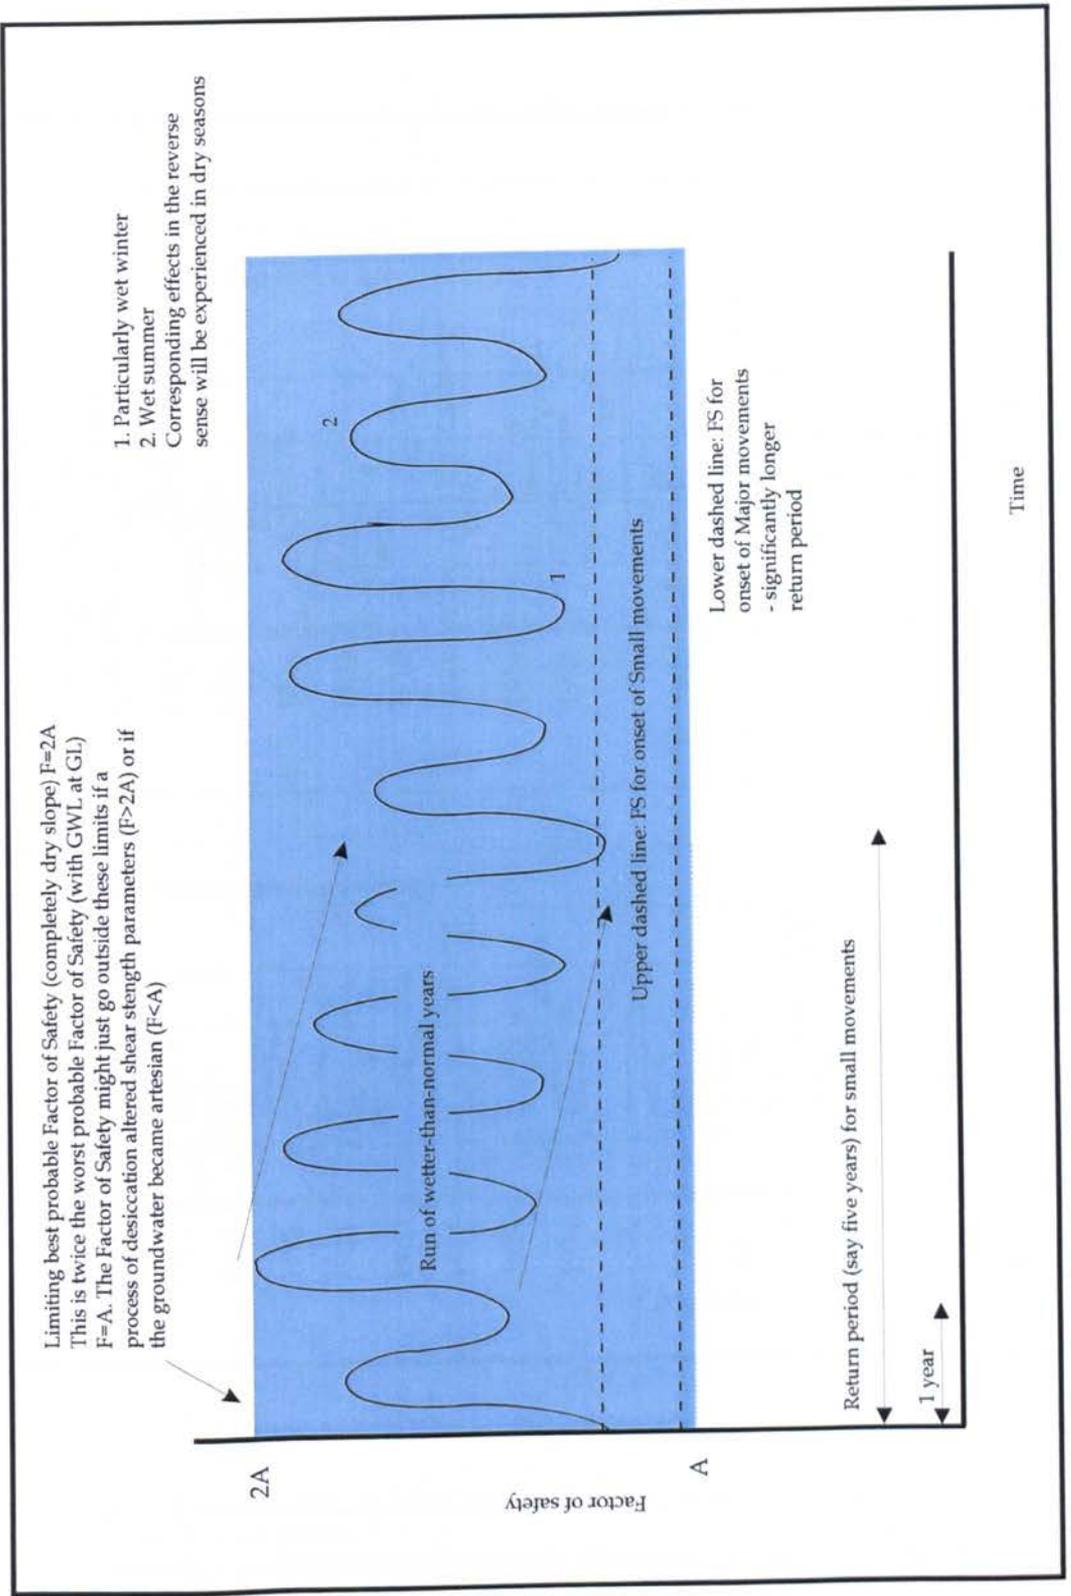
Figure 8.2. The seasonal cyclic variation of the Factor of Safety.

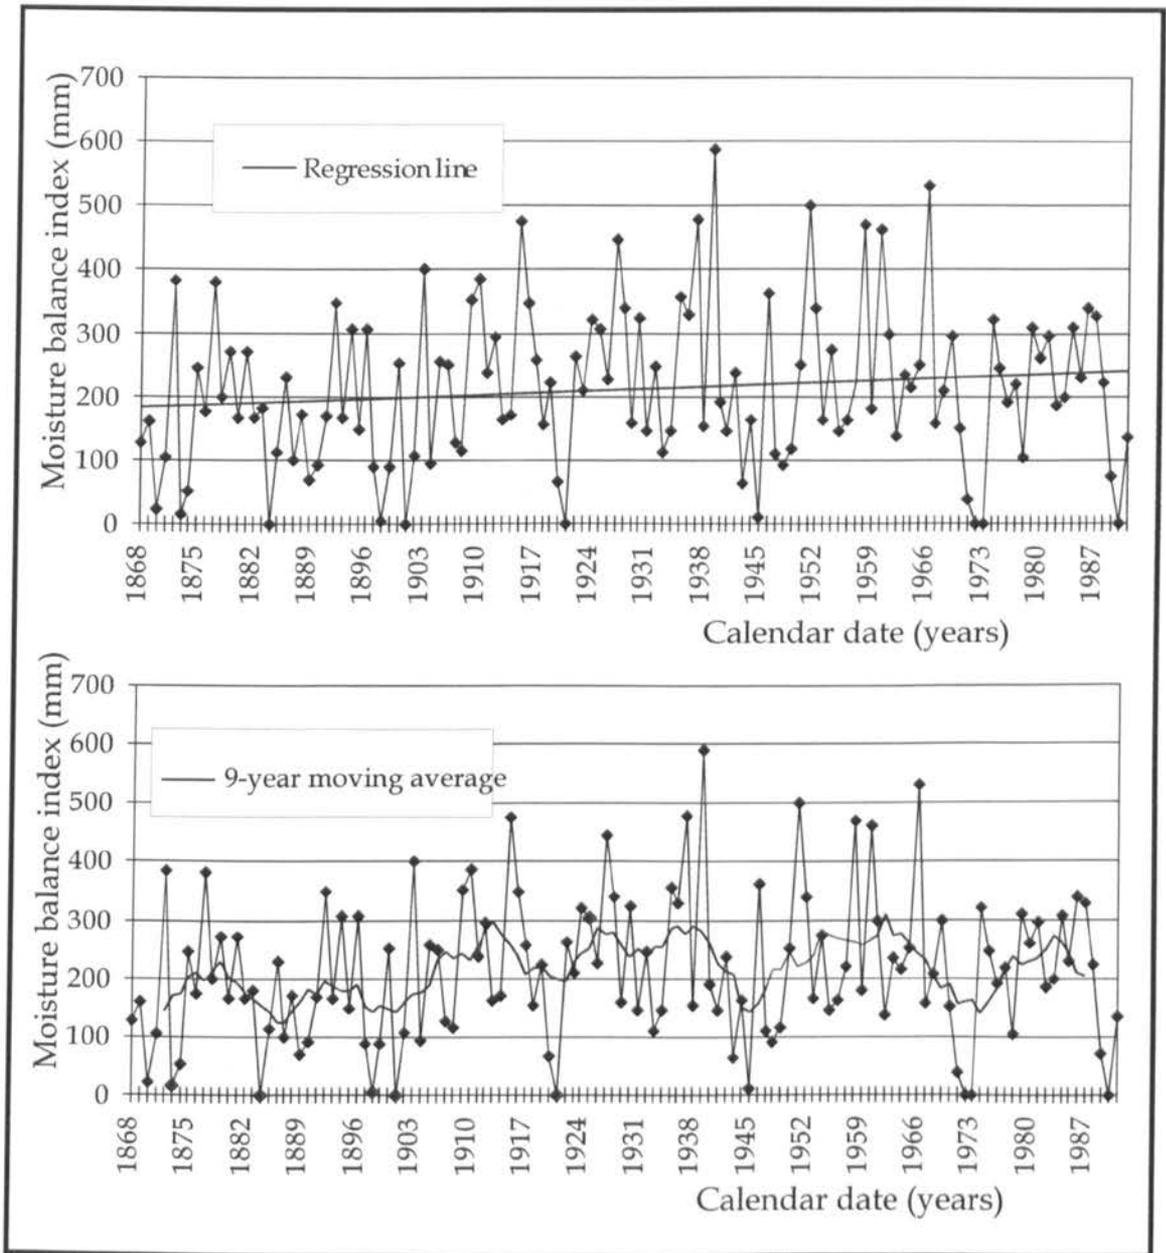
Figure 8.3. Moisture Balance Index against Time for Folkestone, UK, (1868-1991)  
 (a) (Top) Regression Line  
 (b) (Bottom) Nine-year moving average (After Bromhead, Hopper and Ibsen, 1998)
