# Landslides in the Lower Greensand Escarpment of South Kent

Anna Hopper

A thesis submitted in partial fulfilment of the requirements of  
Kingston University  
for the degree of Doctor of Philosophy

December 2000

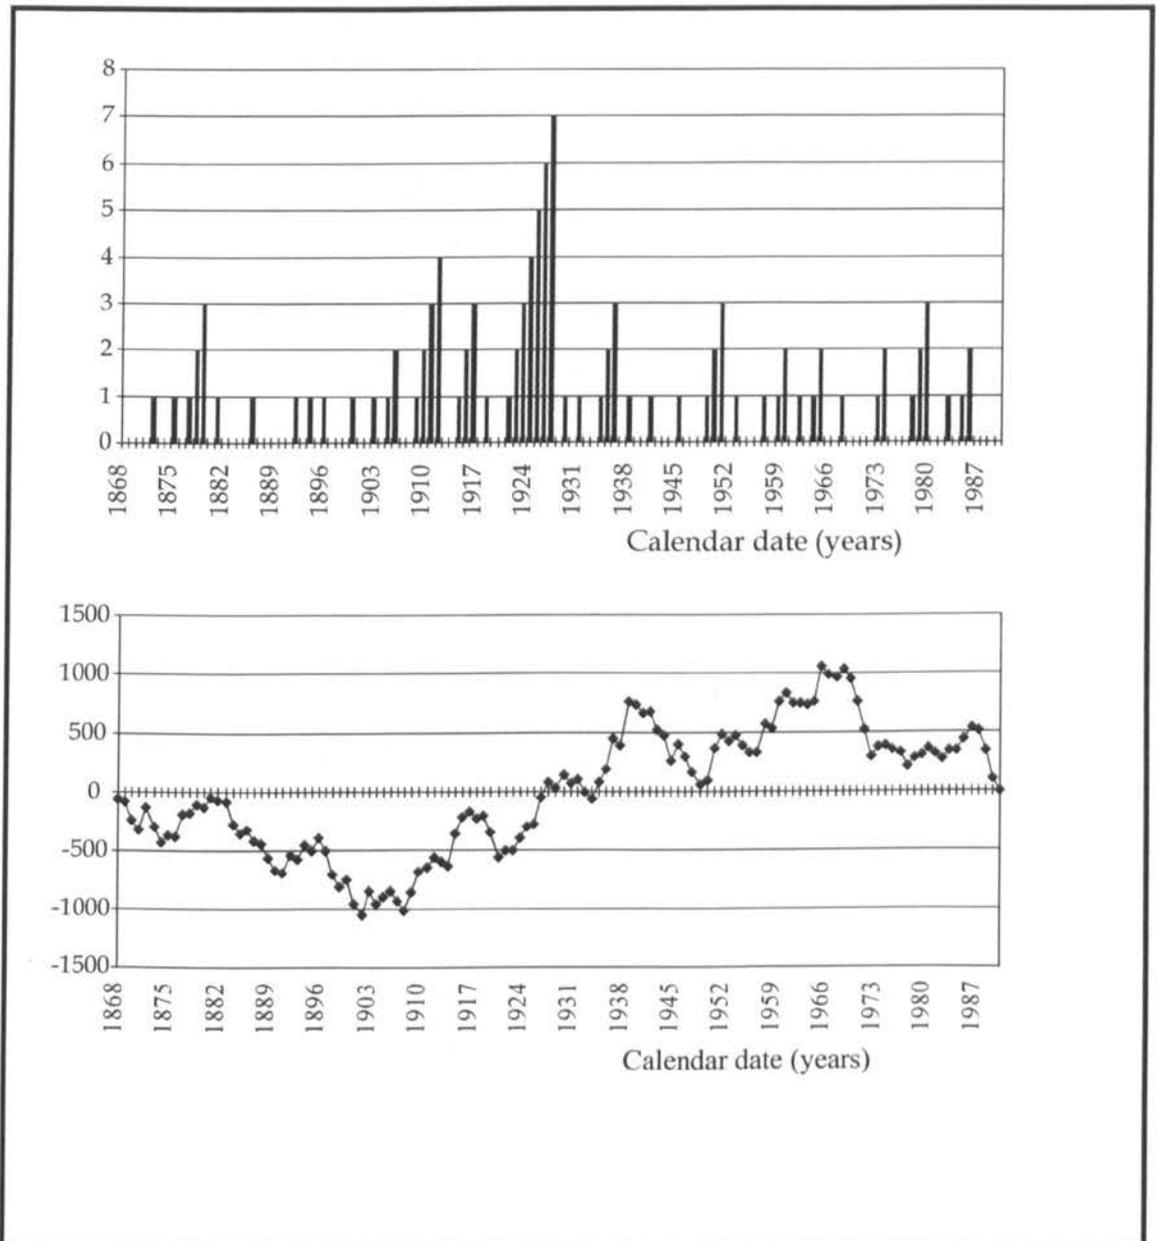
Figure 8.4. Moisture Balance index against time for Folkestone, UK, (1868-1991)

a) (Top) Number of years with above average rainfall

b) (Bottom) Cumulative affective rainfall from the mean. (After Bromhead, Hopper and Ibsen, 1998).

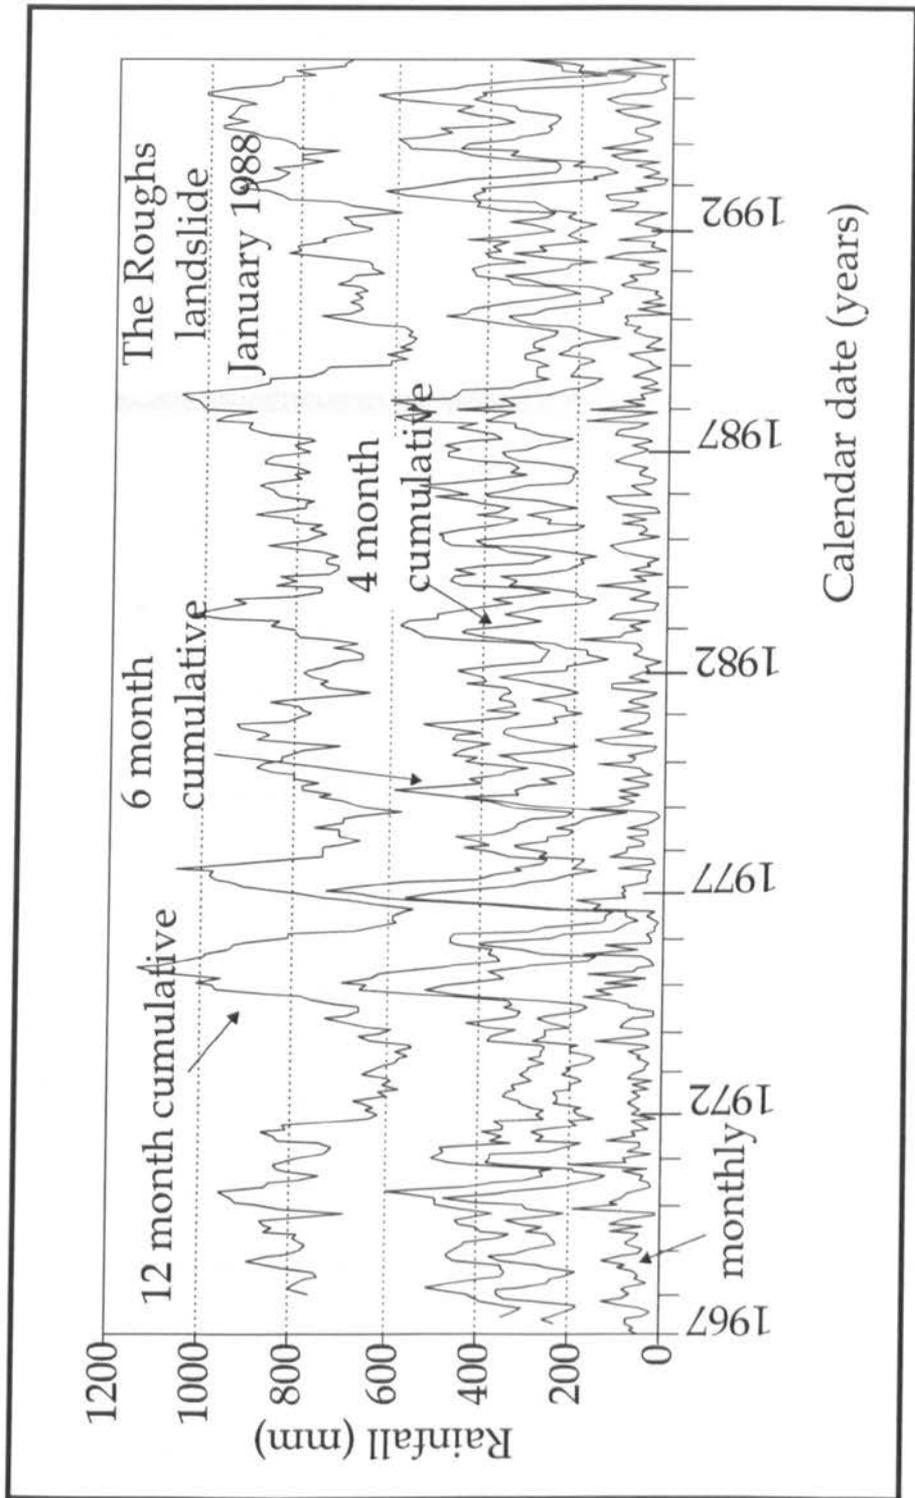
Figure 8.5. Monthly rainfall and cumulative rainfall for 4, 6 and 12 month periods at Sandling Park, (nearest weather station to The Roughs) 1967-1997. (After Bromhead, Hopper and Ibsen, 1998).

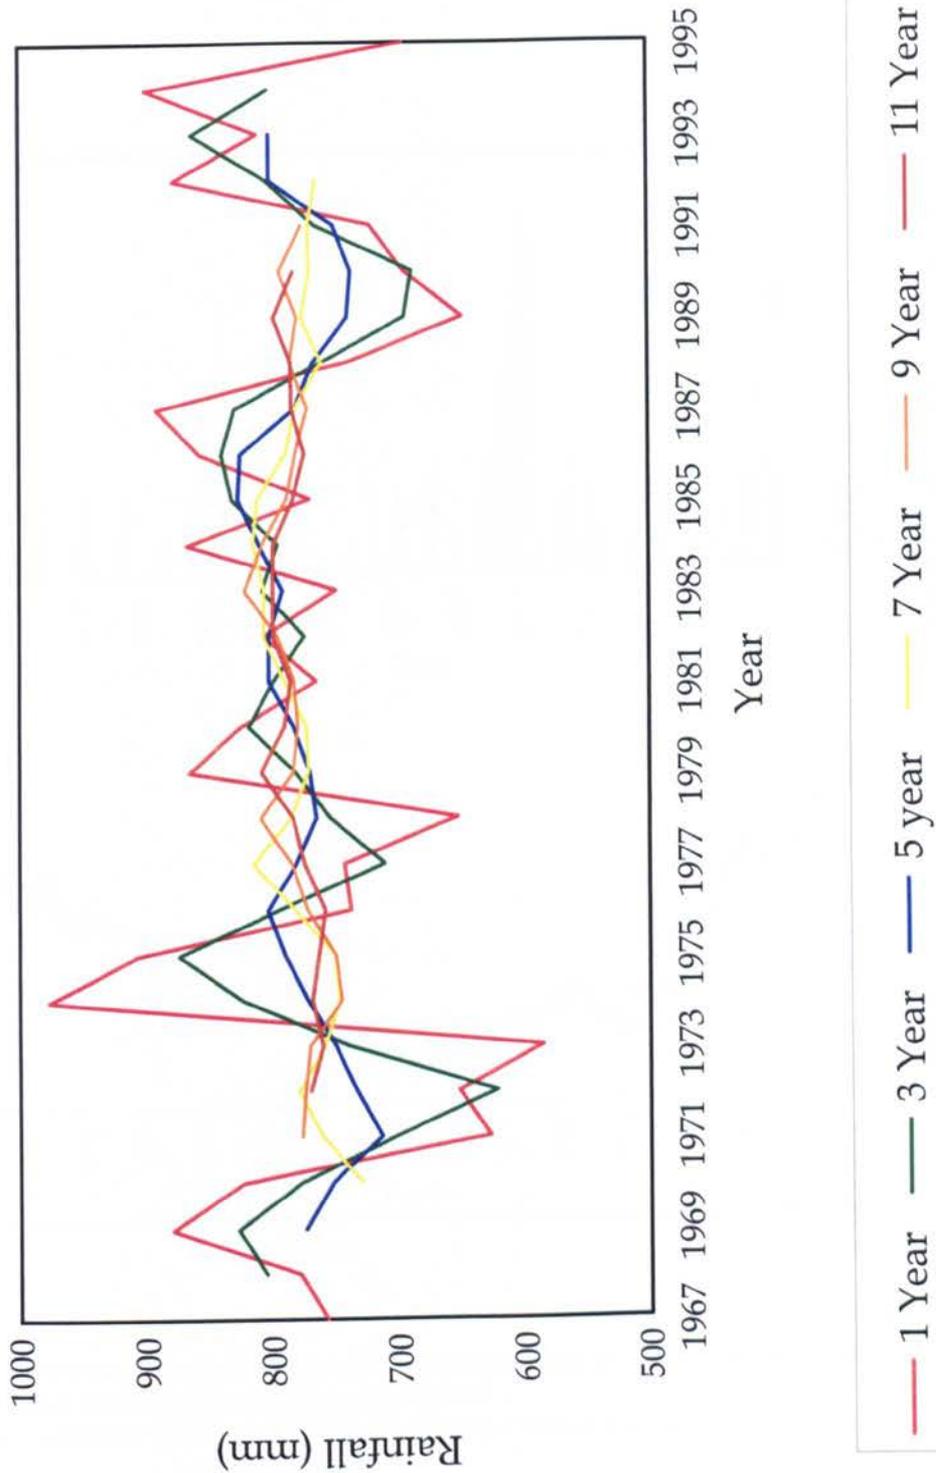
Figure 8.7. Rainfall moving averages, over one to eleven years, at Sandling Park.

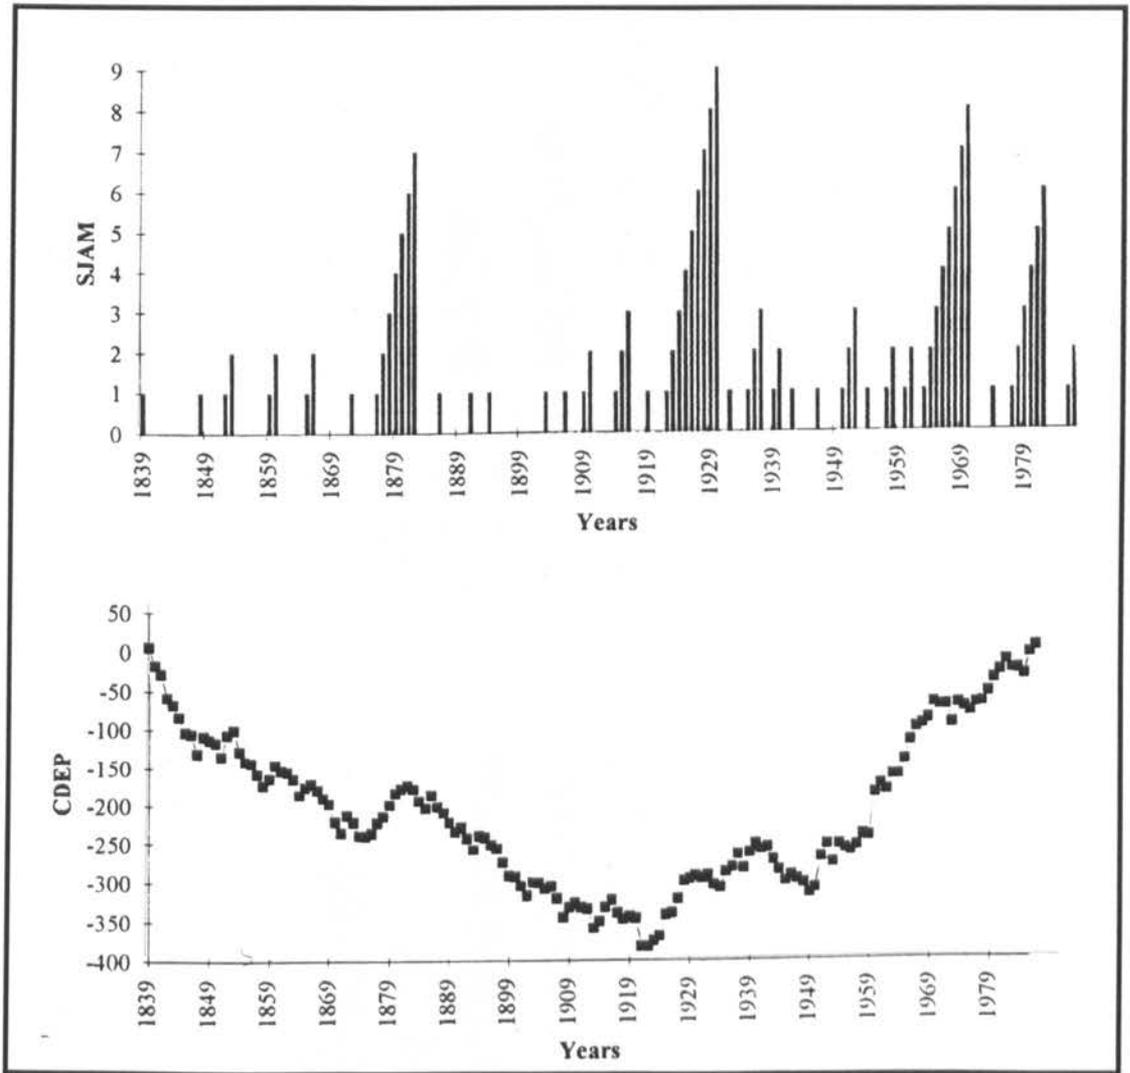
Figure 8.8 Moisture Balance Index against time for Ventnor, Isle of Wight. (1839-1987)  
 (Top) Number of years with above average rainfall.  
 (Bottom) Cumulative effective rainfall from the mean. (Ibsen and Brunsden, 1996).

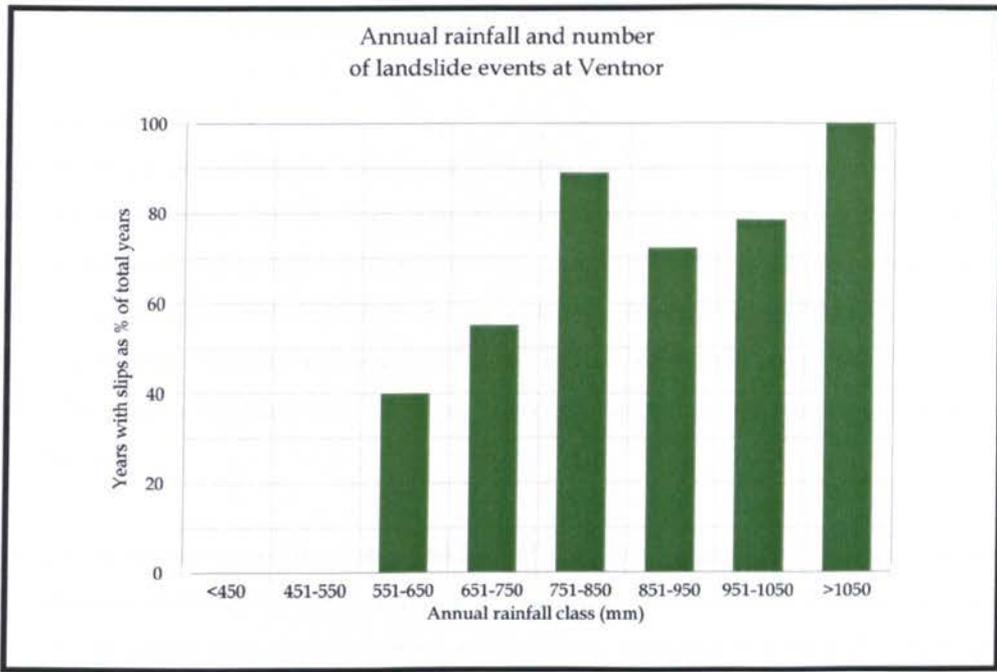
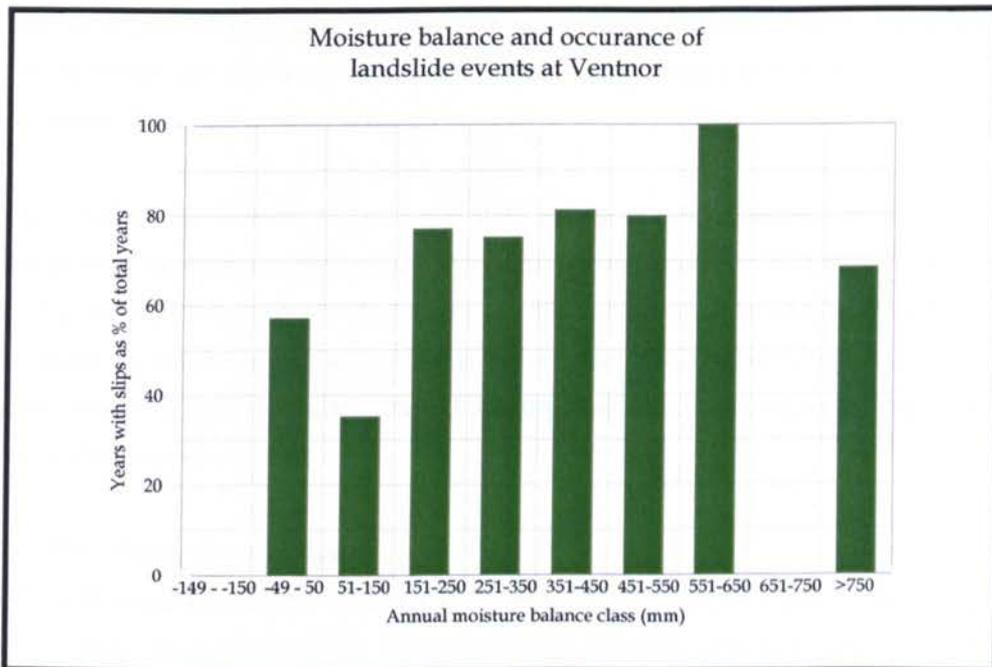
Figure 8.9. Ventnor, Isle of Wight.

(a) (Top). Number of years with landsliding events, as a percentage of total years within each annual rainfall class.

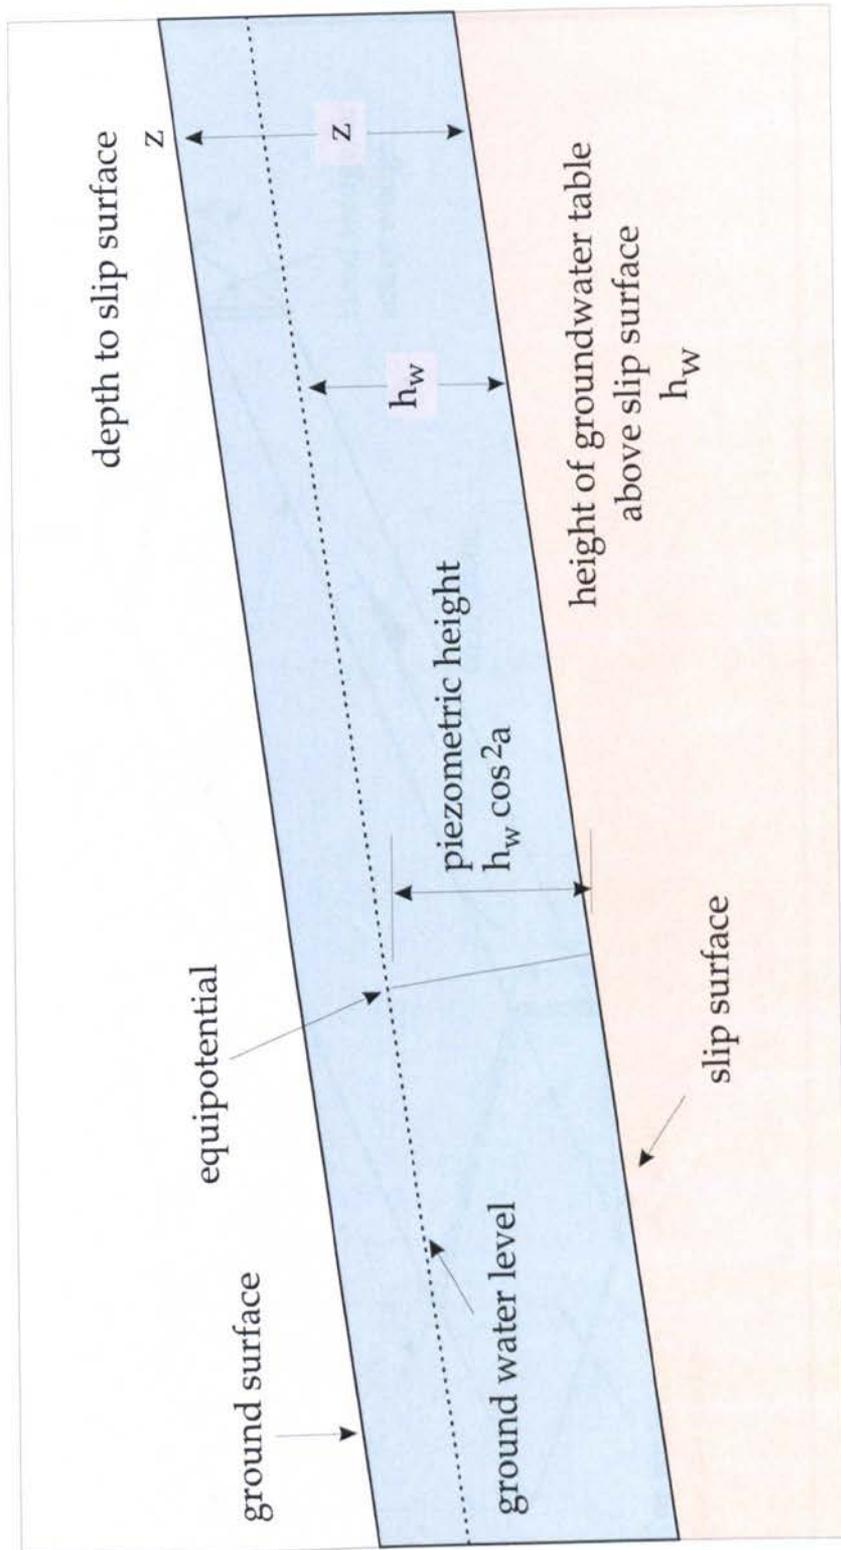
Figure 9.1. Basic dimensions of Haefeli's Infinite Slope method.

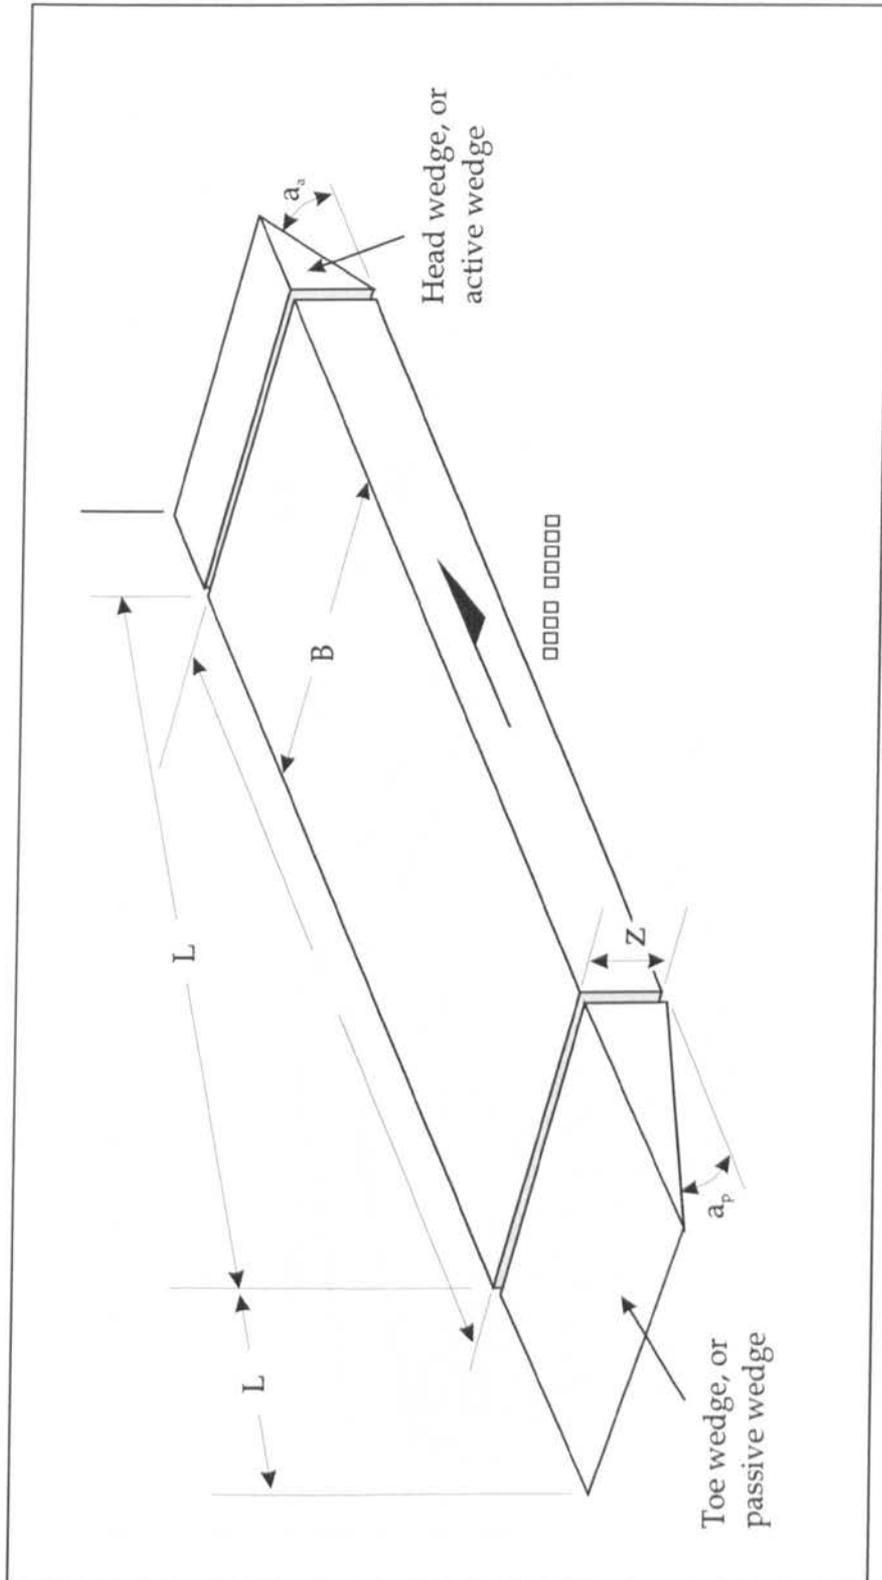
Figure 9.2. Basic dimensions of the finite slope method showing side shear and head and toe wedges.

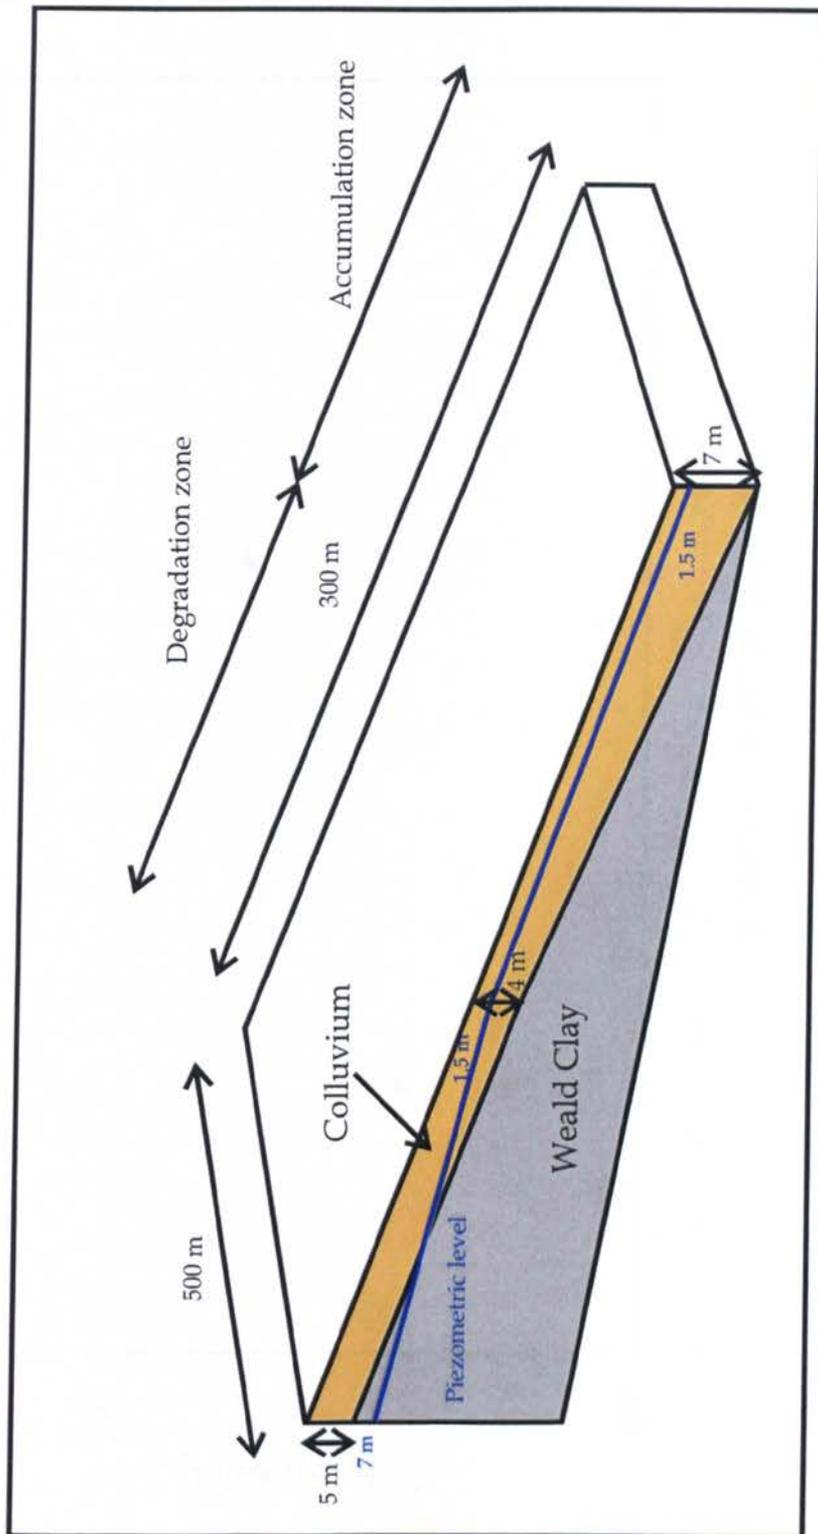
Figure 9.3. Model of the accumulation and degradation zone, showing piezometer levels, used in the finite and infinite slope analysis.

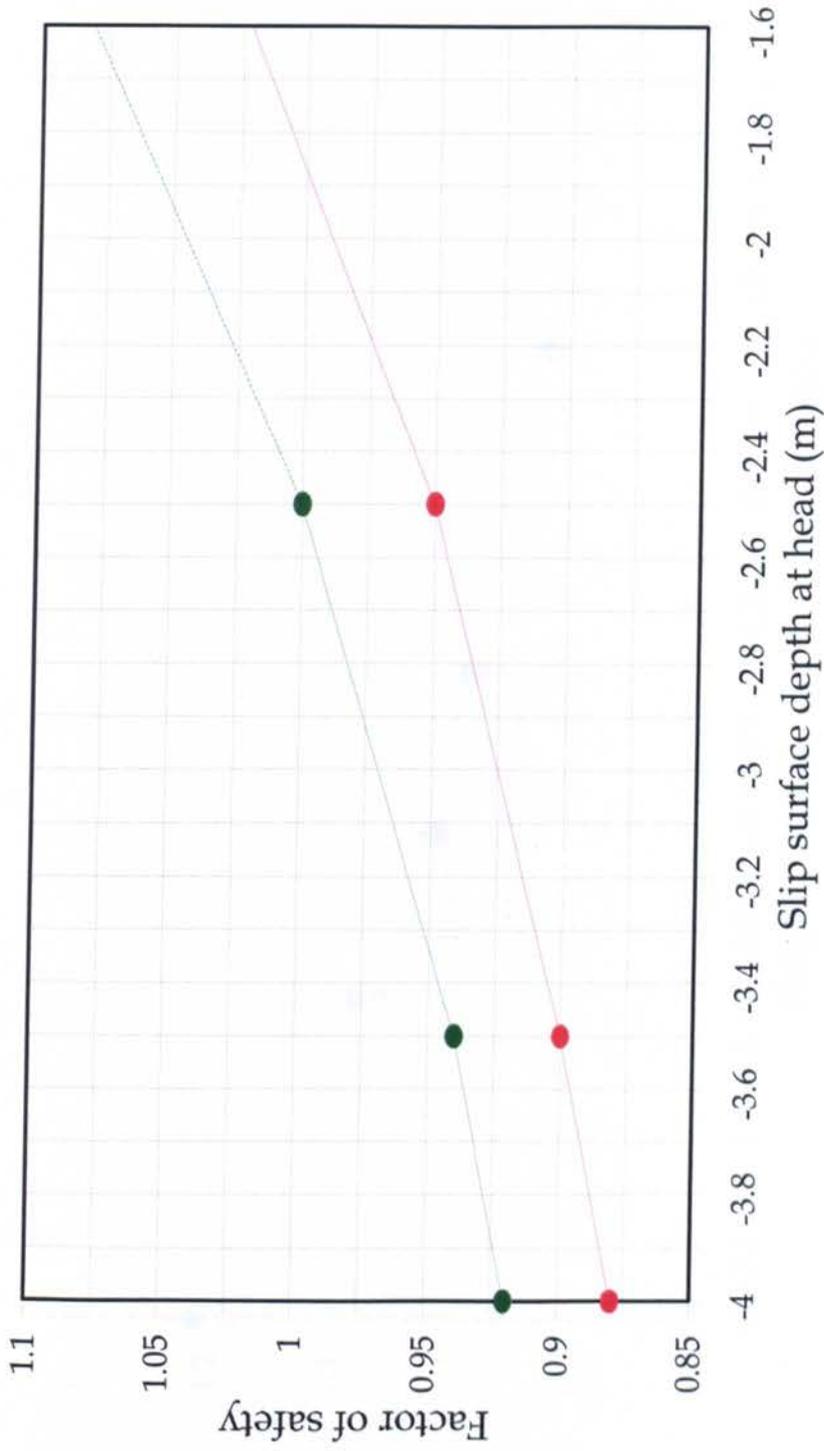
Figure 9.4. Graph showing the relationship between the factor of safety and the depth of the slip surface in the accumulation zone.

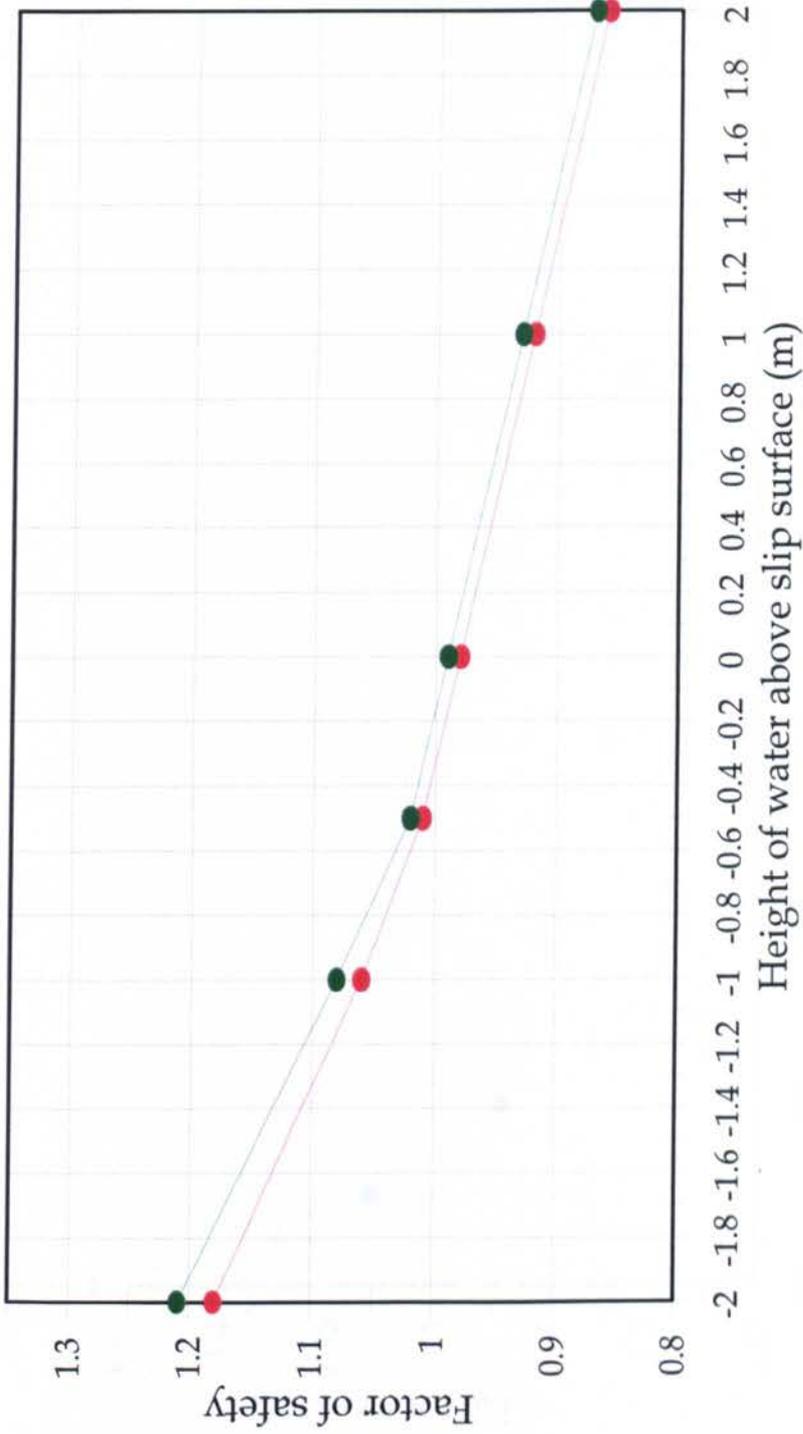
Figure 9.5. Graph showing the relationship between factor of safety and water level at the head of the translational zone.

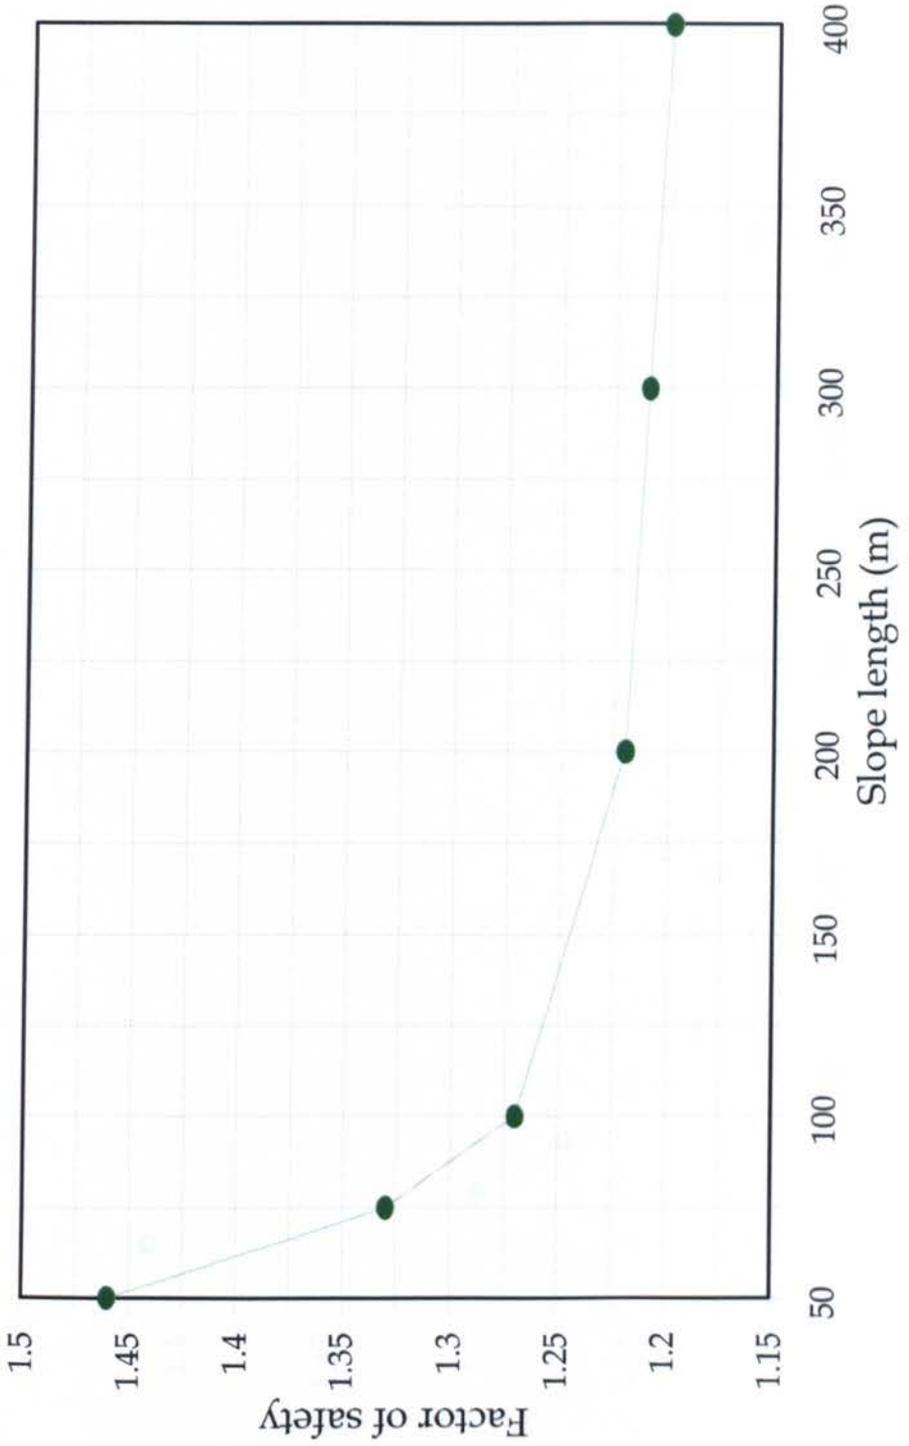
Figure 9.6. Graph showing the relationship between factor of safety and length of the degradation zone.

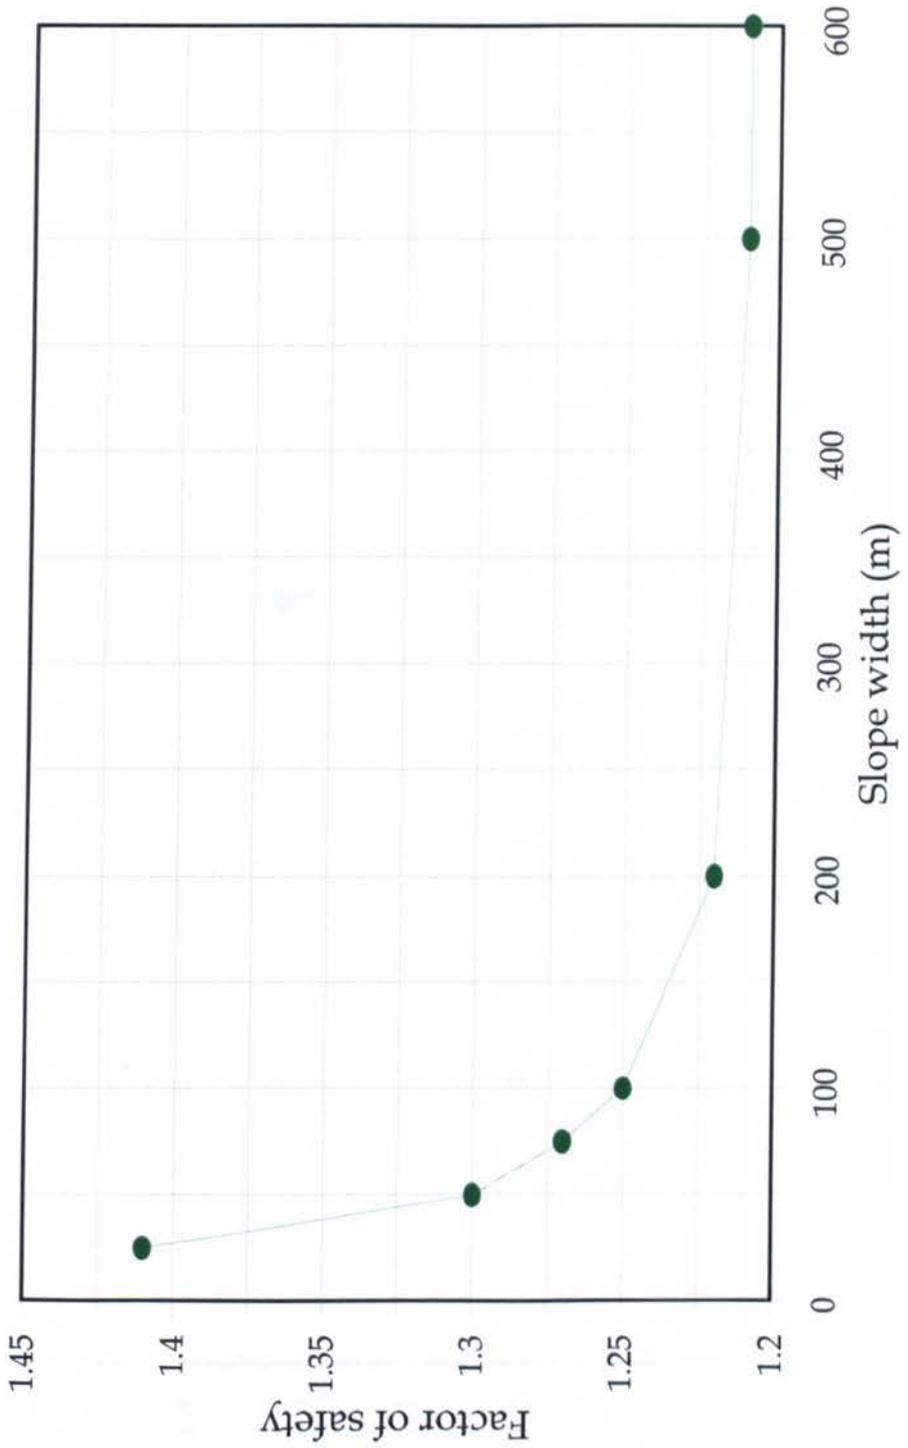
Figure 9.7. Graph showing the relationship between factor of safety and the width of the translational zone.

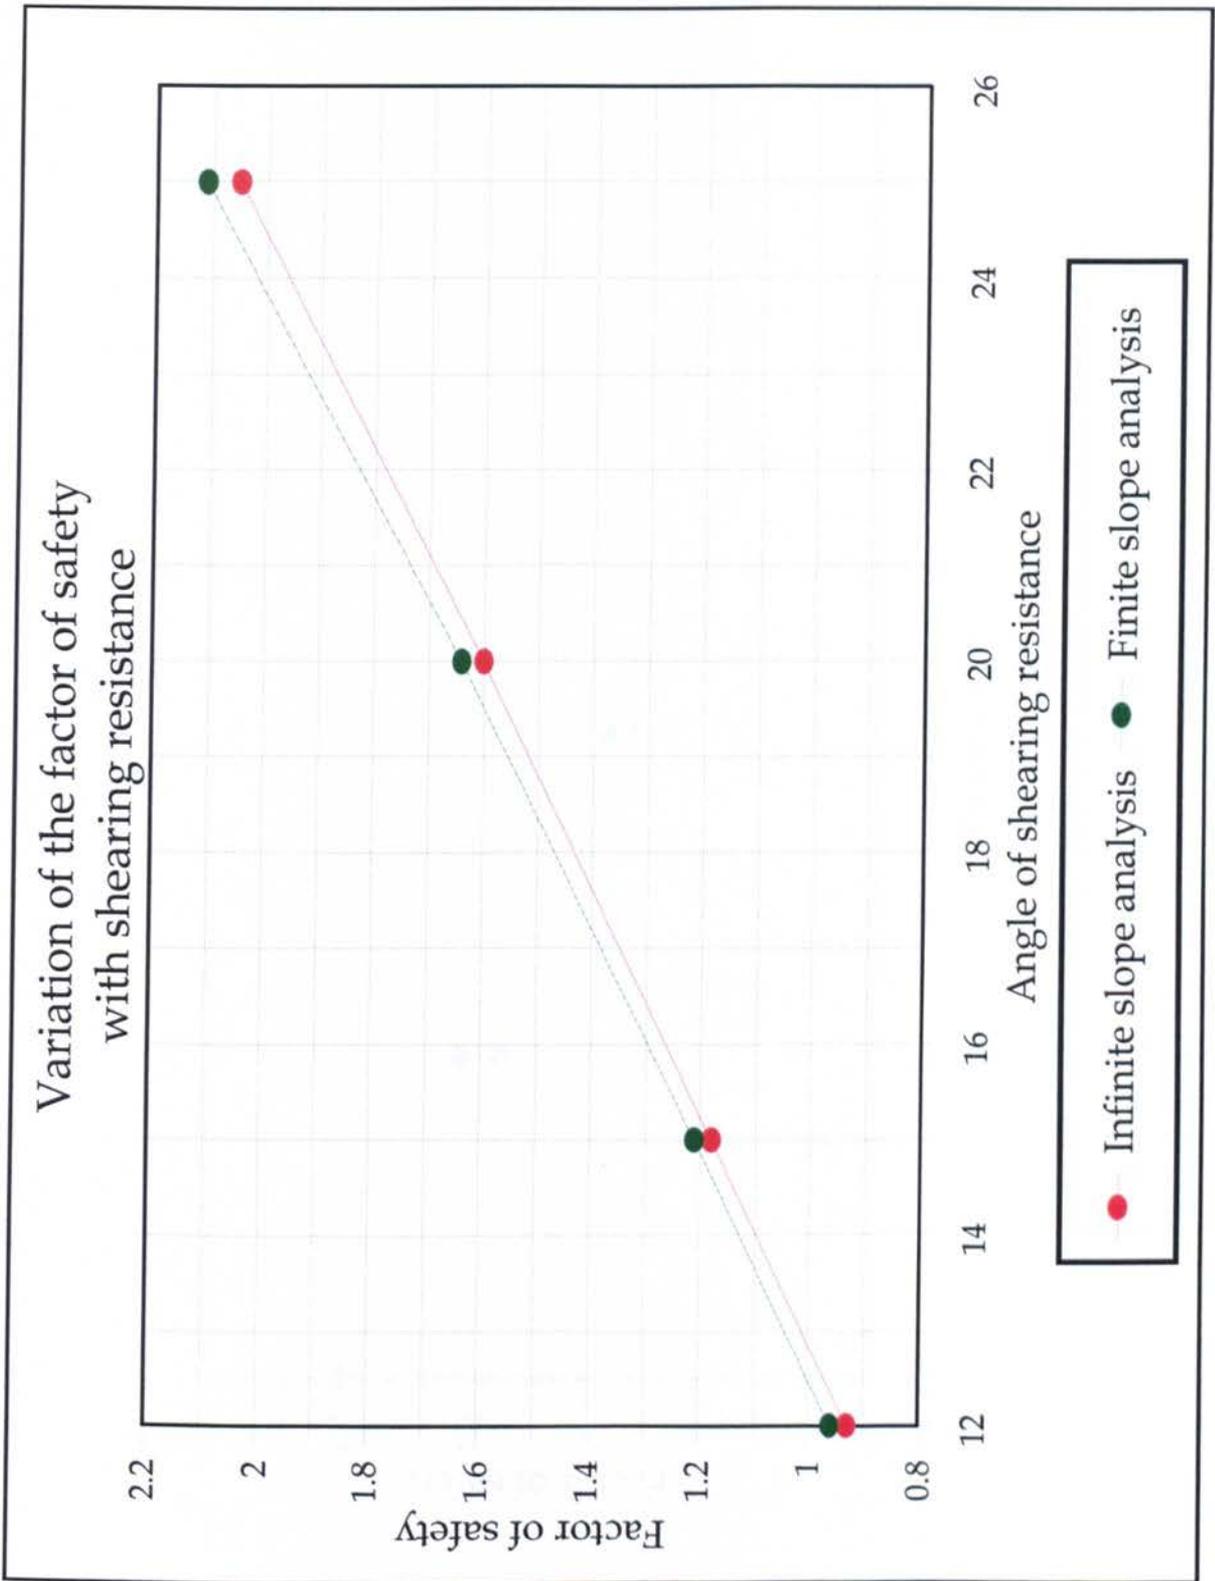
Figure 9.8. Graph showing the relationship between factor of safety and the angle of shear resistance.

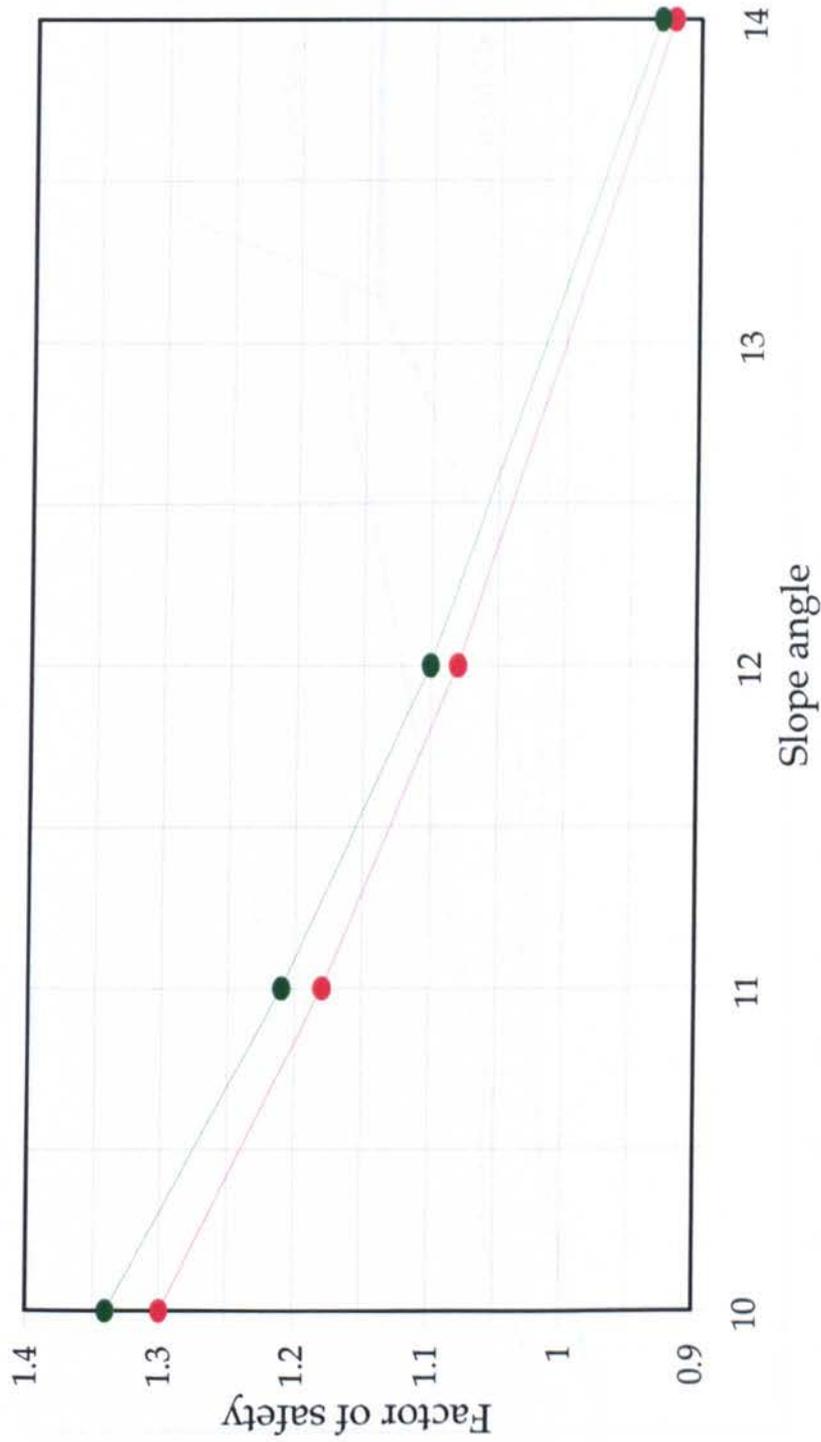
Figure 9.9. Graph showing the relationship between factor of safety and the slope angle.

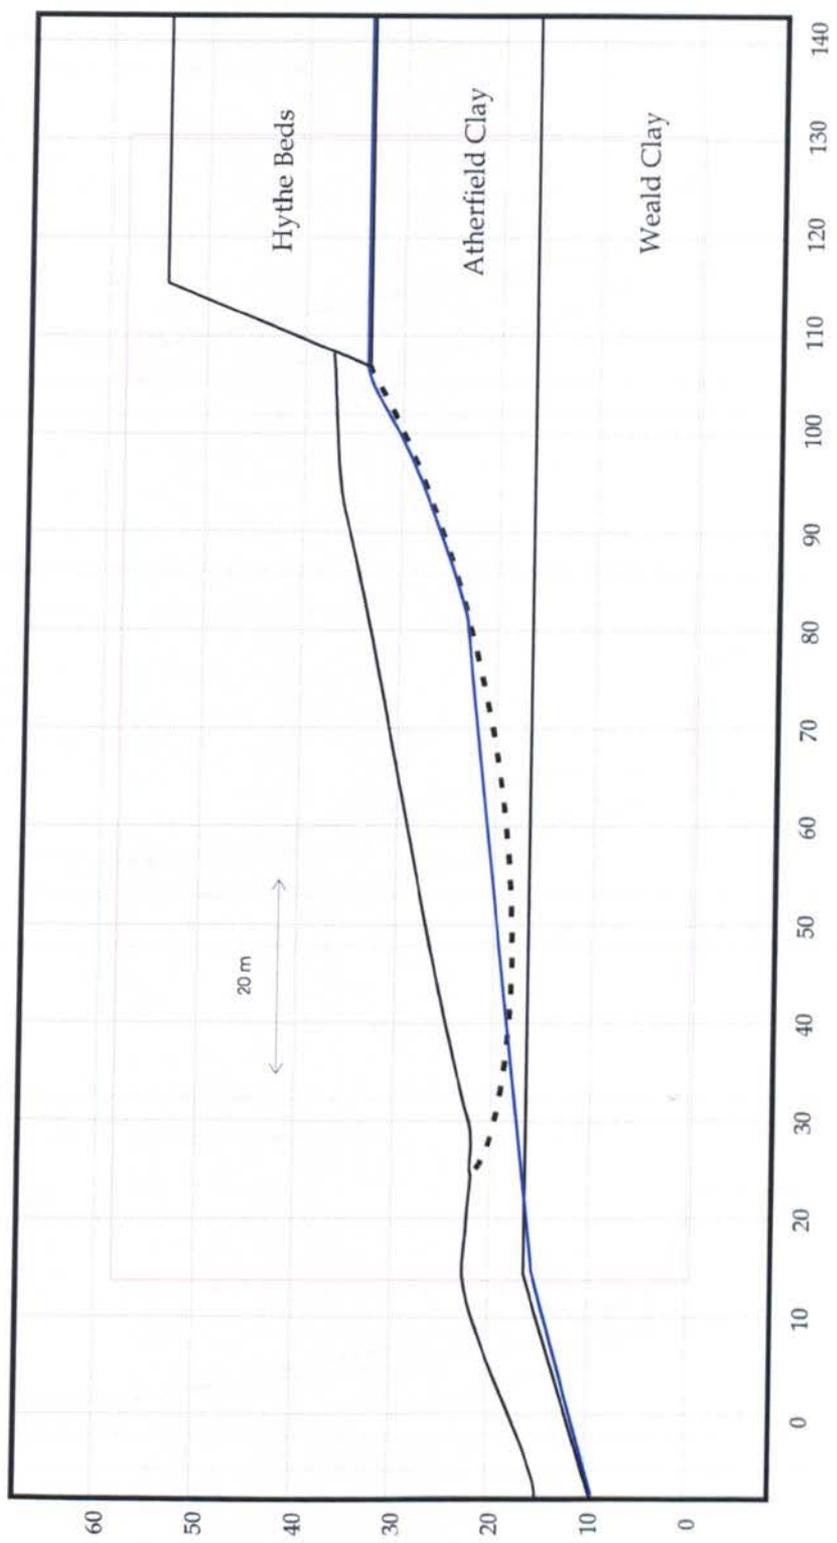
Figure 9.10. Present day situation on The Roughs, used as the model for the Morgenstern and Price analysis of the rotational zone.

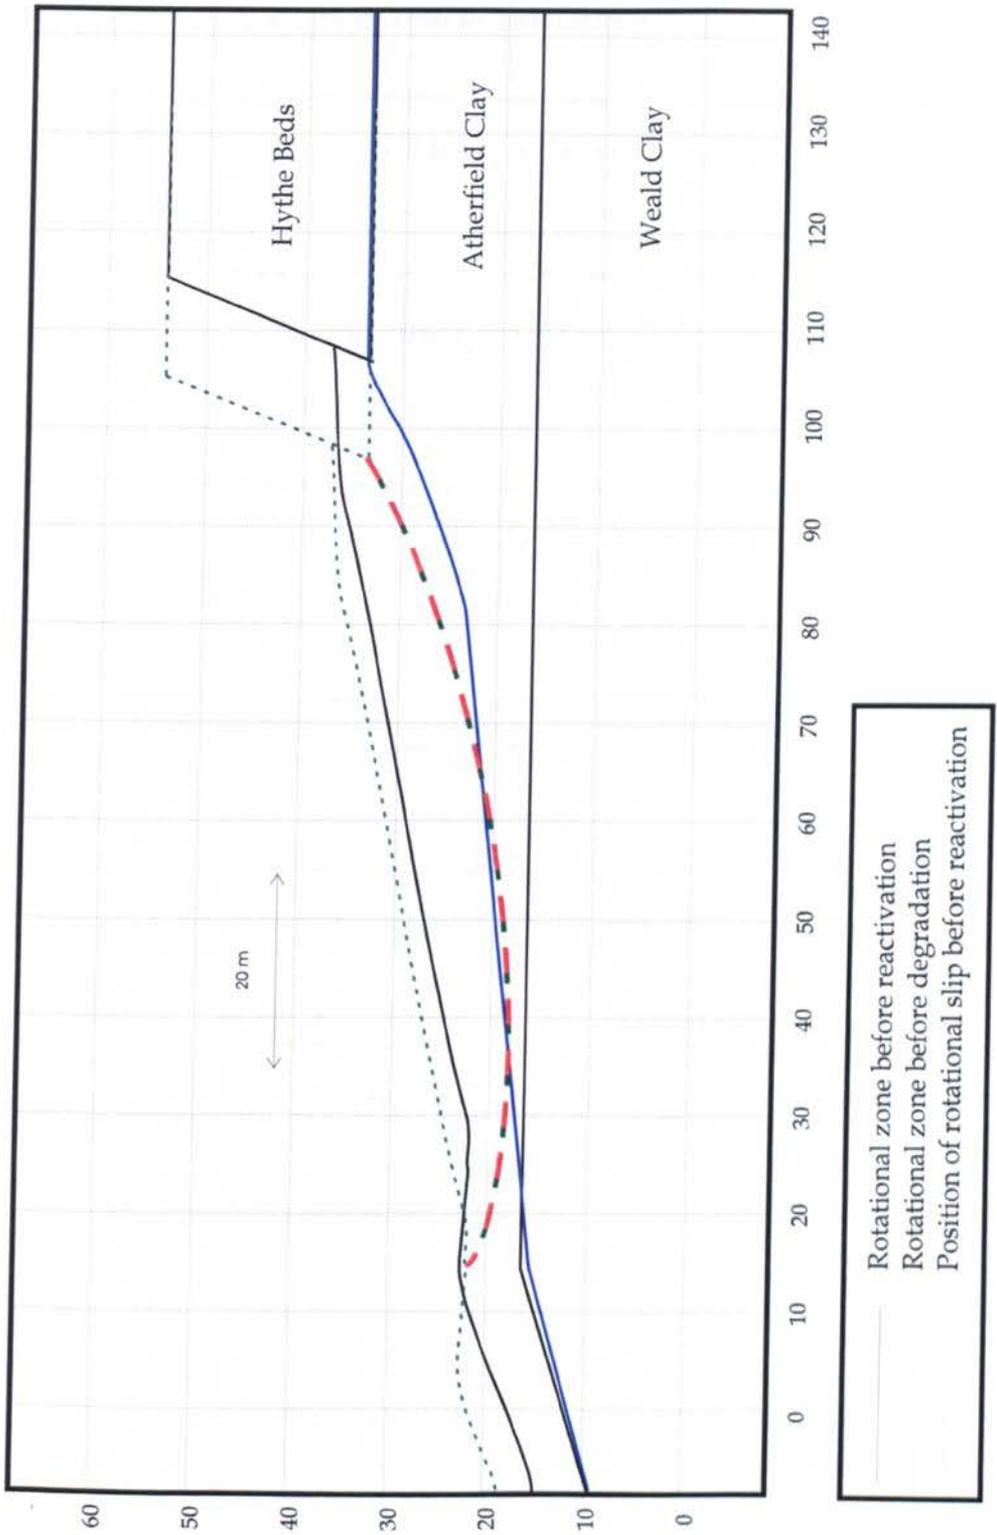
Figure 9.12. Assumed situation on The Roughs before the 1988 reactivation.
