Water vapour corrosion of rare earth monosilicates for environmental barrier coatings application

N. Al Nasiri, N. Patra, D.D. Jayaseelan, W.E. Lee

To appear in: *Ceramics International*

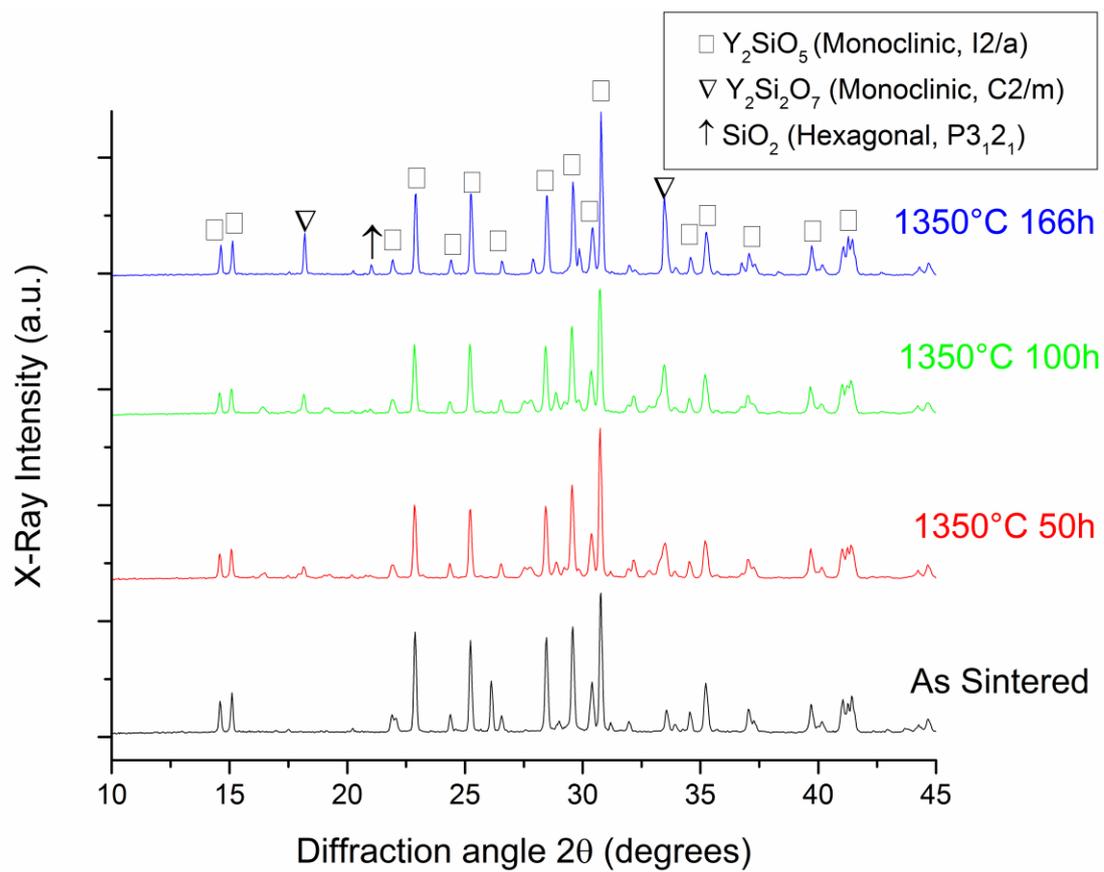
Fig 1: XRD of Y_2SiO_5 for as received and oxidised at 1350 °C for 50, 100 and 166 h in steam conditions.

XRD of sample's surface that was not in contact with the alumina boat for as-sintered samples and those oxidised at 1350 °C for 50, 100 and 166 h in steam for the five RE-silicates is shown in Figures 1 to 5. Figures 1 and 3 show that Y and Er samples were predominantly monosilicate phase before testing. However, Rietveld refinements determined disilicates comprised 5 ± 2 , 15 ± 5 , and 12 ± 2 wt.% of the Gd, Yb and Lu samples, respectively, the desired monosilicates phases thus comprising at least $85\% \pm 2$ wt.% in all samples. For all five RE-silicates formation of crystalline silicon oxide is observed after 50 h exposure in steam suggesting the reaction between silicon present in the bulk of RE-silicate with oxygen in water vapour environment. Y and Er-disilicate peaks were observed after 50 h steam exposure with the highest peak after 166 h steam corrosion ($2\theta = 33^\circ$), however they remained mostly monosilicates. Figure 2 shows that Gd-silicate consisting of mainly monosilicate with 5 ± 2 wt.% of disilicate was completely transformed to $\text{Gd}_{4.67}\text{Si}_3\text{O}_{13}$ after 50 h exposure in steam. Since XRD shows only the presence of $\text{Gd}_{4.67}\text{Si}_3\text{O}_{13}$, it appears to be a stable phase even after exposure to steam at high temperatures (166 hours). Although, monosilicate has been converted to the above phase, it is not clear at what point of time or temperature during the experiments, the oxidised product did not transform much further or did not have any appreciable weight loss. It may be the above phase could have been formed by the solid state reaction between GdO_2 and SiO_2 which are the decomposed products of the silicates. Therefore, more work is required to confirm if $\text{Gd}_{4.67}\text{Si}_3\text{O}_{13}$ system is indeed stable or not for prolonged exposure in steam at high temperatures with better understanding of the Gd-mono/disilicate transformation to $\text{Gd}_{4.67}\text{Si}_3\text{O}_{13}$. On the other hand, more pronounced disilicate peaks were revealed for Yb and Lu samples suggesting that RE-disilicates are more likely to react with water vapour than their counterpart monosilicates (Figures 4 and 5).

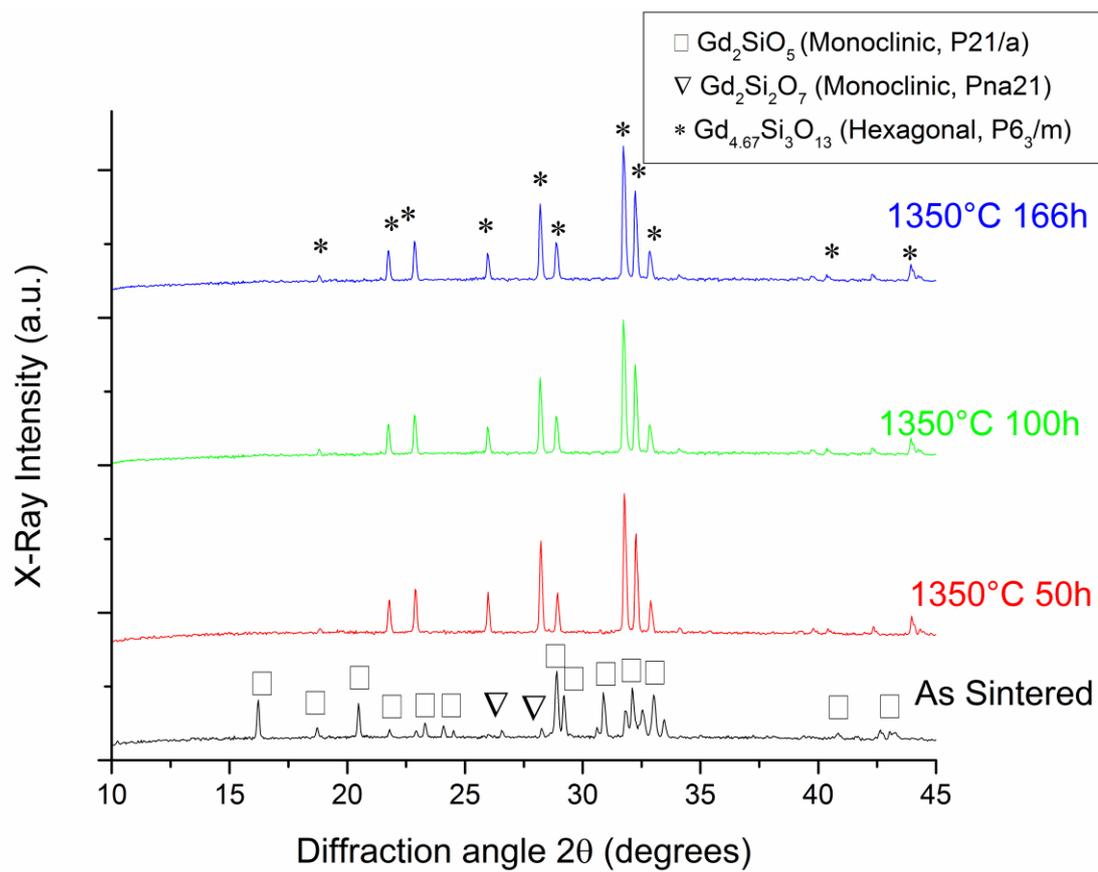
Fig 2: XRD of Gd_2SiO_5 for as received and oxidised at 1350 °C for 50, 100 and 166 h in steam conditions.

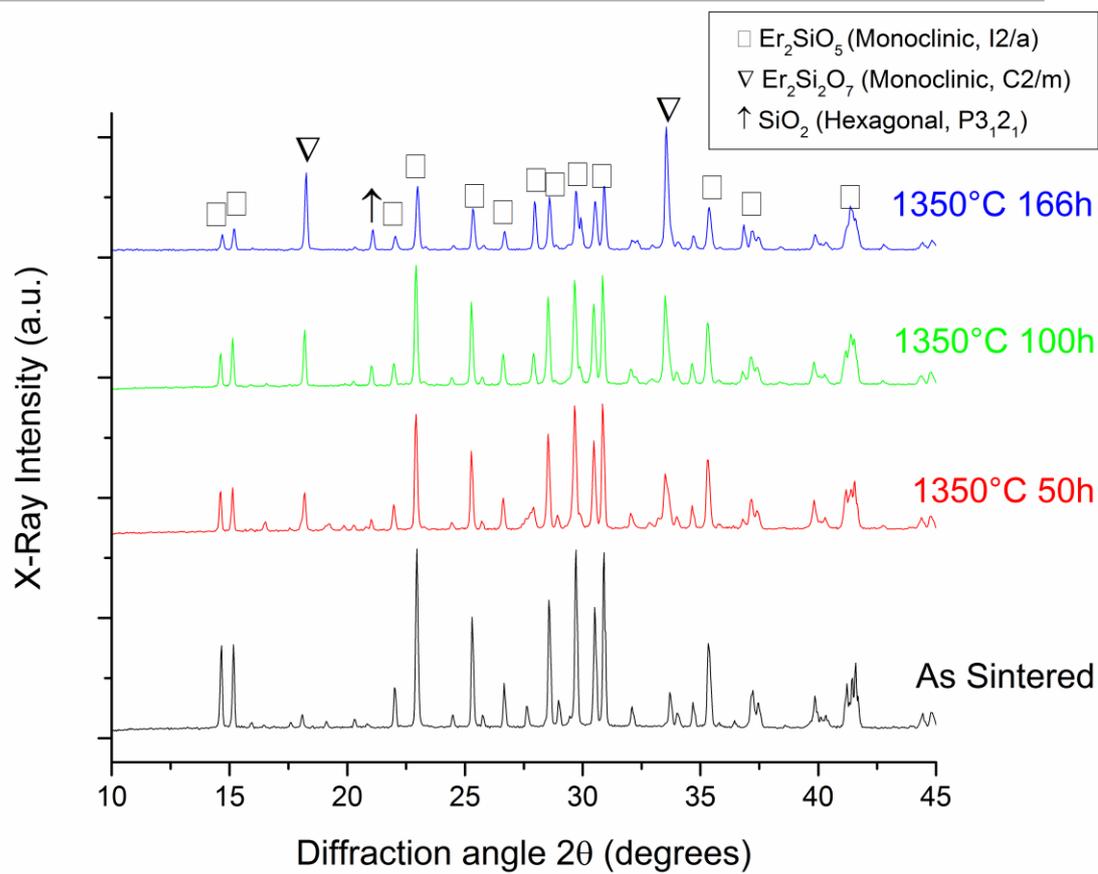
Fig 3: XRD of Er_2SiO_5 for as received and oxidised at 1350 °C for 50, 100 and 166 h in steam conditions.

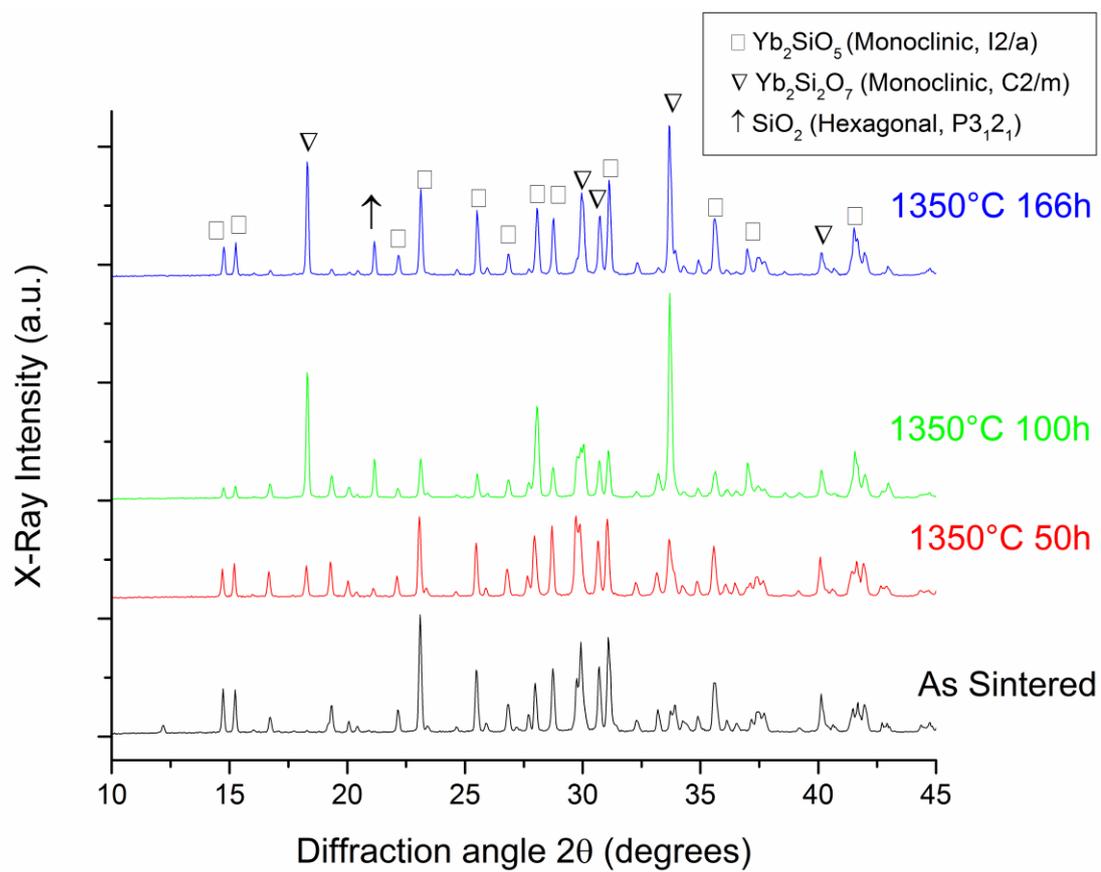
Fig 4: XRD of Yb_2SiO_5 for as received and oxidised at 1350 °C for 50, 100 and 166 h in steam conditions.

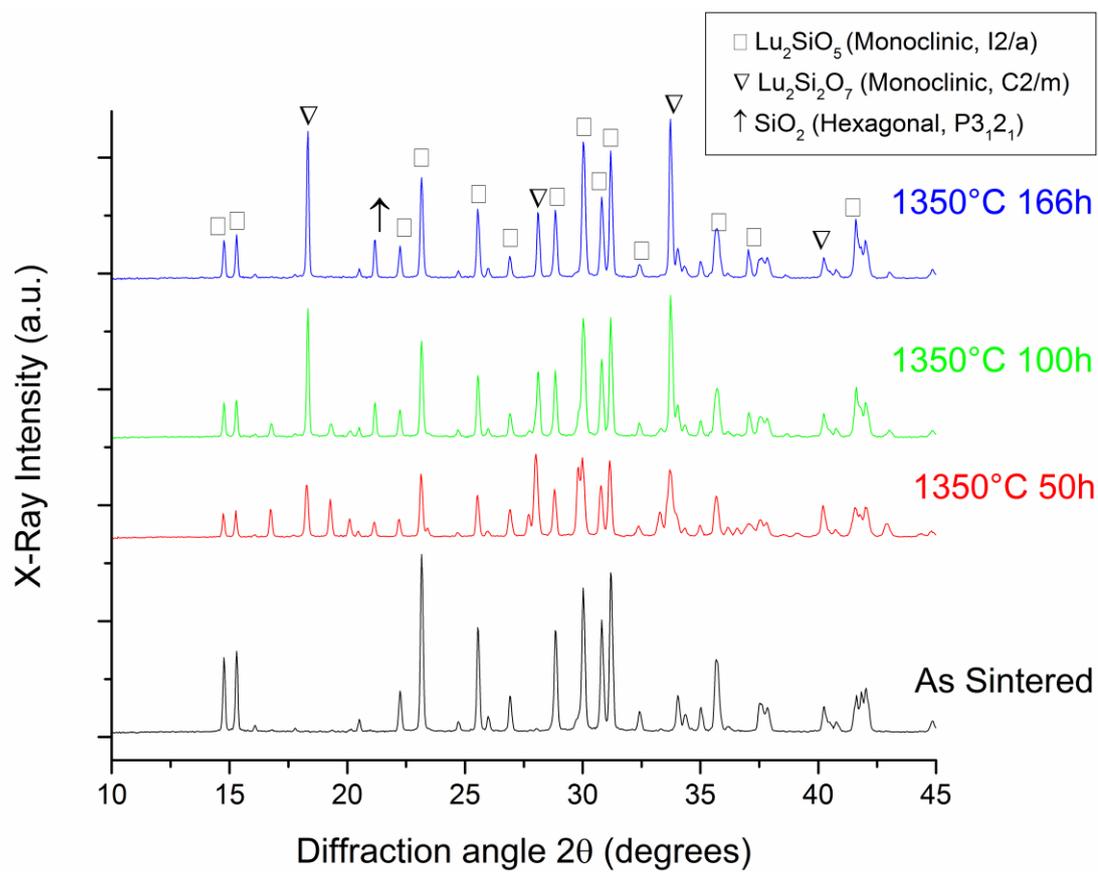
Fig 5: XRD of Lu_2SiO_5 for as received and oxidised at 1350 °C for 50, 100 and 166 h in steam conditions.

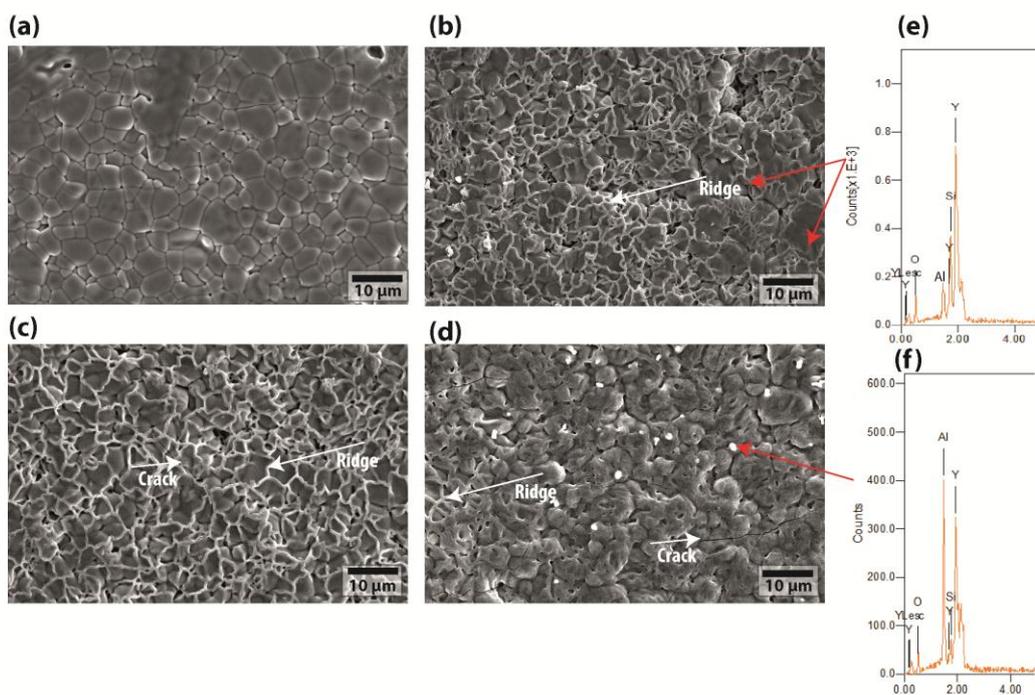
Fig 6: SEI of Y_2SiO_5 (a) thermal etched as sintered, (b) oxidised at 1350 °C for 50 h, (c) oxidised at 1350 °C for 100 h, (d) oxidised at 1350 °C for 166 h in steam, (e) EDS analysis of the grain and ridges and (f) EDS analysis showing Al contamination after 166 h in steam.

Oxidising Y_2SiO_5 samples in water vapour environment reveals the presence of light contrast raised ridges located at the grain boundaries on the surface (Figure 6 (b) and (c)). These ridges may arise from volatilisation of the SiO_2 present in the less stable $\text{Y}_2\text{Si}_2\text{O}_7$ phase leaving behind the stable Y-monosilicate. EDS analysis (Figure 6 (e)) of the grains and the ridges confirm the presence of Y_2SiO_5 . Fewer ridged structures are observed after 166 h water vapour exposure (Figure 6 (d)) with several cracks generated on the surface. The bright

particles observed on the surface are Al contamination (Figure 6 (f)) transferred from the alumina tube furnace to the sample surface via gas phase transport of volatile $\text{Al}(\text{OH})_3$ due to reaction between the alumina and water vapour. The Y_2SiO_5 was stable after 166 h exposure in 90% steam: 10% air and did not decompose to Y_2O_3 as has been found by Lange et al. [20] and Klemm [21]. The reason for this difference in behaviour may be due to the starting single phase of Y-monosilicate of this work compared to a mix of Y-mono/disilicates phases of the work of Lange and Klemm. This confirms the stability of Y-monosilicate phase at higher temperature in steam corrosion environment making it ideal for EBC application.

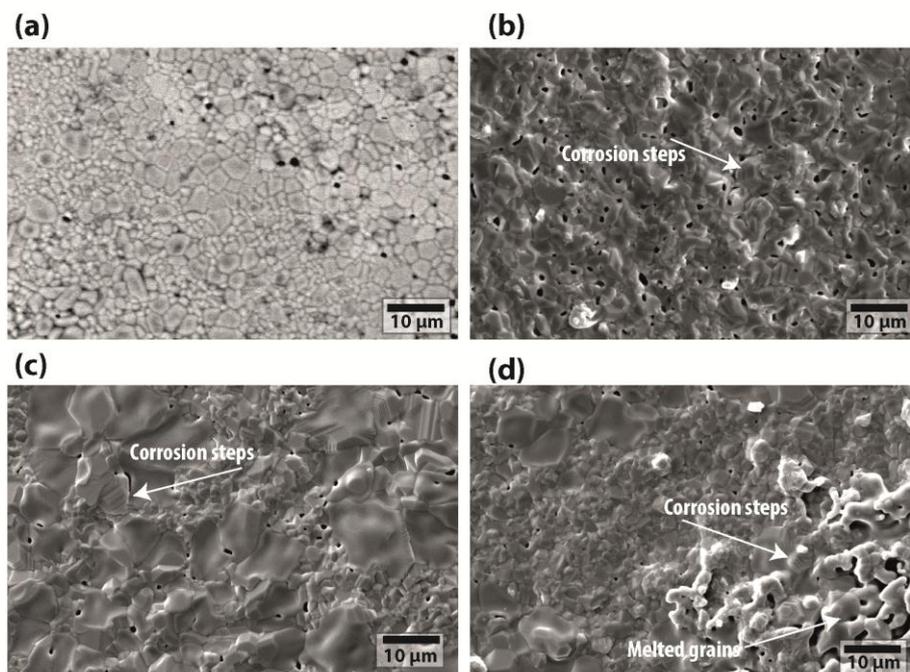
Fig 7: SEI of Gd_2SiO_5 (a) thermal etched as sintered, (b) oxidised at 1350 °C for 50 h, (c) oxidised at 1350 °C for 100 h and (d) oxidised at 1350 °C for 166 h in steam.

The surface microstructure of sintered and thermally etched Gd_2SiO_5 is shown in Figure 7 (a), which consists of fine equiaxed grains with grain size of 4 ± 0.2 . Gd-monosilicate surfaces after water vapour exposure showed different features including striped contrast grains, greater porosity and lack of any raised grain boundary ridges (Figure 7 (b)-(d)). The size of the striped grains varies from 5 to 10 μm and they are distributed randomly over the exposed surface. Such features have not been observed before RE-silicates although similar features were observed by Ueno et al. [13] for TiO_2 and Al_2TiO_5 samples exposed to water vapour corrosion at 1300-1500 $^\circ\text{C}$ for 100 h in 30 wt.% H_2O -70 wt.% O_2 water vapour. They suggested that the homologous series of suboxides generated by the reduction of TiO_2 (i.e. TiO_{2-x}) on the sample surface when observed in [001] projection gives this terraced field of rectangular shaped pits. It is quite possible that a similar homologous series exists in Gd silicates. The rounded grains in Figure 7 (d, arrowed as melted grains) suggest that the grain boundary phase was completely removed due to the reaction of silica presents in the silicate with water vapour at high temperature to form volatile silicon hydroxide (Eq. 3) leaving behind the melted grains with no boundary silica phase.

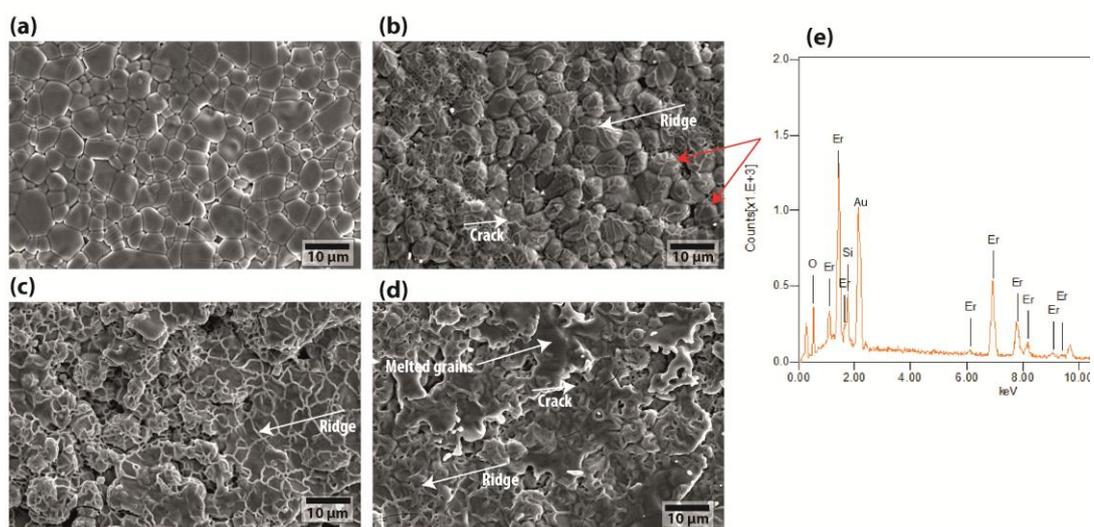
Fig 8: SEI of Er_2SiO_5 (a) thermal etched as sintered, (b) oxidised at 1350 °C for 50 h, (c) oxidised at 1350 °C for 100 h, (d) oxidised at 1350 °C for 166 h in steam and (e) EDS analysis of the grain and ridges.

Figure 8(a) shows the surface morphology of as-sintered and thermally etched Er_2SiO_5 revealing a smooth, crack free surface. The literature contains conflicting corrosion data for

Er-silicate materials in water vapour environment. Ueno et al. [13] observed that samples containing Er-disilicate and Er-monosilicate were completely melted in 30% water vapour at 1500 °C for 100 h. On the other hand, Lee et al. [7] showed that Er-monosilicate with Er-disilicate and Er-oxide samples oxidised in 50% water vapour at 1500 °C for 100 h showed good resistance to water vapour as there was no significant weight gain with alumina contamination. In this study, there was also little weight gain (0.097 - 0.502 mg cm⁻²) for the samples produced with pure Er-monosilicate phase (Table 1). Figures 8 (b) to (d) show the surface morphology of the corroded samples that exhibit ridged features similar to those of Y-monosilicate. Additionally, after 100-166 h exposure to steam corrosion, grains with rounded morphology suggestive of melting were noticed (Figures (c) and (d)) that may be attributed to the reaction of silica around the grain boundaries. EDS (Figure 8 (e)) analysis confirmed the presence of Er-monosilicate inside the grains and around the ridges confirming the stability of Er₂SiO₅ in water vapour corrosion. Cracks were also generated (Figure 8(d)) on the surface possibly due to the transformation of Er₂SiO₅ to Er₂Si₂O₇ arising from the different coefficients of thermal expansion of the different phases or from a change in volume accompanying the transformation.

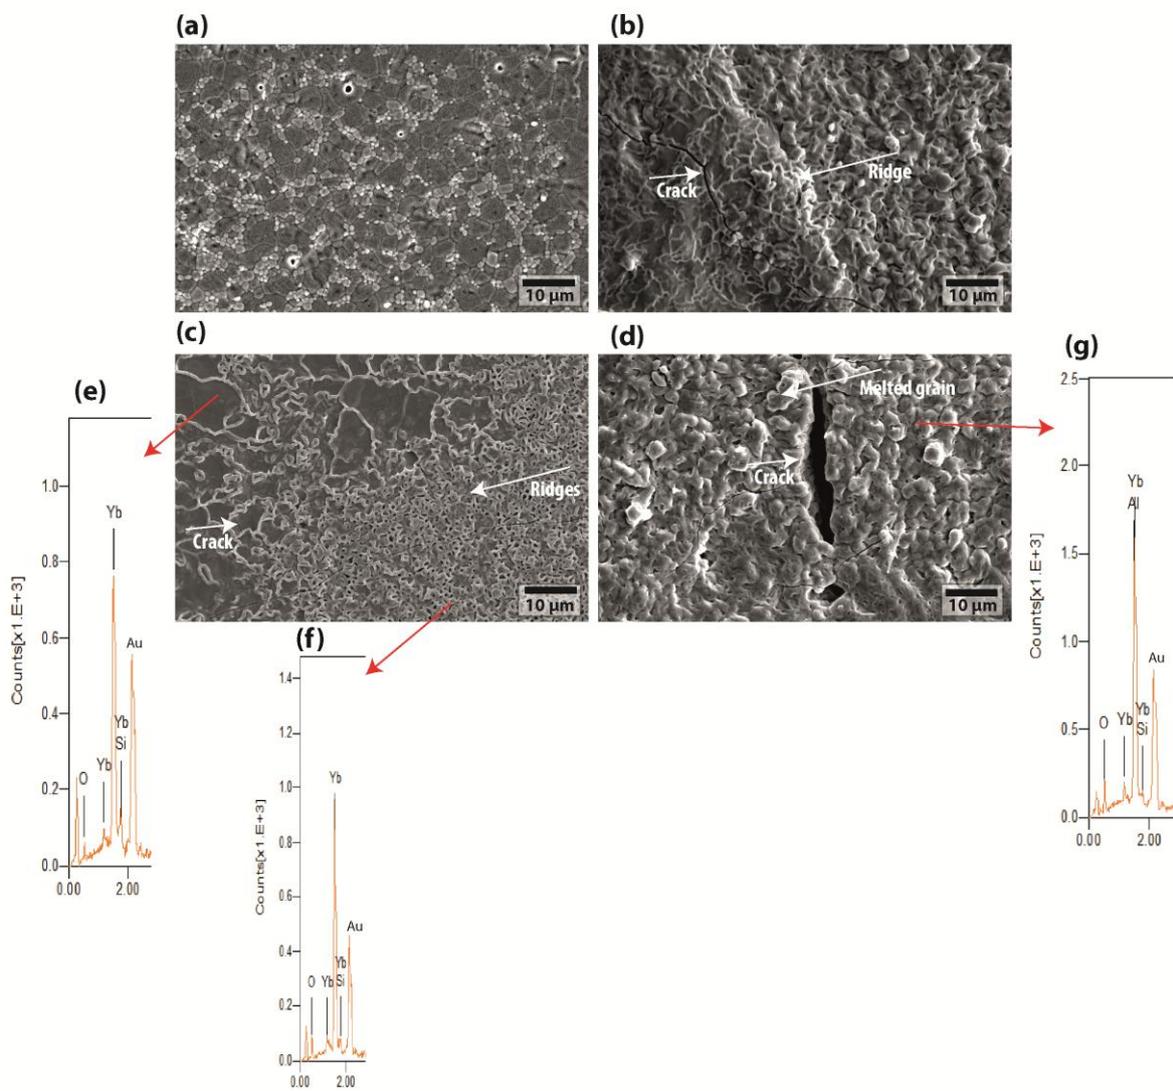
Fig 9: SEI of Yb_2SiO_5 (a) thermal etched as sintered, (b) oxidised at 1350 °C for 50 h, (c) oxidised at 1350 °C for 100 h, (d) oxidised at 1350 °C for 166 h in steam, (e) EDS analysis of dark region, (f) EDS analysis of light region and (g) EDS analysis of a melted grain.

The surface microstructure of as-sintered Yb₂SiO₅ is shown in Figure 9(a). Two phases: dark contrast large (~ 5 micron) equiaxed grains with faceted morphology and bright small (less than a micron) grains mostly along the grain boundaries were observed. EDS analysis (Figure 11 (a)) reveals that the dark regions contain higher Si content than the brighter ones. Yb-silicate samples, after corrosion at 1350 °C for 50 and 100 h in steam showed several cracks on their surfaces, (Figure 9 (b) and (d)). Ridge structures dominated the microstructure for 50 h exposure, similar to the observations for Y and Er-silicates. However, for longer corrosion exposure (100 h, Figure 9(c)), the surface morphology was divided into a dark region of grains and a lighter region of accumulated ridged structure. EDS analysis (Figure 9

(e)) revealed that the dark regions are Yb-monosilicate while the lighter regions (Figure 9 (f)) contain a decreased silicon content suggesting the decomposition of less stable $\text{Yb}_2\text{Si}_2\text{O}_7$ phase to Yb_2SiO_5 . As the exposure time to steam increased to 166 h, surface morphology showed rounded grains indicative of melting (arrowed in Figure 9d) with no distinct grain boundary. EDS analysis (Figure 9 (g)) of the melted structure revealed high levels of Al (15-20 atom.%) contamination with Yb and O. A similar observation was made by Maier et al. [16] on Yb-disilicates samples with Yb-monosilicate phase at 1500 °C for 100 h in 30% steam condition.

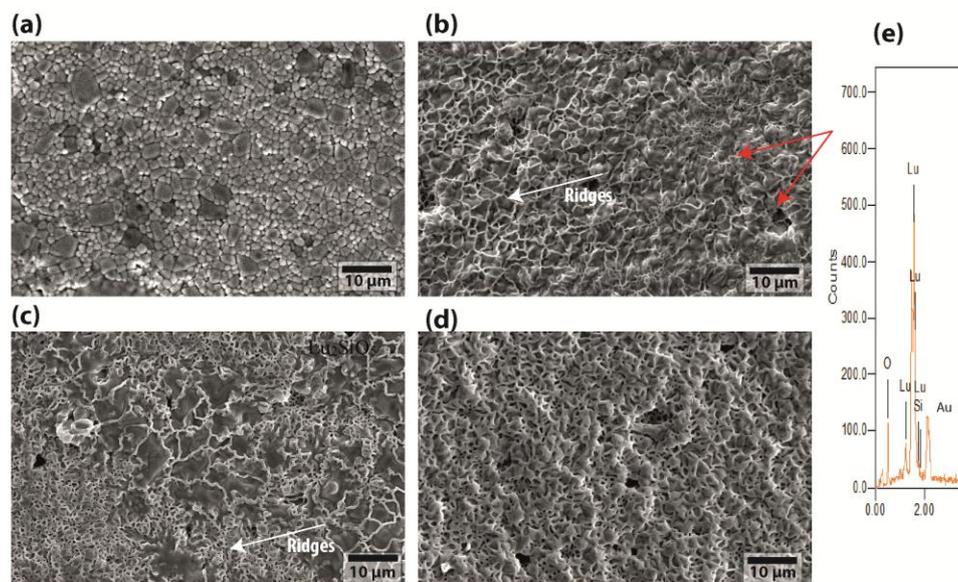
Fig 10: SEI of Lu_2SiO_5 (a) thermal etched as sintered, (b) oxidised at 1350 °C for 50 h, (c) oxidised at 1350 °C for 100 h, (d) oxidised at 1350 °C for 166 h in steam and (e) EDS analysis of the grain and ridges

Figure 10 (a) shows the as-sintered and thermally etched Lu_2SiO_5 with a bimodal grain distribution. The corroded surfaces of Lu-silicate samples show similar ridged structures for 50 and 100 h exposure in steam (Figure 10 (b) and (c)) as seen for Y, Er and Yb-silicates. The decomposition of Lu-disilicate to Lu-monosilicate occurs above 1300 °C and near the grain boundaries as observed by Ueno et al. [13]. EDS analysis (Figure 10 (e)) revealed that both the grains and the ridged structure consist of Lu-silicates with no conversion to its original form (Lu_2O_3). After 166 h exposure to steam, Lu-silicate samples were covered completely with RE and aluminium contamination, similar to the observation in Yb-silicate samples.
