Paper title: The Vaiont landslide: Re-assessment of the evidence leads to rejection of the consensus

Authors: Alan P. Dykes ^{1*}, Edward N. Bromhead ²

Key words: Vaiont, landslide, rock slide, geology, geotechnics, failure surface geometry

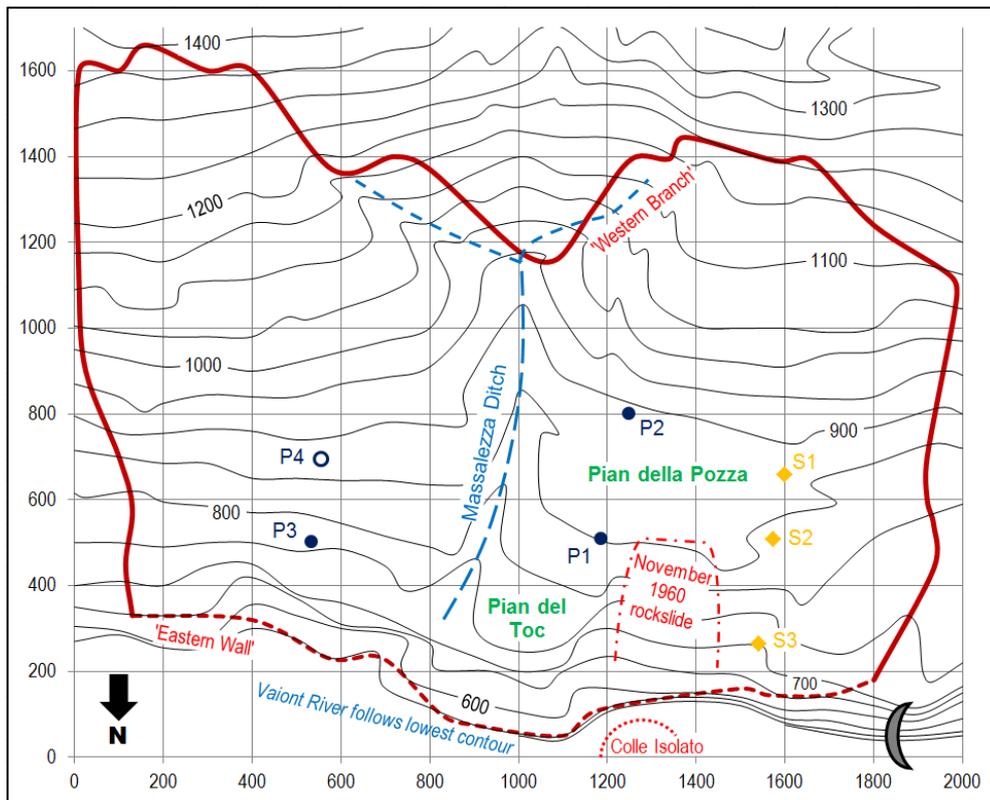
Figure 2. Map of the landslide area prior to 1963 plotted on an arbitrary grid with x and y scales in metres. Contours are in metres at 50 m vertical intervals. The solid dark red line defines the margins of the 1963 landslide, with the approximate line of its breakout in the gorge indicated by the broken line. Locations and features mentioned in the text are labelled, including piezometers P1-P4 and boreholes S1-S3. The dam is shown in the lower right corner at $x = 1850$ m.

1. At the so-called 'eastern wall' of the gorge (upstream end, left bank: Fig. 2), Semenza found a layer of what he described as 'extremely fractured rocks (cataclasts)'. He wrote: 'It was logical to think that these cataclasts would also run under all the northern wall' (2010, p.61) and interpreted them as being the failure surface of an ancient landslide. However, these mylonites/cataclasts were not found any further towards the dam (Broili 1967), and borehole S3 that was drilled in 1960 (Fig. 2) did not reveal any such rocks of any thickness at the depth of the 1963 failure surface (also noted by Semenza 1965: see below). Hendron and Patton (1985) suggested the possibility of 'tectonic faulting' in the form of a thrust along the bedding creating a weakness at the position indicated by Guidici and Semenza (1960) could give the impression that the 1963 landslide was a reactivation of an old slide – although Hutchinson and Kwan (unpublished manuscript 1986) noted that if it was a tectonic shear then it may have recovered strength by 1960. Nonveiller (1992) also assumed that the 1963 landslide was a reactivation of a prehistoric slide but nevertheless with progressive failure taking place. The location of the 'eastern wall' outcrop observed by Semenza met the line of the Col Tramontin Fault. It seems reasonable to suggest that movements along this fault zone could have disrupted adjacent bedding to differing degrees resulting in variable thicknesses and distributions of fault gouge, especially if part of the bedding plane did coincide with a local thrust fault. Therefore, the observed 'cataclasts' do not constitute evidence of an ancient landslide.

2. The Colle Isolato comprised a mass of rock on the right side of the gorge (Fig. 2), resting on horizontal layers of river gravels that infill an older, narrower 'inner' gorge (Semenza 2001, 2010). It was structurally discordant with the in-situ rock of the right side but consistent with the left side. Semenza's interpretation of all the visible details was that this mass was probably a remnant of the toe of the ancient landslide that slid from the left side, crossed (and blocked?) the pre-1963 gorge and came to rest when it hit the right side of the gorge. However, the Colle Isolato deposit appears to have buried river gravels as observed and photographed by Semenza, i.e. it must post-date an earlier blockage and infilling of an older inner gorge. Neither the age nor indeed the extent of the gorge realignment affects the key point, which is that the landslide that formed the Colle Isolato does not necessarily constitute evidence of a large ancient landslide coincident (at least in part) with the extent of the 1963 failure. Broili (1967) noted that borehole S1, drilled in 1960 (Fig. 2) revealed a layer of silt and sand below the Pian della Pozza, perhaps 100 m higher than the 1963 failure surface, that could have resulted from a large slide of perhaps 30-40 million m³. This, or a smaller

Many of the early assumptions – and thus interpretations – were based on field geological observations and mapping, which were reinforced by subsequent information such as borehole cores that had poor rates of recovery (<30% even from intact rock below the failure surface: [Hendron and Patton 1985](#)), from a stratigraphic sequence about which there was far less understanding at that time. The failure surface of the 1963 landslide was described as having a 'chair' shape (C3) on the basis of observations of exposed rock faces in the Piave valley at Longarone. Indeed, this structure is clearly visible in the left wall of the valley immediately south of the downstream end of the Vaiont gorge (Fig. 7) and can also be seen at a higher elevation in the right wall. It had been assumed that this structure, relating to the Erto Syncline, persisted upstream along the gorge though with the subhorizontal 'seat' dipping eastwards at up to 20° ([Broili 1967](#); [Semenza 2001, 2010](#)). Unfortunately, this idea of the (sub-)horizontal 'seat' was further reinforced by a critical error by [Semenza \(1965, Section C.5\)](#). In July 1960, three boreholes were drilled with the aim of locating the layer of 'cataclastic' material observed in the 'eastern wall' of the south side of the gorge (see Section 2.2, (i), above) that had been interpreted as the failure surface of the ancient landslide. This material was not encountered in any borehole. Consequently, Semenza suggested that this layer must have extended 'almost horizontally' much further from the gorge, i.e. beyond borehole S1 (furthest from the gorge within the western half of the landslide: Fig. 2).

During September–October 1961, four piezometers were installed within the north side of the mountain slope (Fig. 2) although piezometer P4 ‘failed early’ and yielded no data ([Müller 1964](#)). Data from P2 initially showed water levels up to 90 m higher than the reservoir level, which was thought to indicate significantly artesian groundwater pressures ([Müller 1964](#); [Hendron and Patton 1985](#)), but later it showed a water table consistent with P1, P3 and the reservoir elevation.

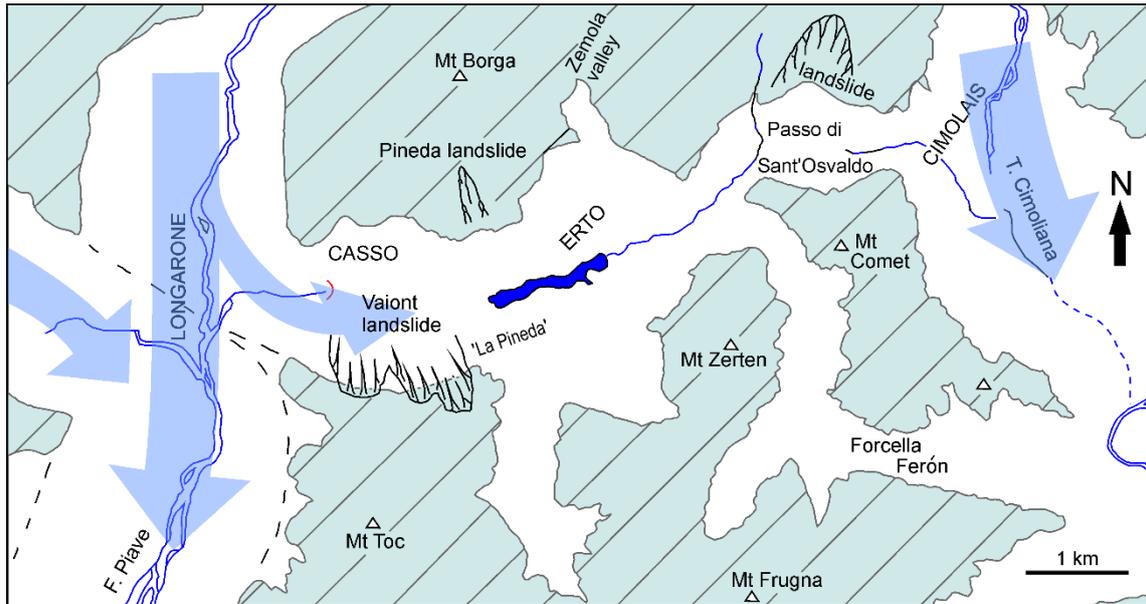
Figure 3. Map of the hypothesised glacial context of the Vaiont landslide. Land over 1100 m elevation is shaded green with cross-hatching. Locations of towns and villages are indicated by the positions of their names. The residual Vaiont lake impounded by the landslide is the dark blue shape in the centre. The pale blue arrows indicate the key glaciers.

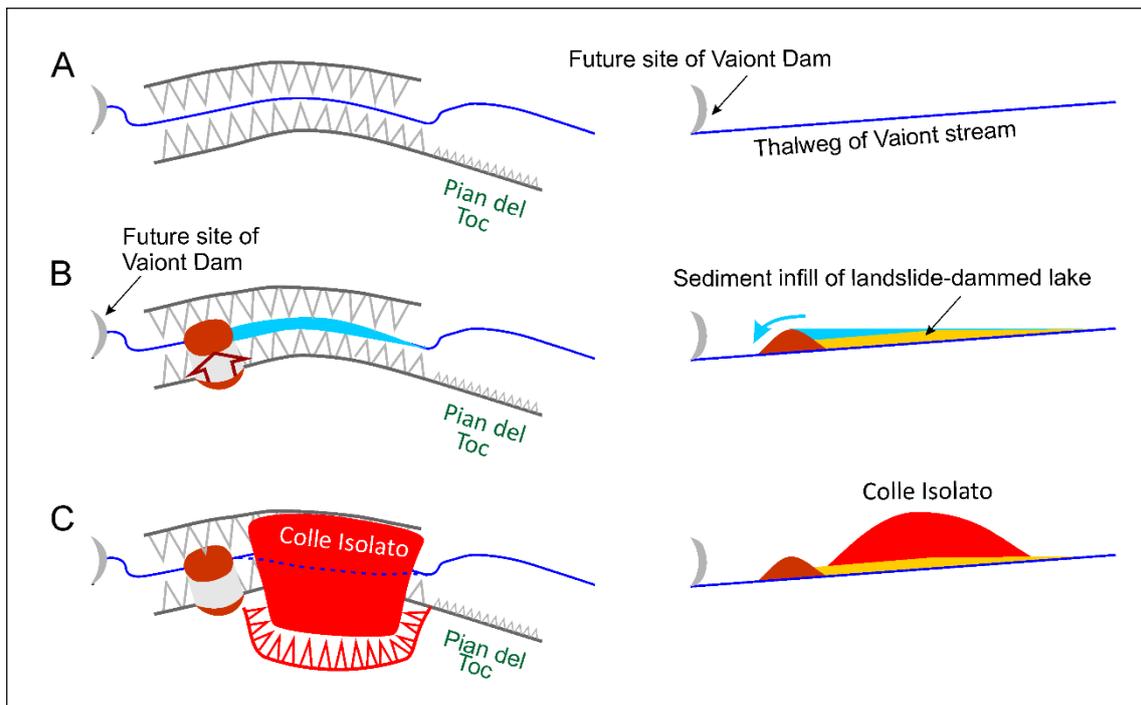
Figure 4. Hypothetical explanation for the Colle Isolato and its apparently buried river gravels, showing plan and river long profile views. The diagrams are not to scale, and the post-1960 location of the dam is shown for context only. The grey triangles indicate very steep (probably near vertical) cliffs of the inner gorge. (A) Early alignment of the inner gorge upstream of the dam. (B) A small landslide from either side of the gorge (south side shown) blocks the inner gorge, which then infills upstream of the blockage with fluvio-glacial sediment as the river flows over (then through) the landslide dam. (C) A much larger landslide from the south side completely buries the old inner gorge and causes the river to cut a new course through the slide mass slightly further south (dotted blue line). The source area of the landslide shapes the outer gorge downslope of the Pian della Pozza, including the site of the November 1960 landslide, and the slide deposit forms the Colle Isolato.

slide from the face of the otherwise intact left wall of the gorge (e.g. Fig. 17 in [Wolter et al. 2016](#); Broili suggested ~ 9 million m^3), could have formed the Colle Isolato. We suggest the latter to be the more likely case (Fig. 4)

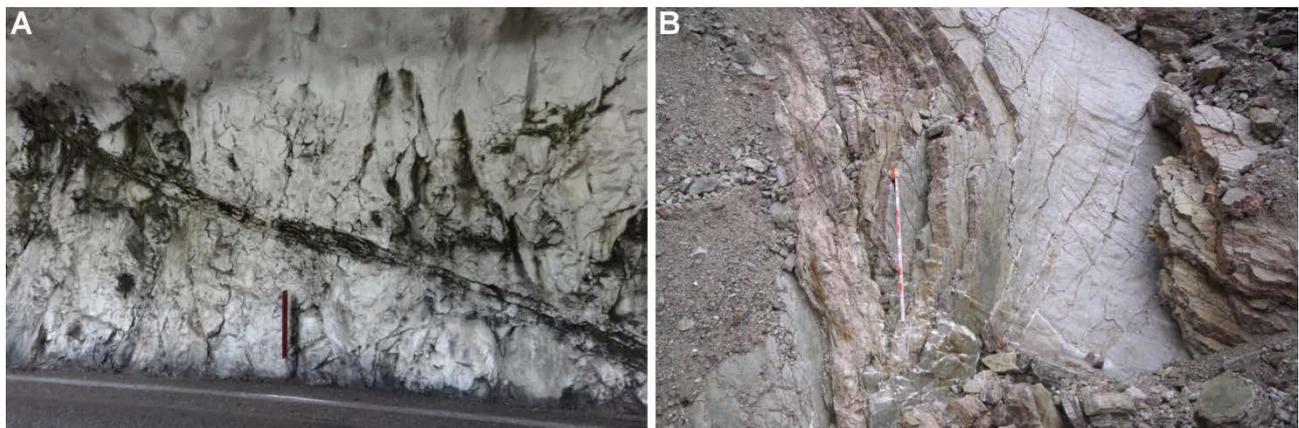
Figure 5. (A) Interbedded clay layer within the Biancone Formation in the unlined wall of the road tunnel adjacent to the Vaiont dam (eastward dip to the right, the roof arch is shotcreted). Photo: ENB. (B) Thin beds of limestone and clay on the failure surface of Vaiont landslide just west of the Massalezza Ditch (see [Ghirotti et al. 2013](#) for details of this location). The measurement scale is 1 m long. Photo: APD.

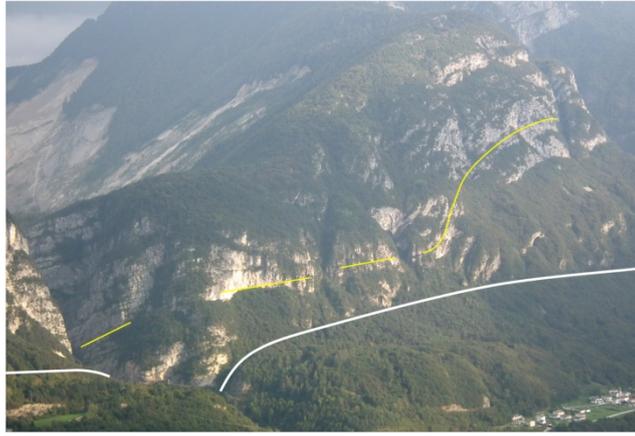
Figure 7. Left wall of the Piave Valley above Longarone in September 2011, showing the ‘chair’ structure (bedding indicated by yellow lines) that was mistakenly assumed to extend beneath at least the western half of the landslide. The white line marks the alignment of the Col delle Tosatte Fault. The downstream end of the Vaiont Gorge is at the lower left of the image and part of the landslide scar is visible in the upper left part. Photo: APD.

It is the geometry of the 'chair', with its steep 'back' and horizontal or sub-horizontal 'seat', and/or failure to take account of the alignment of such cross-sections with respect to a 3-dimensional bowl-shaped failure surface (Müller 1964; Kiersch 1964; Broili 1967), that has confounded previous attempts to provide a single explanation of all aspects of the event. However, NE-SW tectonic compression deformed the 'chair' structure associated with the Erto syncline east of the N-S Col delle Tosetta fault (Fig. 6). This 'Stage 2' compression (see Section 2.2, above) formed the Massalezza syncline and created a bowl-shaped 3D structure (Massironi et al. 2013) which, when viewed in N-S subvertical cross-section in the left wall of the Piave valley opposite Longarone, happens to look like a 'chair' (Fig. 7).

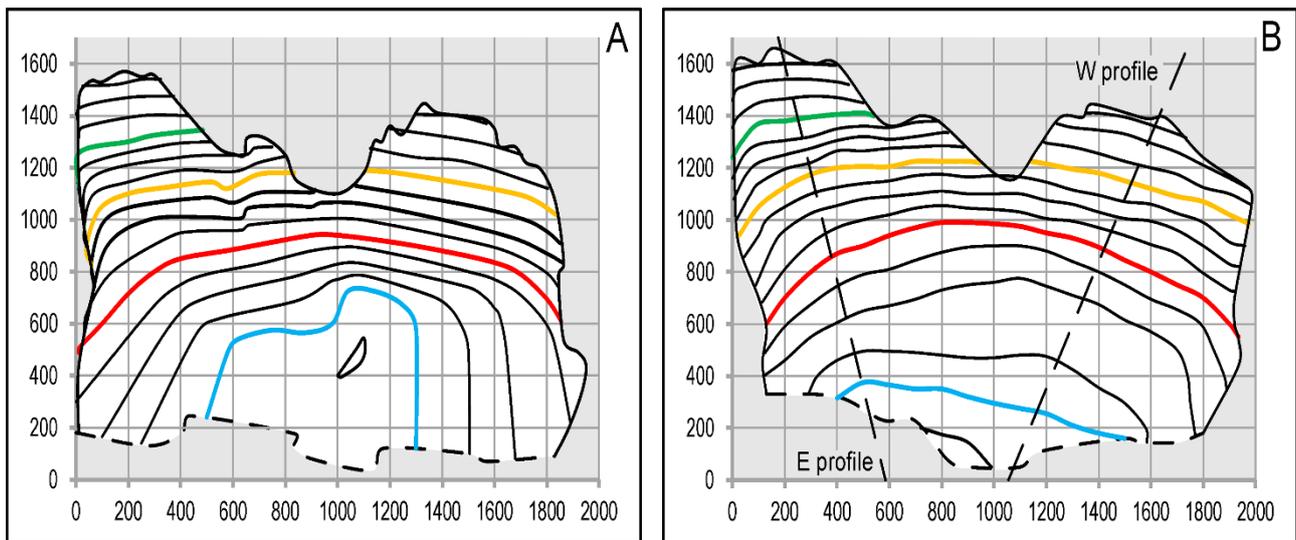
Figure 8. (A) Map of the failure surface according to Broili (1967) as adopted by Müller (1968). (B) Map of the failure surface according to Bistacchi et al. (2013), showing the lines of the two profile cross-sections in Fig. 9. Both maps use the same arbitrary grid as Fig. 2 with axis scales in metres. The outline of the 1963 landslide is shown by the thick black line, with the outcrop of the failure surface along the gorge indicated by the broken black line. Contours are at 50 m vertical intervals increasing upslope away from the gorge: blue = 600 m, red = 800 m, dark yellow = 1000 m, green = 1200 m.

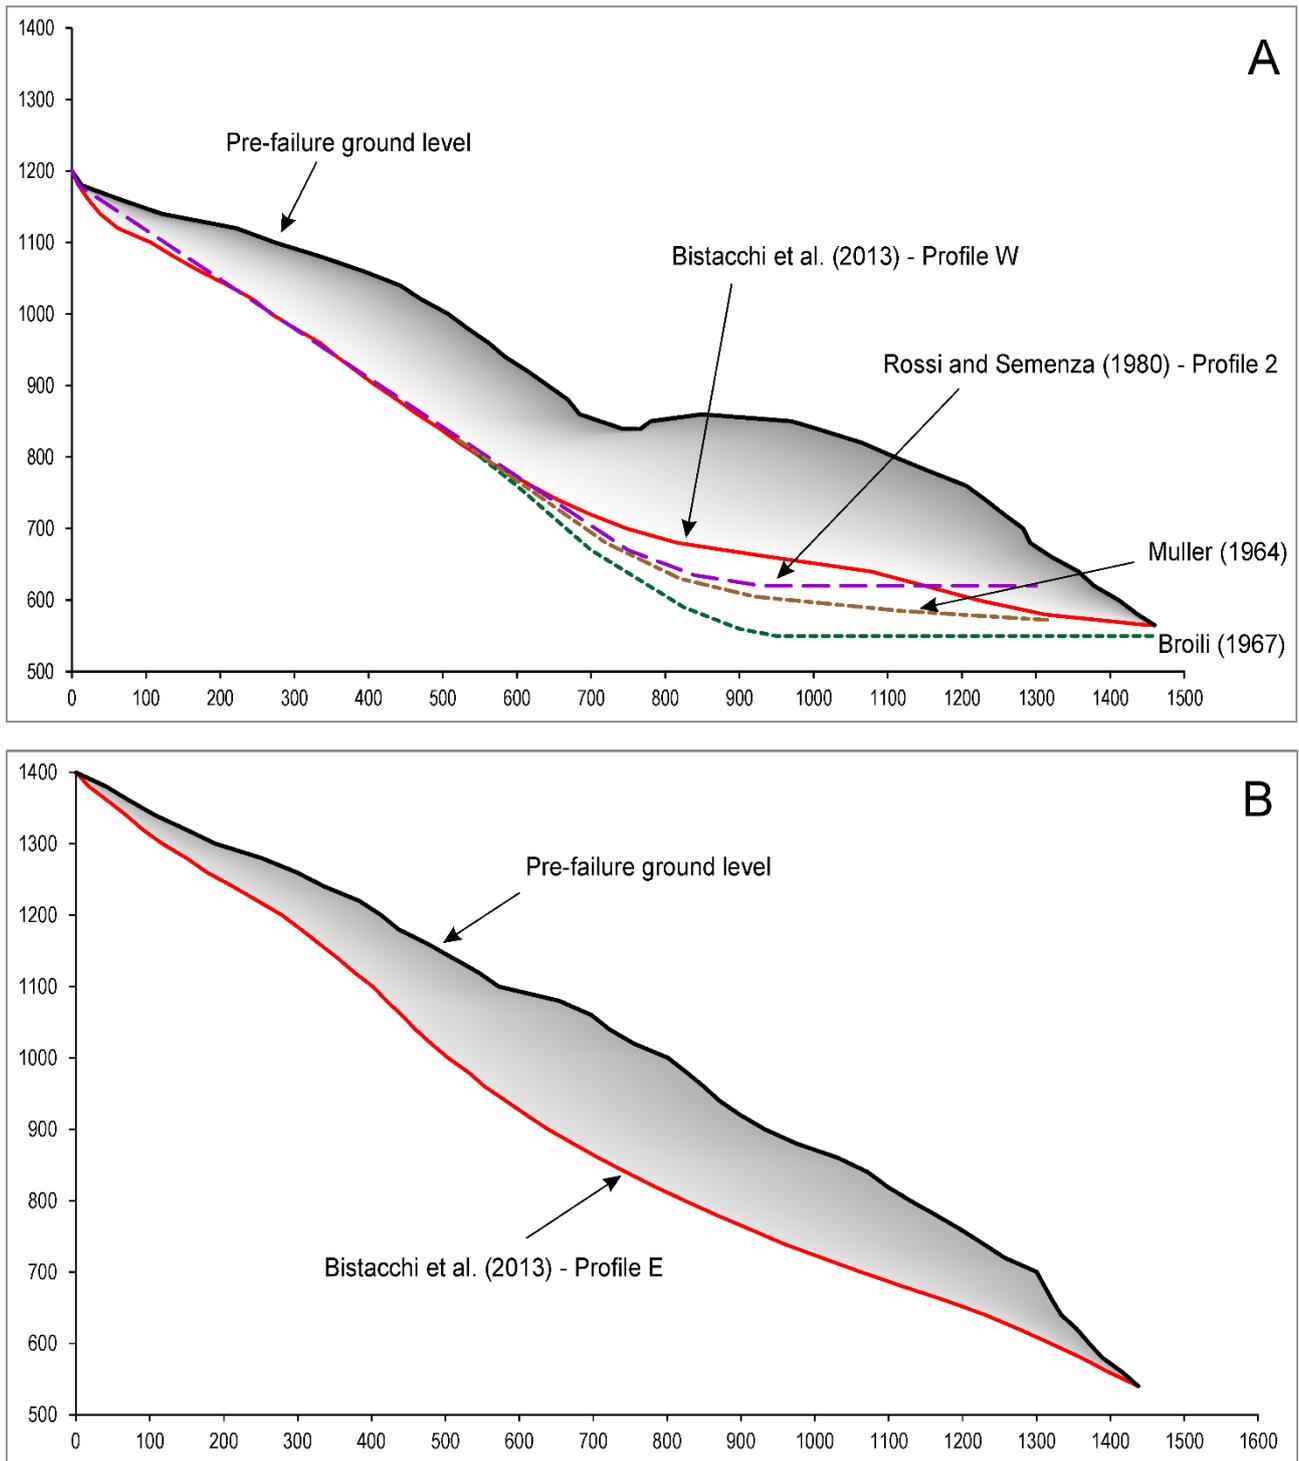
Figure 9. (A) Cross-section through the western part of the Vaiont landslide along the line of Bistacchi et al.'s (2013) 'Profile W', also showing some previous failure surface interpretations superimposed on this profile. Note that the profile of Rossi and Semenza (1980) does not correspond at the toe due to its orientation being slightly different. (B) Bistacchi et al.'s 'Profile E'. All axes in metres; vertical axes are elevations above mean sea level.

Cross-sections from the new failure surface geometry (e.g. Fig. 9A) show the failure surface becoming steeper towards the gorge in the west side of the slope, i.e. corresponding with photographs of the bedding below the western edge of the Punta del Toc at the eastern end of the November 1960 landslide (i.e. contrary to C3). Kiersch (1964) had identified stress relief joints parallel to the upper edge of the gorge, also visible in contemporary photographs (Masé et al. 2004).

The east side of the landslide was almost translational in nature (Fig. 9B). The upper part of the east slope did not initially fail, but moved later – after the destructive waves had diminished – and came to rest on top of the main failed mass with most of the tree cover still standing. This is the ‘eastern lobe’ of [Semenza \(2001, 2010\)](#) and others. There is one colour photograph in the National Park Visitor Centre in Erto village (which is dedicated to the Vaiont disaster), taken immediately after the landslide in daylight the next morning (10 October 1963), that shows a similar but smaller part of the upper west side that behaved similarly. [Wolter et al. \(2016\)](#) identified the retrogressive blocks from both sides of the landslide as ‘blocks C and D’ in their recent study. Hence there is contemporary photographic and modern analytical evidence of retrogressive development of both sides of the landslide after the flood had subsided.

Figure 9A shows cross-sections through the landslide by [Broili \(1967\)](#) and [Rossi and Semenza \(1980\)](#) that have horizontal lower segments and very steep upper parts. Many other assumed cross-sections similarly have (sub)horizontal lower segments. If there was such a large extent of almost horizontal basal shear surface (C3), any increase in reservoir surface elevation above the level of the basal shear surface should have raised pore water pressures across a significant proportion of the entire failure surface (e.g. up to 1 MPa by November 1960), thus reducing the effective shear strength accordingly. At the same time the beneficial effect of the reservoir, i.e. providing lateral support to the toe of the slope, was very limited because the submerged depth of the future landslide mass above the basal shear surface was little more than the same 100 m that produced the pore water pressures.

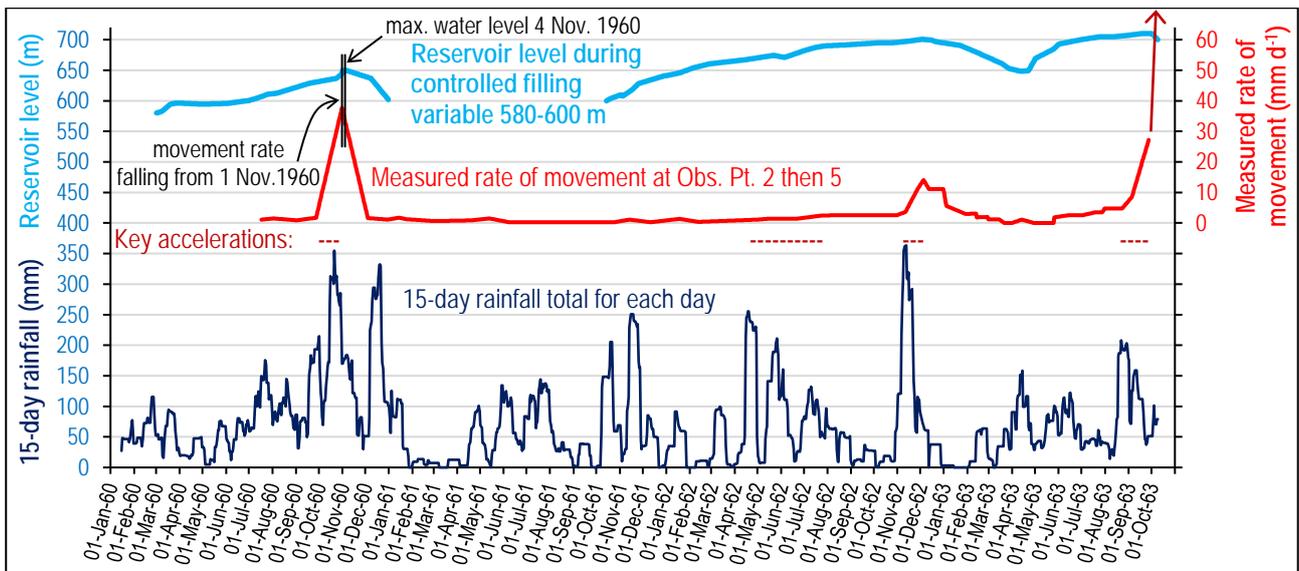
Figure 10. Composite graph of 15-day rainfall totals at Erto (derived from data presented in [Hendron and Patton 1985](#), Appendix A), reservoir water level elevation and movement rates in the lower western part of the developing landslide ([Müller 1964](#)), for the period 15 January 1960 to 9 October 1963 inclusive.

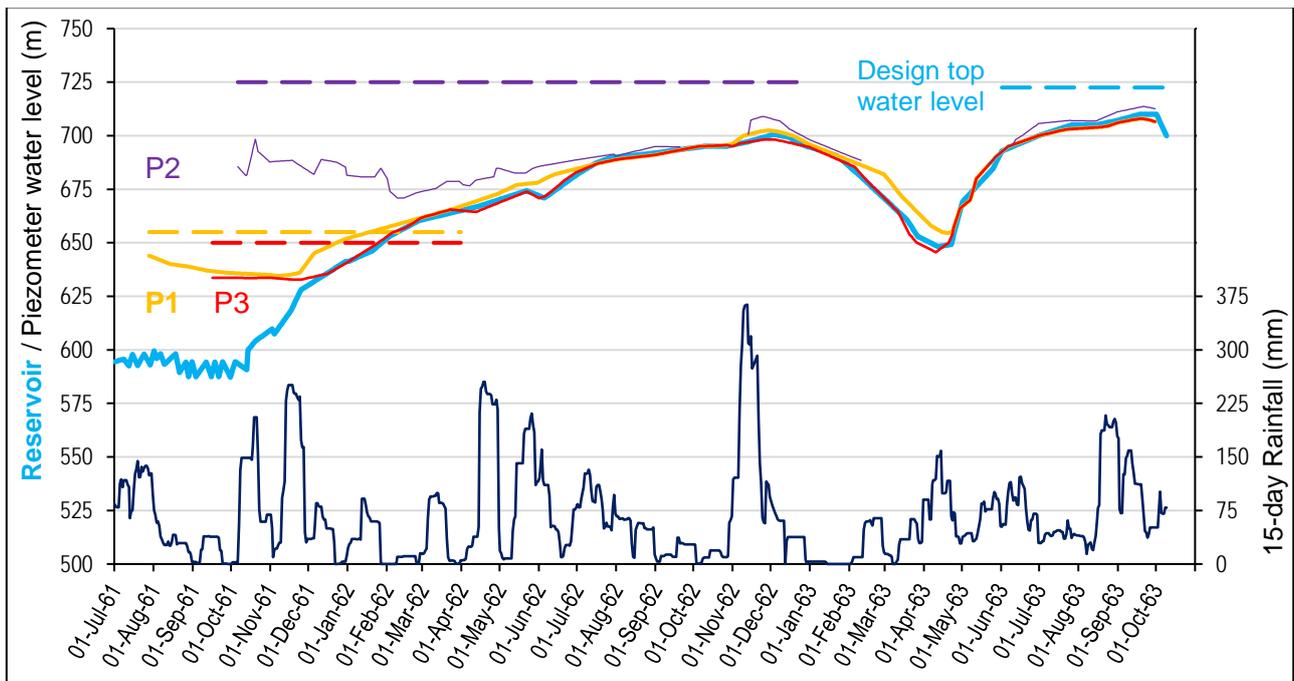
Figure 11. Composite graph of reservoir and piezometer water level elevations in the lower western part of the developing landslide (Müller 1964) and 15-day rainfall totals at Erto (derived from data presented in Hendron and Patton 1985, Appendix A), for the period 1 July 1961 to 9 October 1963 inclusive. The elevation of the failure surface at each piezometer is indicated by the broken line in the same colour.

Replotting these data with the failure surface elevations of Bistacchi et al. (2013) at the piezometer locations (Fig. 11) reveal details contrary to any previous account. The failure occurred along clay layers at varying stratigraphic positions within the Fonzaso Formation, so in reality ‘failure surface elevation’ means an indicative position that may vary by several metres higher or lower than the stated value.

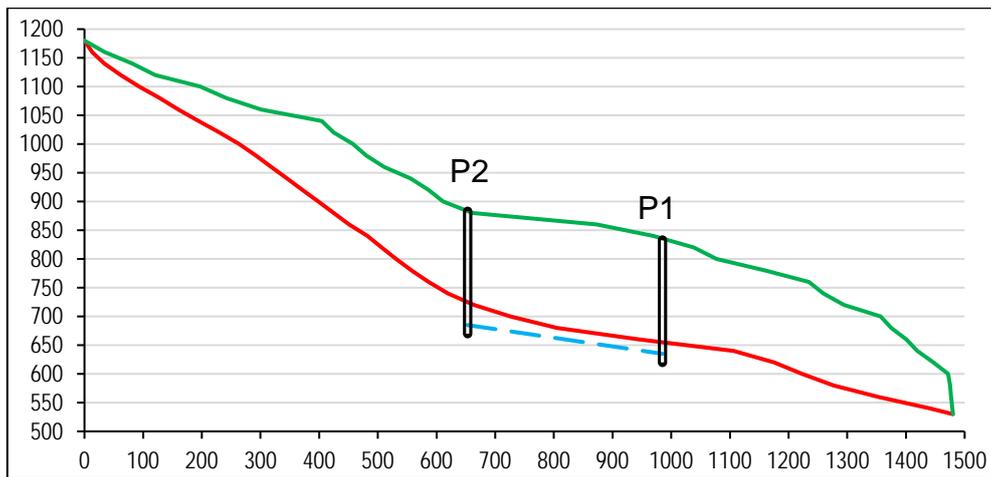
Figure 12. Cross-section through the west side of the landslide aligned with piezometers P1 and P2 showing the recorded water levels around November 1961 (Müller 1964) and an indicative ‘lower aquifer’ water table (broken blue line) between them. Based on Semenza (1965), both west side piezometers are assumed to be 220 m deep as shown here. Both axes in metres; the vertical axis indicates elevation above mean sea level.

The much higher initial water levels in P2 compared with P1 can now be seen to result from a ‘lower aquifer’ water table, at least 20 m below the failure surface elevation, that probably broadly follows the geometry of the bedding (Fig. 12). P3 was affected by the reservoir first because it was located closer to the gorge than P1; P2 was much further away from the gorge and higher up the inclined bedding, hence it remained unaffected for longer. Reports of solution cavities by Hendron and Patton (1985) suggested a relatively high overall permeability for the Vajont Limestone below the landslide mass; responses of P1 and P2 to rainfall may have supported this observation but conversely may have been influenced by piezometer leakage from above the clay layers (see below).

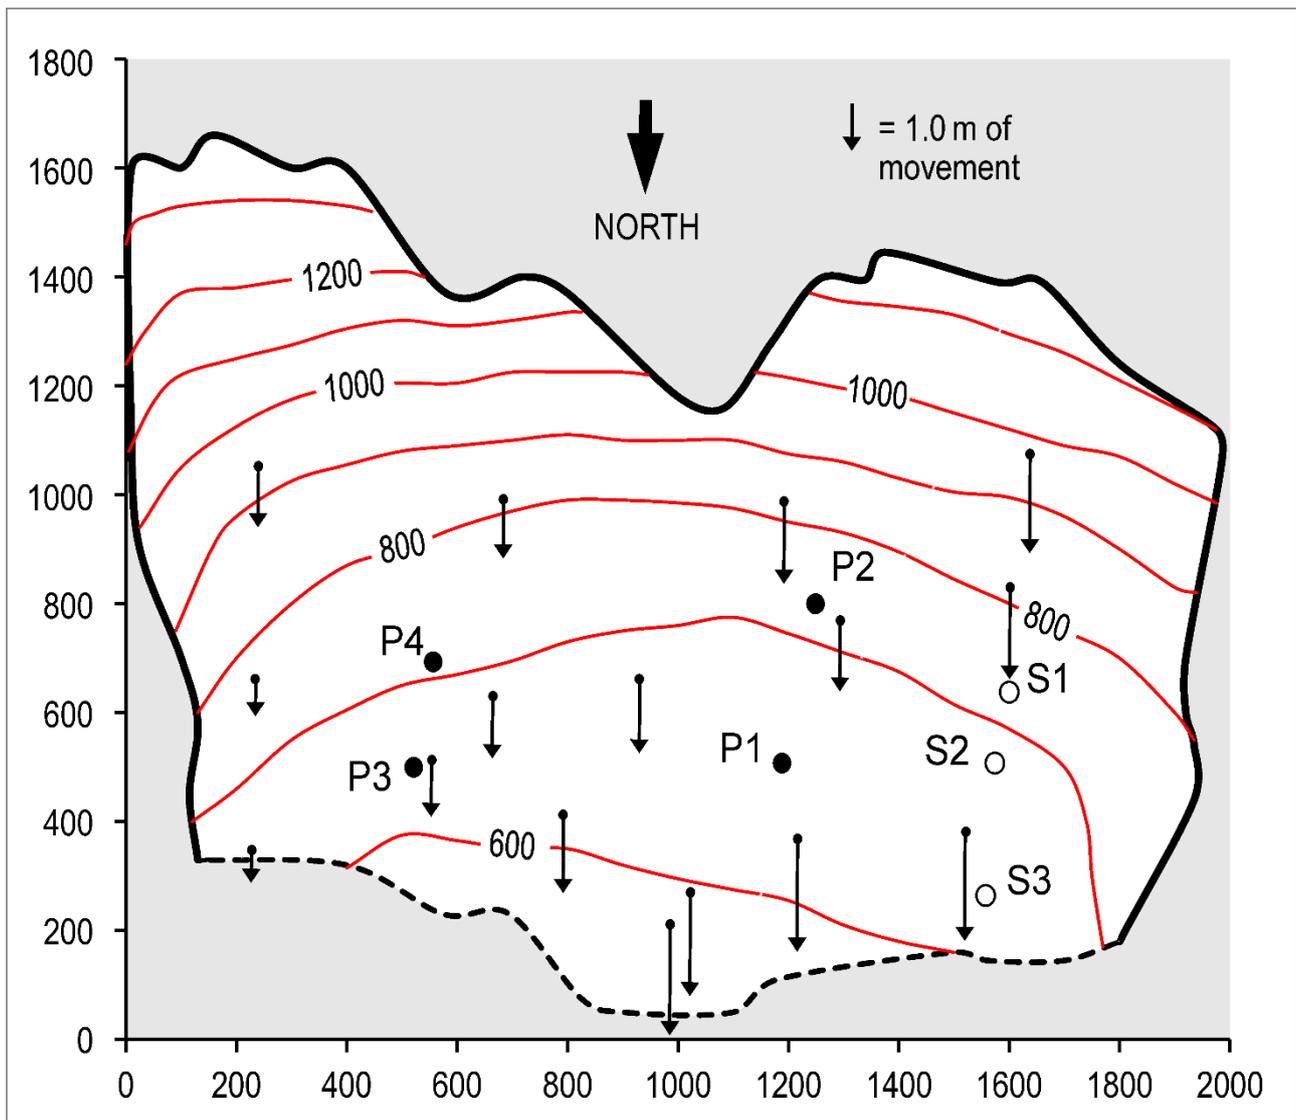
Figure 13. Simplified map of the failure surface of the landslide (after [Bistacchi et al. 2013](#)) showing the locations of boreholes S1-S3, piezometers P1-P4 and total displacement magnitudes at 16 monitoring sites (not vectors; arrow lengths scale with displacement) between December 1960 and the end of September 1963 ([Müller 1964](#)). Axes and contour values are in metres.
