1 **Journal:** Quarterly Journal of Engineering Geology and Hydrogeology  
2  
3  
4 **Reference:** qjegh2020-146 R2  
5  
6  
7 **Paper title:** Photographic Feature:  
8 The Southwell Topple – reassessment of a very large coastal toppling failure  
9 on the Isle of Portland  
10  
11  
12 **Authors:** Alan P Dykes<sup>1\*</sup> and Edward N Bromhead<sup>2</sup>  
13  
14  
15 **Author affiliations:** <sup>1</sup> Centre for Earth and Environmental Science Research, School of  
16 Engineering and the Environment, Kingston University, Penrhyn Road,  
17 Kingston upon Thames, KT1 2EE, UK  
18 <sup>2</sup> Private Consultant and Emeritus Professor, Kingston University  
19  
20  
21 **Correspondence:** \* Corresponding author (A P Dykes). Address shown above.  
22 Email: a.p.dykes@kingston.ac.uk  
23 Tel.: +44 (0)208 417 7018  
24  
25  
26 **Manuscript data:** 3755 words (manuscript text including Abstract and Figure captions,

53 **Photographic feature: The Southwell Topple – reassessment of a very large**  
54 **coastal toppling failure on the Isle of Portland, UK**

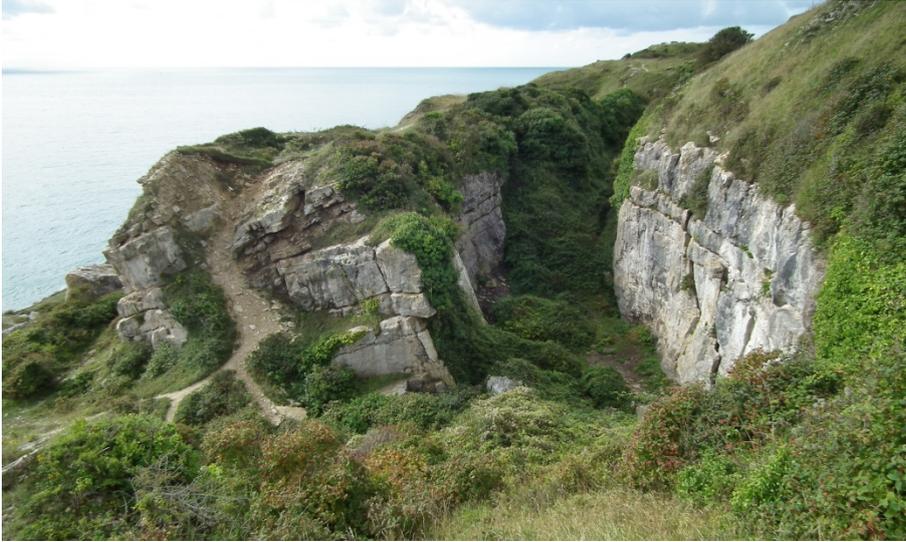
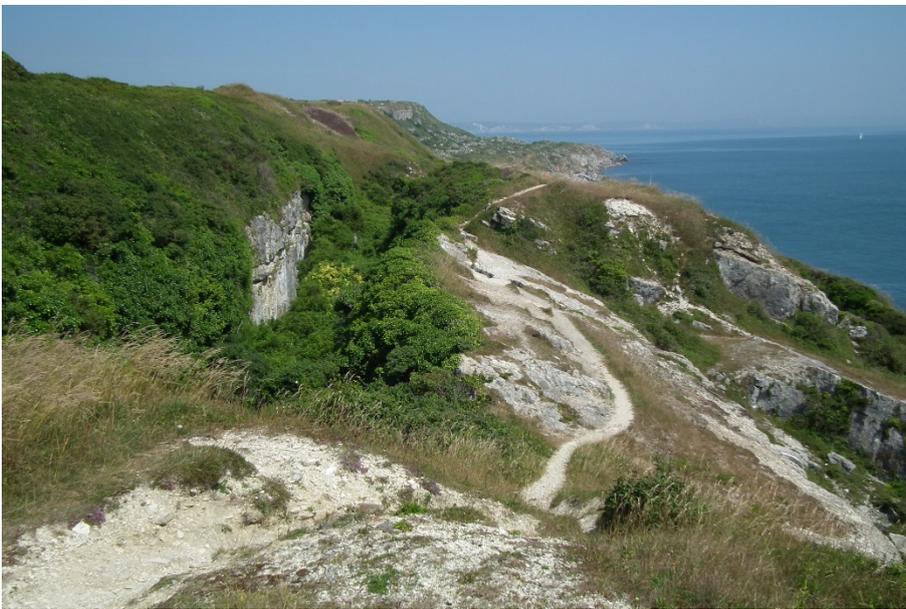
5 **Figure 1.** The southernmost block of the Southwell Topple. (a) View towards the south. The block can be  
6 seen to comprise two blocks with 2-3 m of relative vertical displacement between them. (b) Opposite view  
7 along the same block.

108 formation of scree slopes. The latter can be seen more clearly along the northwest coast at West  
109 Weare (Fig. 5) where marine erosion maintains steeper slopes below the upper cliffs (Fig. 3). In a  
110 few places small but complex zones of instability have required engineering interventions, such as  
111 realignment of the main road up to the Portland plateau at Priory Corner, above the northern end of  
112 West Cliff at West Weare (Pugh *et al.* 2000). However, the Southwell Topple (Fig. 1) is unique  
113 even for the Isle of Portland.

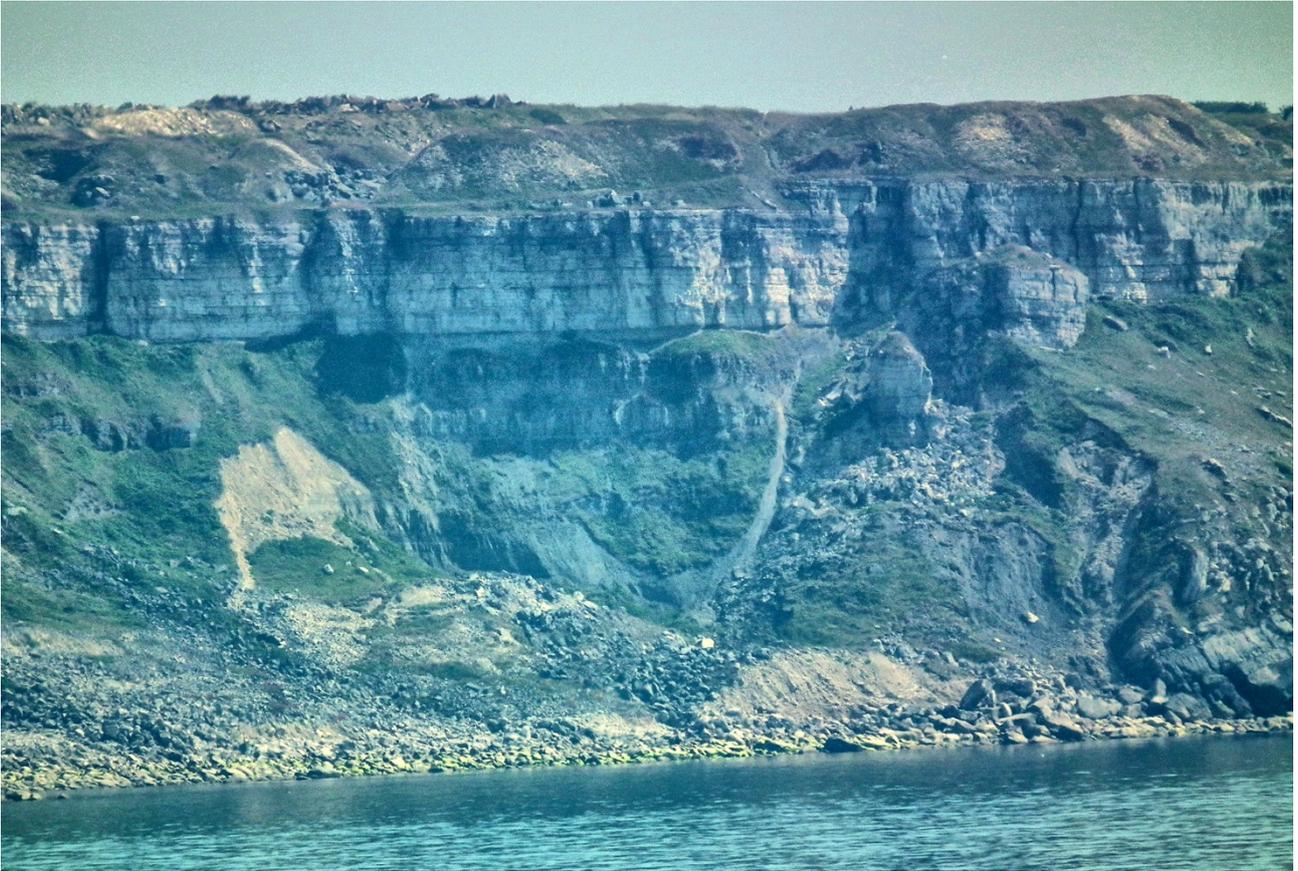
12 **Figure 3.** Coastal landsliding near Blacknor, south of West Weare, Portland: shallow rotational sliding and  
13 translational debris slides in the lower slope materials (mostly rockfall/topple debris with quarry waste) and  
14 small block slides of Portland Stone towards the upper right of this view. Image colour and tone digitally  
15 modified to enhance clarity of visible features.

99 More than one third of the land area of the Isle of Portland is affected by landslides and other types  
100 of mass movements, mostly around the circumference (Fig. 3). Those on the extreme north of the  
101 island, beneath the former Naval Base and under the village of Chesilton, are very deep-seated with  
102 basal slip surfaces well below present sea level (seated in the Kimmeridge Clay in some cases).

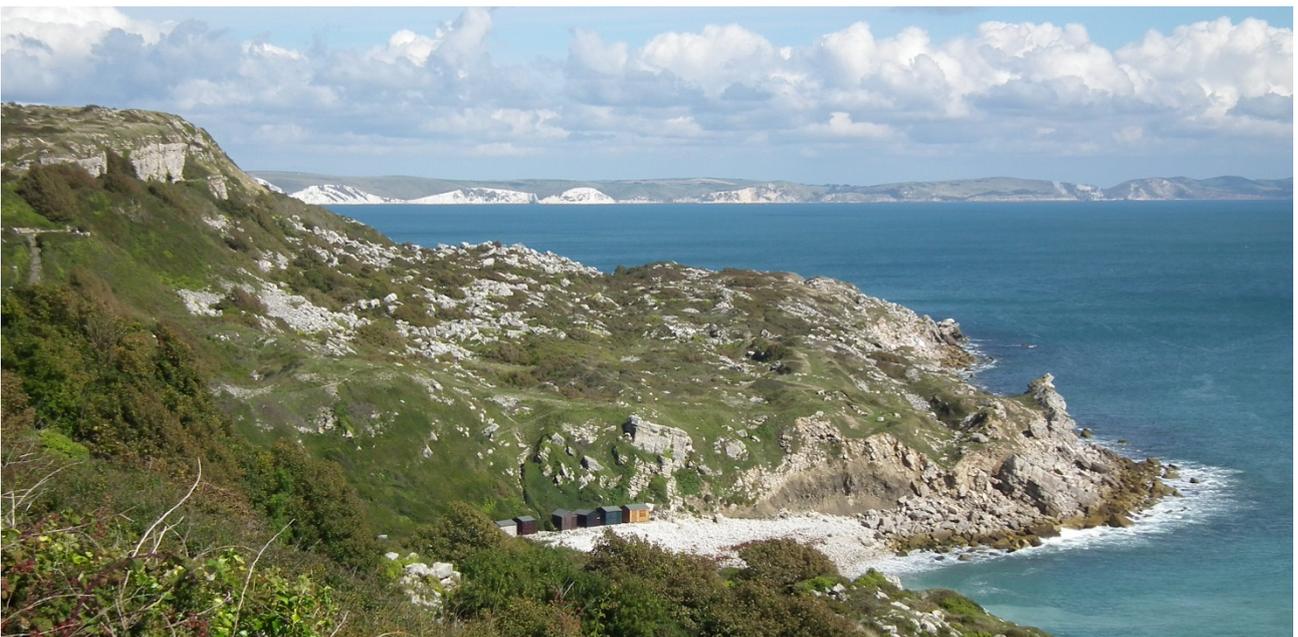
18 **Figure 4.** Compound landsliding at Penn's Weare, north of Church Ope Cove, Portland.

103 Along the northeast-facing coastline compound slides dominate (Fig. 4), sometimes with basal  
104 shear surfaces at a higher level (Brunsden *et al.* 1996), but much of the landslide morphology has  
105 been obscured by quarry waste dumped over several hundred years (Privett 2019). Where the rear  
106 scarps of such landslides are high and formed in Portland Stone (i.e. the unit commonly referred to  
107 as 'Portland Limestone'), small toppling failures are relatively common, leading to cliff falls and

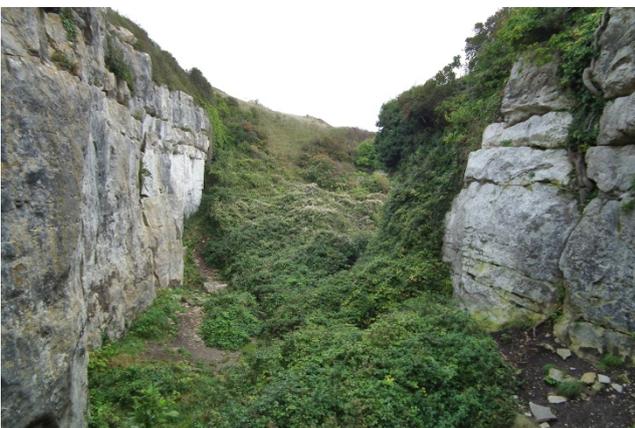
39 **Figure 8.** The Freestone Series of the Upper Portland Stone inside the chasm behind the toppled block  
 40 (right) at the Southwell Landslide, Portland (view towards the north).

126 from 1710, shows that the village of Southwell already existed, probably as a hamlet of no more  
127 than a few houses, but the map unsurprisingly lacks any details. The first edition of a large scale  
128 Ordnance Survey map was not produced until more than a century after the landslide supposedly  
129 occurred, but the '1860s' edition (possibly the first for this location, exact date unknown) clearly  
130 shows there to have been a recognisable single block more than 300 m long parallel to the coast and  
131 around 15 m wide (Fig. 7). Outward rotation of this block created a 10-15 m wide 'chasm' upslope  
132 of the block along much and possibly all of its length (Fig. 8).

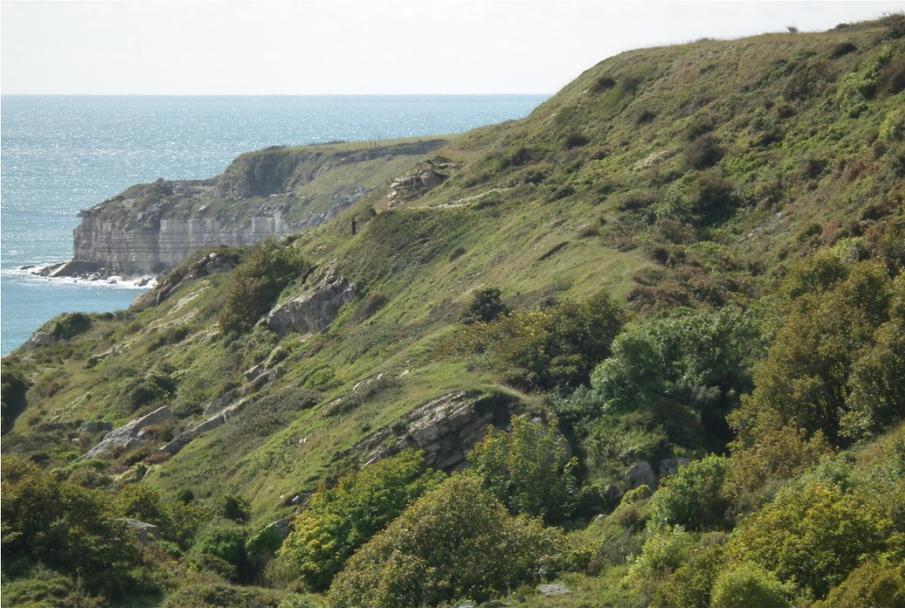
42 **Figure 9.** View south along the northern part of the Southwell Topple. The visible upper surface of the block  
 43 is inclined at around 20° towards the sea and may have lost its cover of Purbeck Beds and overburden by  
 44 sliding following the main topple event. The line of the infilled chasm is marked by the visible step in the  
 45 slope above-right of centre. In the distance is God Nore, where the Cherty Series of the Portland Stone has  
 46 descended to sea level to form the sea cliff and the Freestone Series has been quarried from above the cliff.

155 middle part of the topple having been buried, the chasm infilled (Fig. 9) and, in one part, a section  
156 of the topple block removed for some reason (indicated in Fig. 6) – serendipitously providing an  
157 excellent cross-section for contemporary visitors!

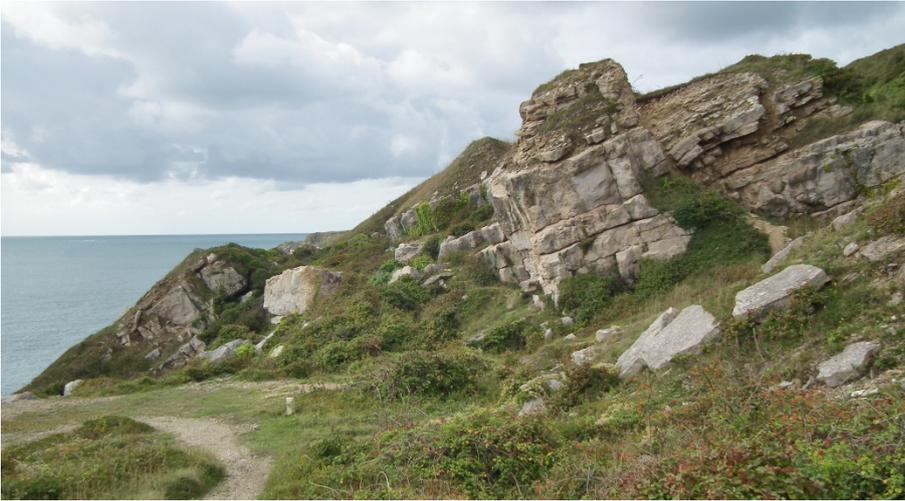
53 **Figure 11.** More rotated (older?) topples seaward of the southern end of the Southwell Topple block.

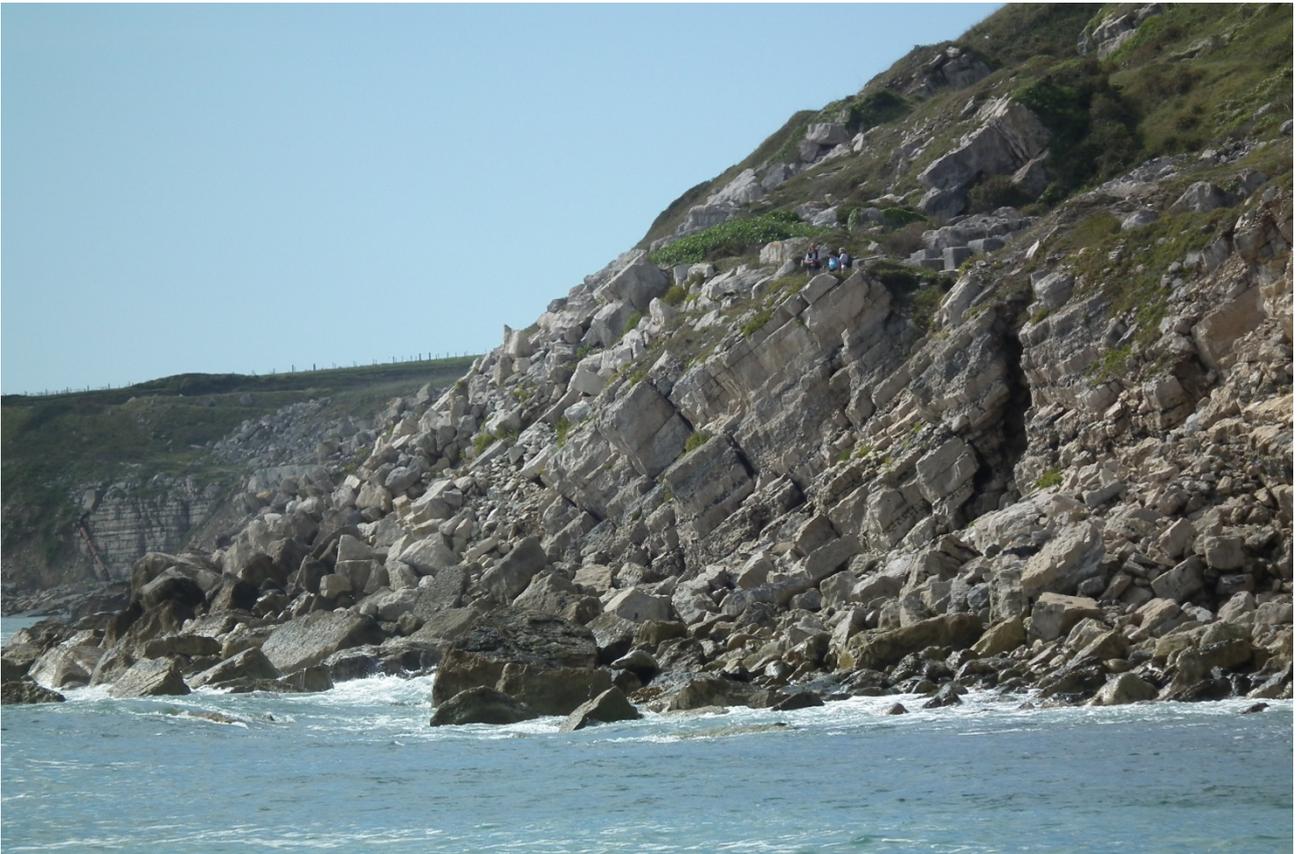
57 **Figure 12.** Toppled strata along the lower cliff below the Southwell Topple block. Note the people above-  
58 right of centre for scale.

169  
170 The existence of the seawards topples (Fig. 12) ‘armours’ the coast against wave attack to a certain  
171 degree, which means the 1734 failure cannot reasonably be *directly* explained in terms of  
172 undercutting by marine erosion. However, the relationship between the main topple block and the  
173 seaward topples requires some further consideration. We examined possible failure mechanisms for  
174 the main block of the Southwell Topple previously but, pending detailed stability and deformation  
175 modelling (requiring subsurface data), could only conclude that it was not related to any  
176 anthropogenic factors or to any sort of deformation of the Kimmeridge Clay ([Dykes \*et al.\* 2016](#)).  
177 We did, however, suggest that the most likely cause of the 1734 movement was ‘external forcing’ in  
178 the form of accumulations of rainwater and/or ice, associated with Little Ice Age climatic

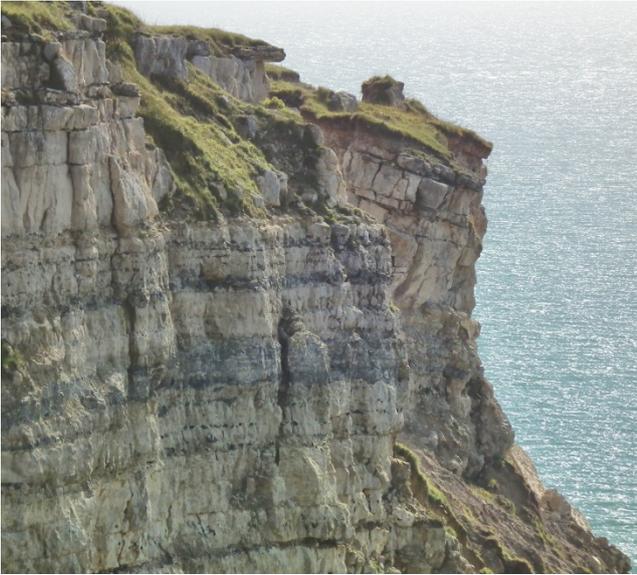
87 **Figure 15.** Larger topple developing in the Cherty Beds of the Portland Stone at West Weare, Portland. The  
88 vertical displacement of around 5 m suggests that the underlying weaker Portland Sand has been crushed.

289 the Shambles Syncline. Toppling occurs in numerous other places on Portland particularly where  
290 there are much higher cliffs of Portland Stone overlying weaker beds (Fig. 15) – but nowhere near  
291 on the same scale or extent as in the Southwell Topple.
