Hazards from lakes and reservoirs: new interpretation of the Vaiont disaster

Keywords: Vaiont landslide; Impulse wave; Lake tsunami; Dam project; Causal factors for disaster

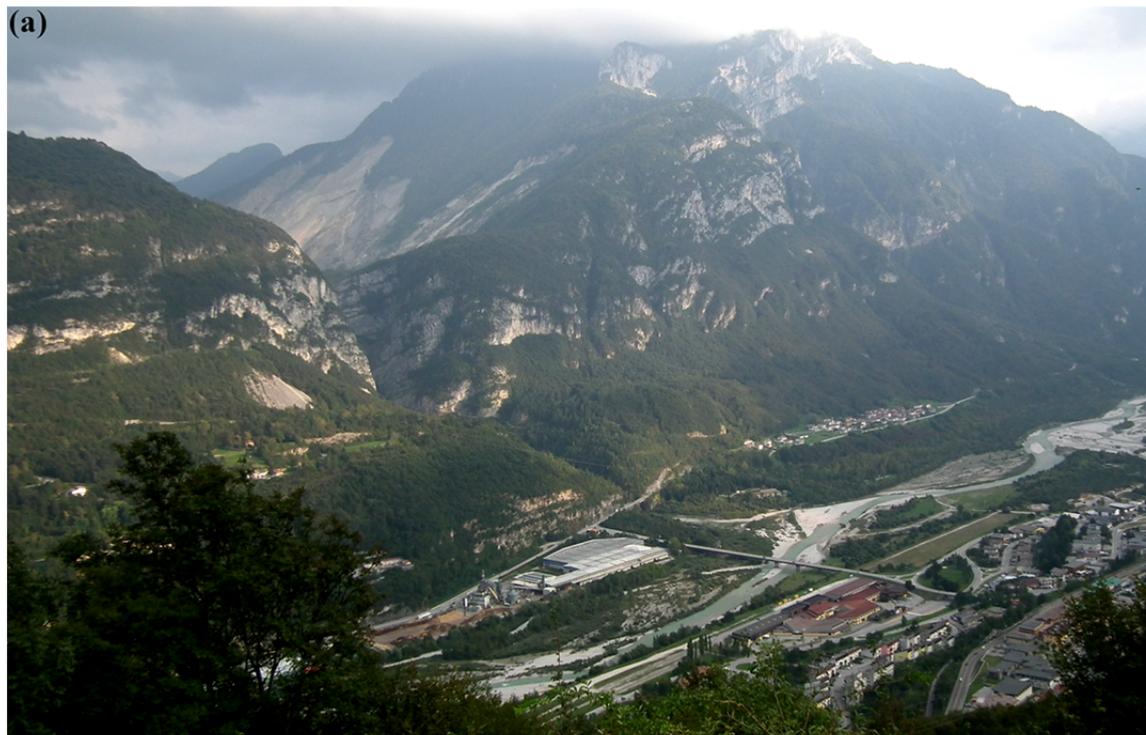
Fig. 2 (a) View from the Vaiont memorial at Podenzoi showing the landslide scar (upper left), the gorge (centre-left) and Longarone (lower right). Photo: APD. (b) Map and longitudinal section showing the extent and height of the displacement wave produced by the landslide. The red circle indicates the location and approximate extent of Longarone before the disaster. Source: Friulian Dolomites Natural Park archive (with permission).

By 1960, what was then the tallest concrete arch dam in the world at 264 m in height (Fig. 2), blocking the lower end of the Vaiont gorge above the town of Longarone, was almost complete and filling of the reservoir had started. In October 1960 a 2 km long M-shaped crack became visible across the northern slope of Mt Toc (which defined much of the outline of the eventual landslide) and in November 1960 a large rockslide (~700,000 m³) occurred into the half-filled gorge from the steep toeslope a short distance upstream from the dam. The geological investigations and data obtained prior to the final failure of the unstable slope, summarised in this paper, have been extensively reported, analysed and interpreted many times elsewhere (e.g. Müller 1964; Semenza 1965, 2001, 2010; Hendron and Patton 1985, 1986; Dykes and Bromhead 2018a). The disaster that eventually ensued was over within a few minutes of the failure of the last intact limestone beds beneath the NE part of the slope.

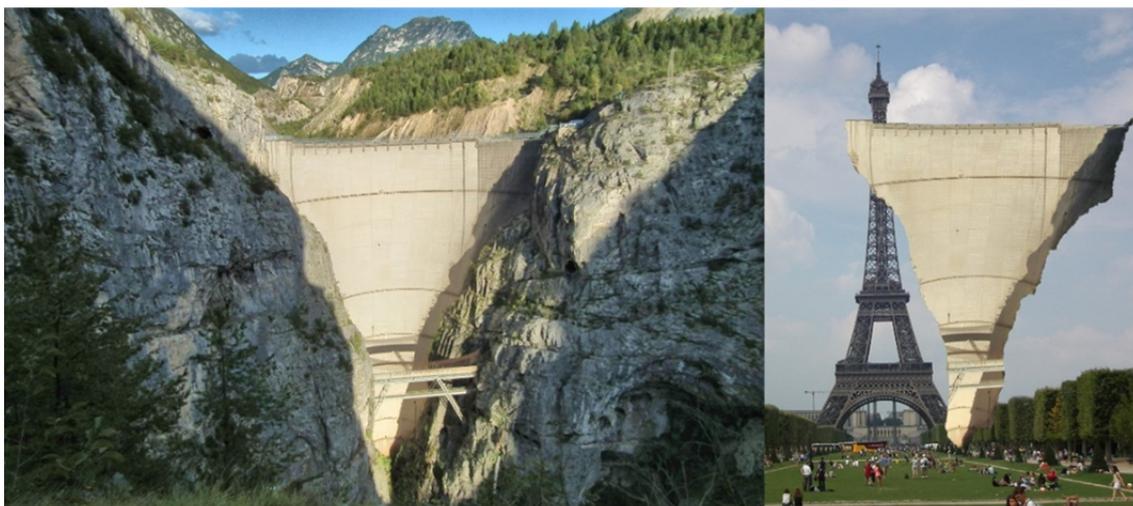
Fig. 4 The Vaiont dam in 2010, almost entirely intact and subsequently made open to visitors. The Eiffel Tower is shown to provide an indication of scale for the in-situ view. Photos: APD.

The Vaiont gorge meets the Piave Valley at right-angles opposite the town of Longarone (Fig. 1). The top of the Vaiont dam (Fig. 4) is visible from the commercial centre of Longarone, 250 m lower (40 m above the Piave River) and only 2.1 km downstream (Fig. 5). The older residents of Longarone were concerned about the new dam, probably remembering the collapse of the Gleno Dam in 1923 (174 km WSW from Longarone), while residents of the Vaiont valley and particularly Erto highlighted the known propensity for landslides in the valley that was ignored by project managers for the dam (Barrotta and Montuschi 2018). Initial examinations of the geomorphology of the Vaiont valley by Prof. Giorgio Dal Piaz in 1928 and again in 1958 had identified no concerns about slope stability along either side of the valley (Bozzi et al. 1964, cited in Hendron and Patton

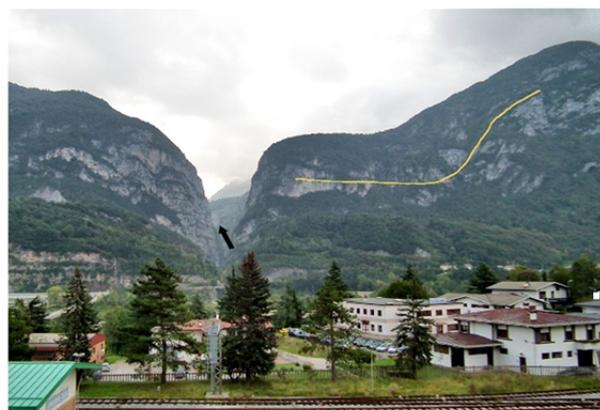
Fig. 5 The left abutment of the dam (indicated by the black arrow) as seen from a hotel breakfast table in Longarone. One bedding plane is highlighted in yellow to show the 'chair'-shaped structure visible in the cliff at the south side of the gorge. Photo: APD.

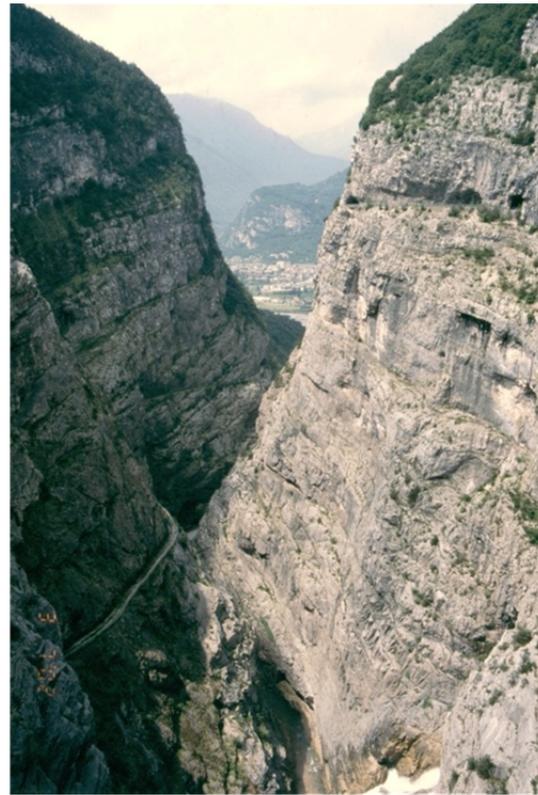
Fig. 6 View down the Vaiont gorge from the top of the dam. The stream is at the bottom-centre of this view. Photo: ENB.

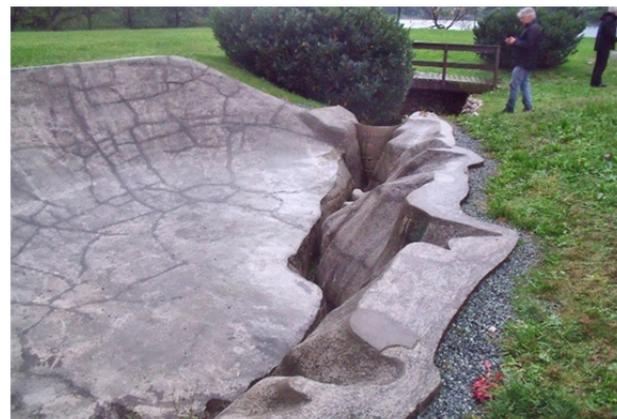
Fig. 11 The 1: 200 scale model of the Vaiont landslide at Nove power station in 2013, showing the large sub-horizontal failure surface forming the assumed ‘chair’ shape. Photo: APD.

of the landslide was constructed at Nove (Fig. 11) and an initial series of experiments were undertaken by Prof. Augusto Ghetti;

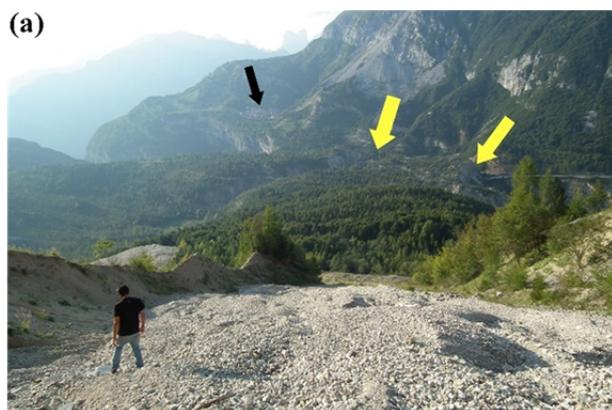
Fig. 12 (a) View downstream (to the west) across the landslide from high up the east side failure scar. The yellow arrows indicate the leading edge of the failed mass above the northern side of the gorge, and the black arrow indicates Casso village. (b) View past the dam (lower left) from the left side towards Casso (indicated by black arrows). The main part of the village is behind and above the top of the cliff (out of sight) at the lower arrow. Photos: APD; ENB.

(c) The reservoir had occupied an extremely deep and narrow gorge with a steep mountain slope rising from the gorge opposite from the landslide, i.e. the site was constrained, with no wide floodplain, alluvial fan or similar low-lying topography that could allow the wave to travel and dissipate. Indeed, the leading edge of the landslide mass came to rest on the rising slope above the opposite side of the gorge (Fig. 12a).

The wave was probably still growing as it hit the opposite side of the valley to produce the maximum runup of 240 m above pre-failure water level (225 m higher than the dam) just west of Casso village (Fig. 12b).

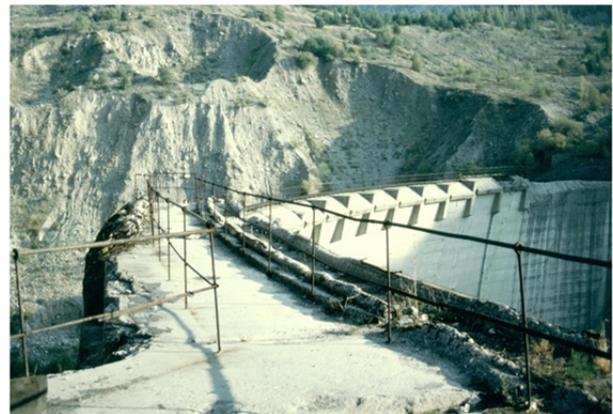
Fig. 13 View across the top of the dam showing the remains of the road in the foreground (right side of the dam) and the missing parapet wall at the far right of the photo (left side of the dam). Photo: ENB.

The dam was subjected to forces many times greater than those it was designed to resist (2.4 MPa water pressure and up to 5.7 MPa thrust of ‘arch’ abutments) (Walters 1962). The roadway that was carried above a kind of crest spillway structure and part of the parapet wall was lost (Fig. 13), and the associated works including the small underground power plant and the above ground office building were

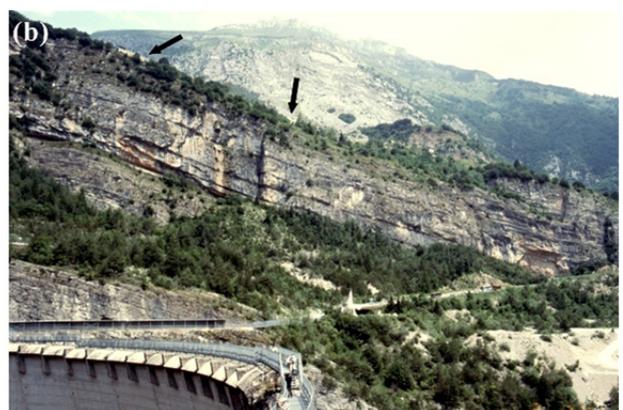
completely destroyed, but the dam was otherwise undamaged and remains standing to this day.
