# Influence of Low Velocity Impact on Oxidation Performance of SiC coated C/SiC Composites

**Abstract:** Dropped-weight impact tests were carried out to investigate the coating damage behavior of SiC coated plain-woven C/SiC composites under low velocity impact (LVI). The oxidation performance after impact was evaluated in a wet oxygen environment. The relationships between coating damage area, oxidizing weight loss and the flexural strength after oxidation with the impact energy were analyzed. It was concluded from the test results that 0.5J was the impact energy corresponding to damage initiation of the coating, where the oxidation loss was 2.49% and the strength retention ratio was 94.92%, almost the same as the untreated coating. Between 0.5J and 2J, the weight loss of oxidation increased with impact energy, and the oxidation mechanism gradually changed from a diffusion-controlled local oxidation to a reaction-controlled uniform oxidation. When the impact energy was larger than 2J, although the coating damage still increased with impact energy, weight loss and residual flexural strength remained almost constant. The residual strength remaining was no more than 8% of the non-ox

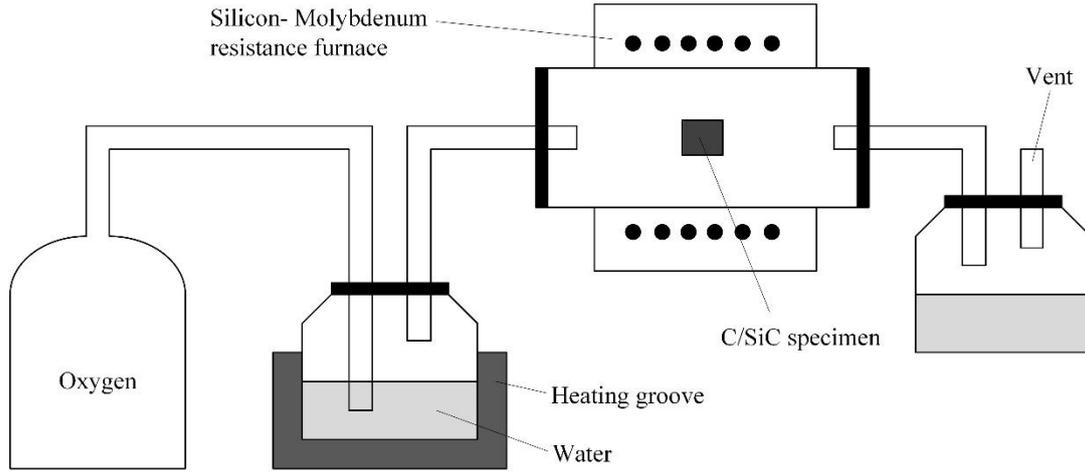
Fig. 1. Oxidation test system.

Isothermal oxidation tests of all the as received and impacted specimens were conducted in a wet oxygen environment. The test system is shown in Figure 1. C/SiC specimens were heated to 1300°C in a silicon-molybdenum resistance furnace. A flow atmosphere consisting of an oxygen-water vapor mixture at atmospheric pressure was imported into the furnace at the same time. The partial pressures of oxygen and water vapor were both 0.5 atm. The total oxidation time was 10 hours. Specimens were separately weighed before and after oxidized for a fixed time using an electronic balance with a sensitivity of 0.1mg. Before weighing, the specimens were dried. Then the rate of mass loss  $\Delta m$  was defined to be

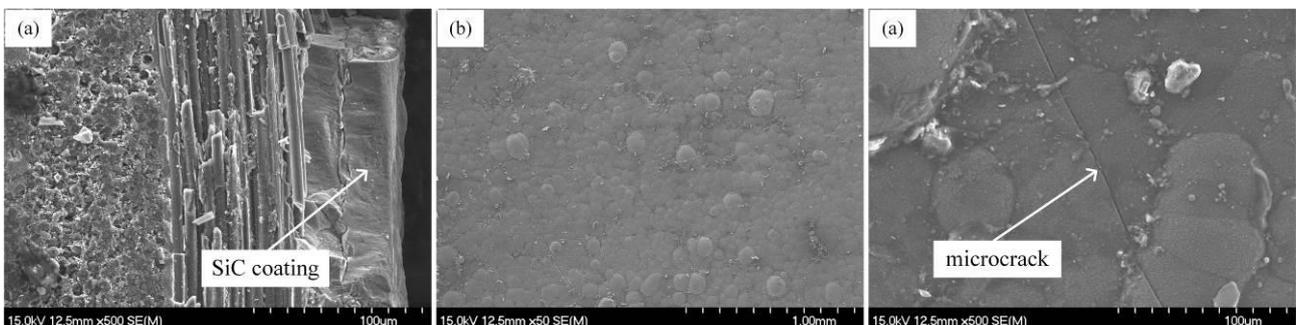
Fig. 2. SEM morphologies of as-received plain-woven C/SiC (a) cross-section; (b) surface of CVD-SiC coating; (c) coating microcrack.

Figure 2 shows the micro-morphologies of the C/SiC specimen. The C/SiC substrate is covered by two thin layers of CVD-SiC coating (Fig.2 (a)). The thickness of each layer is around 20 $\mu$ m. The coating is dense, and no visible surface damage can be observed (Fig.2 (b)), except some micro-cracks (Fig.2 (c)). These narrow coating cracks are generated during the preparation cooling process due to the thermal mismatch between the coating and the substrates, and they provide a diffusive path for the oxidizing atmosphere.

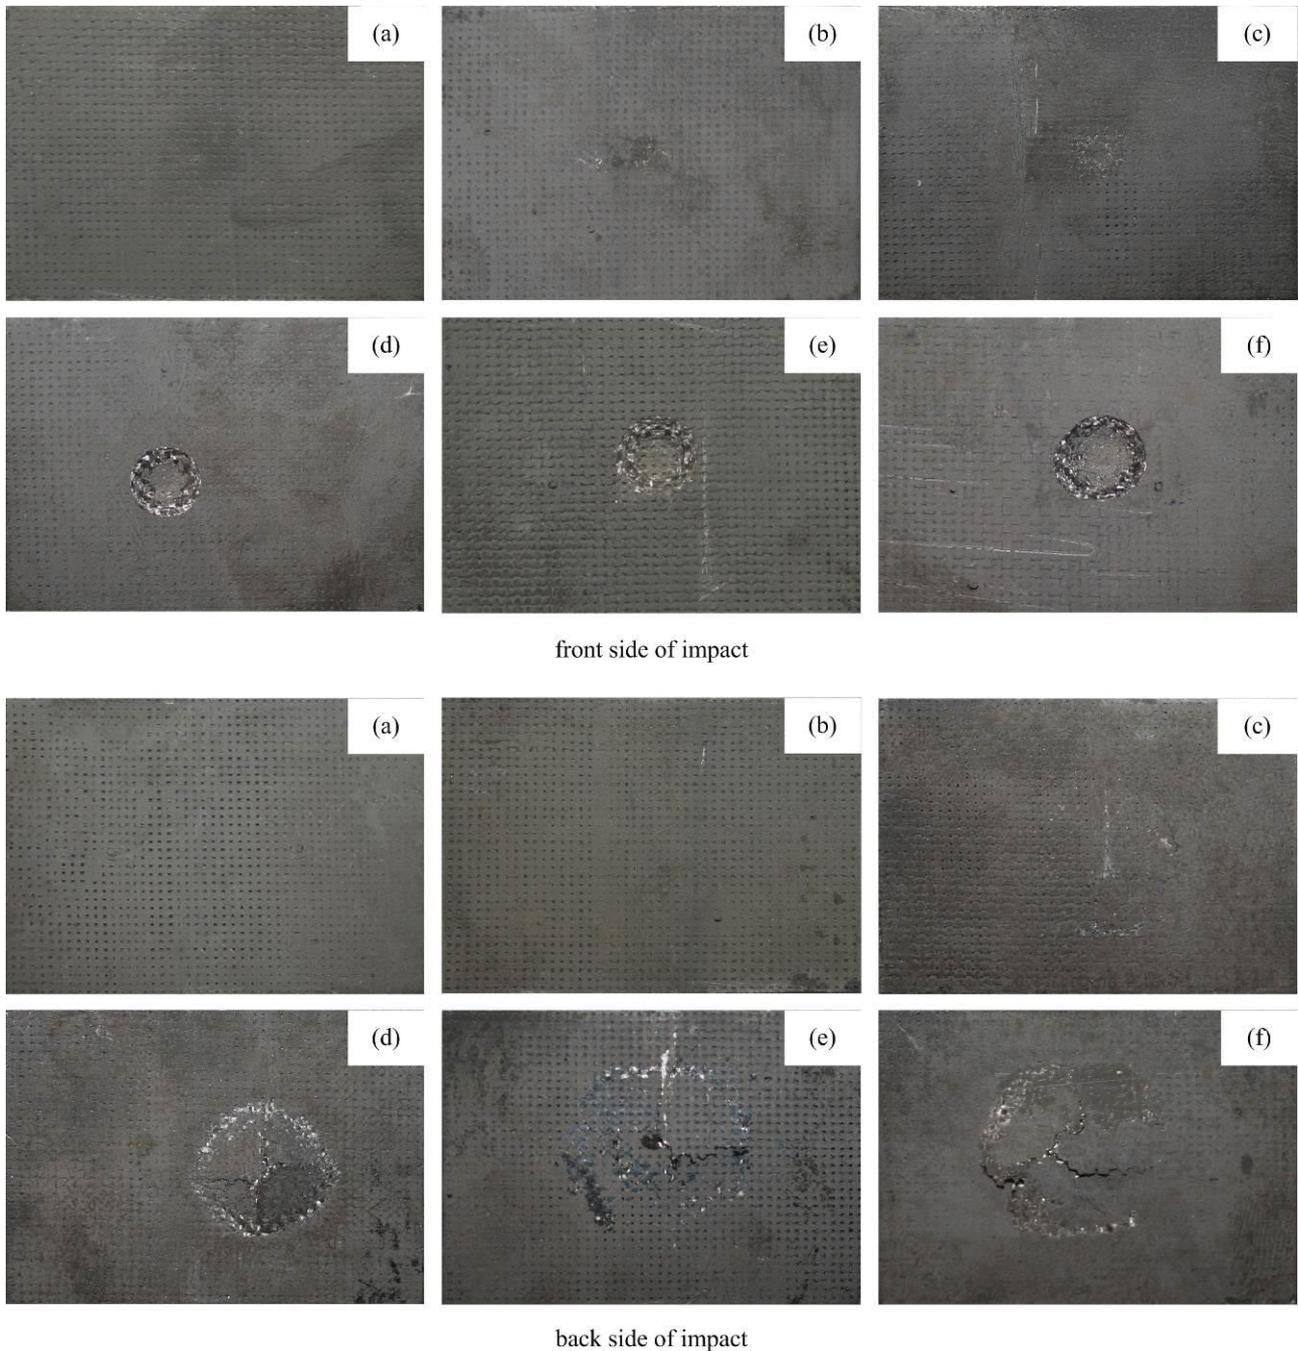
Fig.3. Optical photographs of the 2D-C/SiC specimens after impact at various energy levels: (a) 0.5J, (b) 1.0J, (c) 2.0J, (d) 3.0J, (e) 4.0J, (f) 5.0J.

Surface photos of the C/SiC specimen after impact at various energy levels are shown in Figure 3. Both the front and back sides facing the impact were recorded. Impact-induced damage is not found in the supporting positions. In the case of an impact energy of 0.5J, there was no impact coating damage found on either side. When the impact energy increases to 1.0J, some white spots were found in the impacting area on the front side, probably caused by friction between the impactor head and the coating. There was still no coating damage identified on the back side. Then, with increasing impact energy, obvious coating damage could be identified on both sides. A circular pit was formed on the front side, and on the back side, some related damage appeared. Cracks and exfoliation could easily be observed.

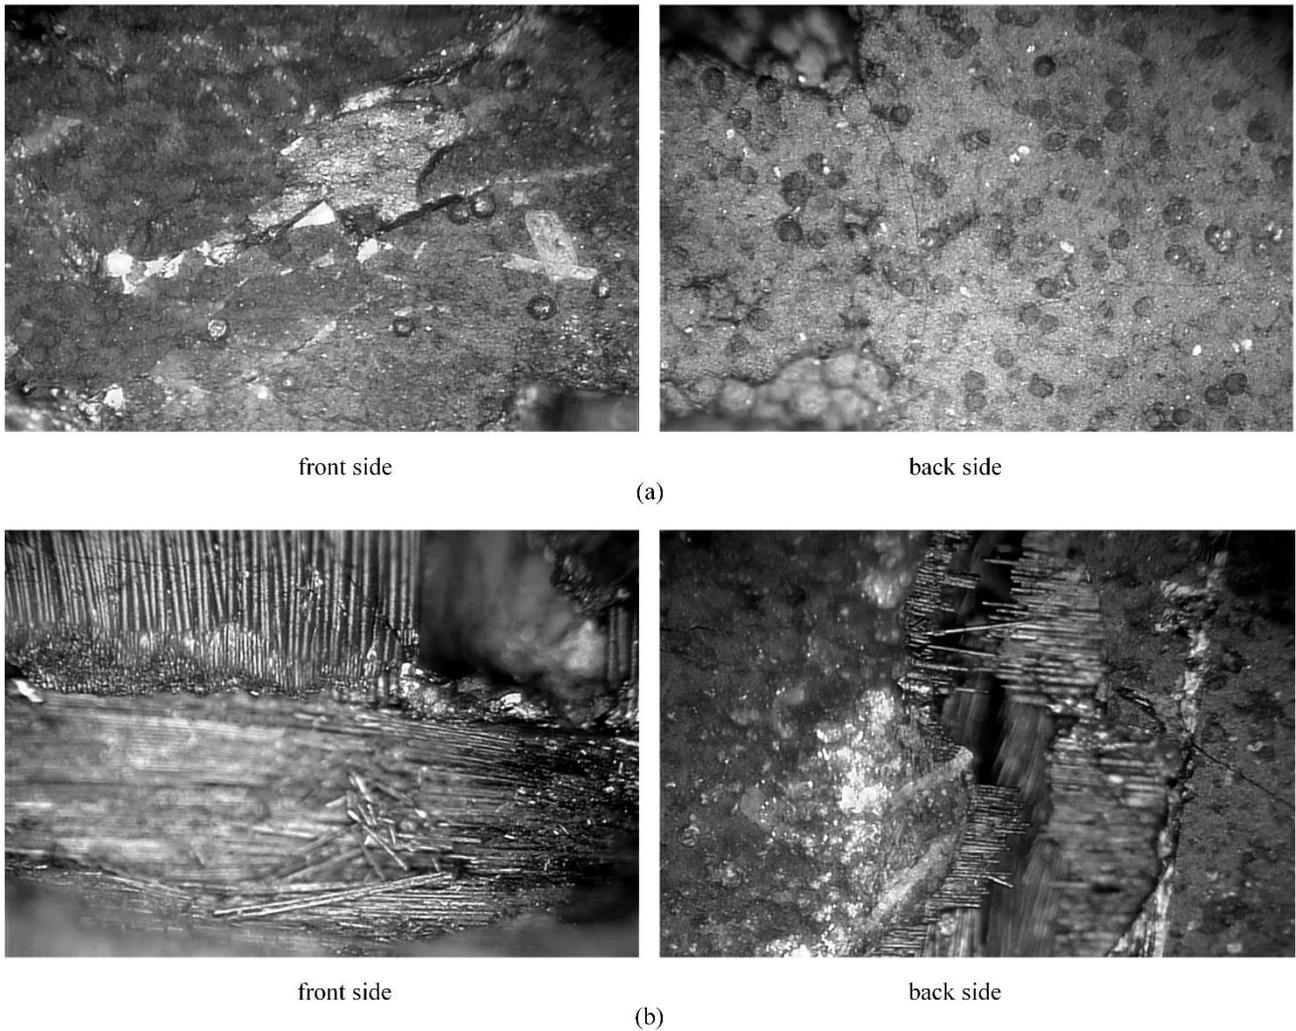
Fig.4. Optical microscopic photography of impacting area ( $350\times$ ): (a) 1.0J; (b) 5.0J.

Fig. 4 compares the coating damage in the impact area after an impact of low energy (1.0J) and high energy (5.0J), using optical microscopic photography. In the case of the lower energy impact, there were a few cracks and local exfoliation on the front side, but no damage occurs on the back side, whereas in the case of higher energy impact, the

coating is badly destroyed on both sides. A large area of coating exfoliates from the substrates, fibers are exposed with some of them being broken.

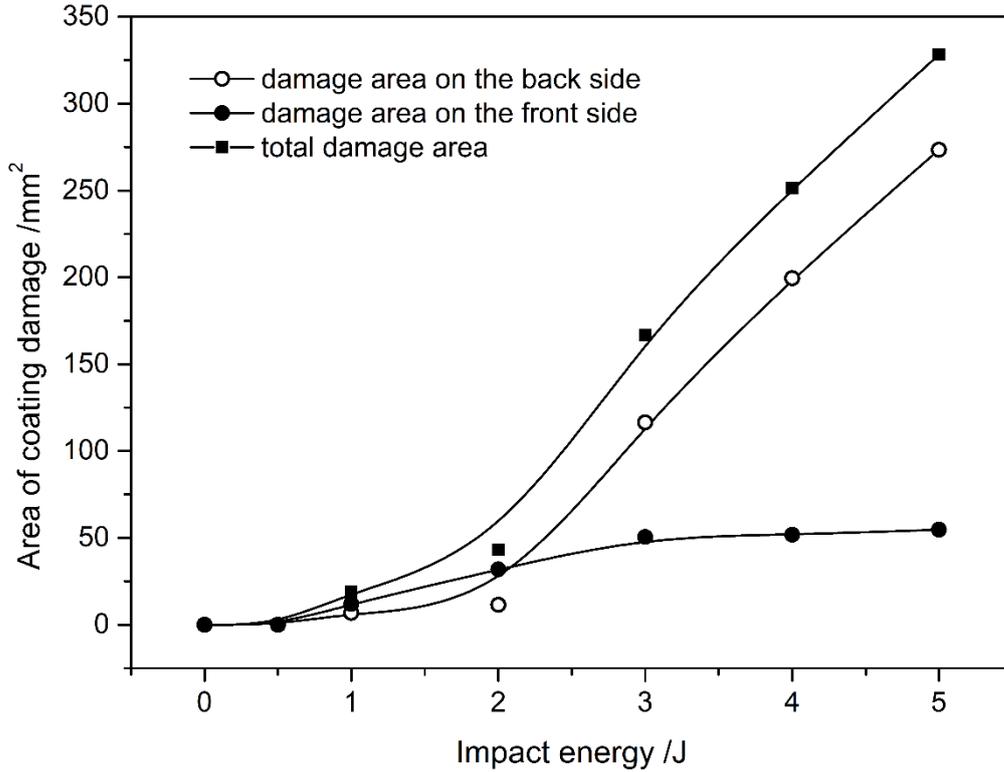
Fig.5. Damage areas of SiC coating after impact at various energy levels.

Fig. 5 illustrates the effect of impact energy on the coating damage of 2D C/SiC wherein impact energy values for the front, back and their total are plotted. There was nearly no damage produced when the impact energy was 0.5J. However, as the impact energy increases, it is observed that the damage area on the front side increase slightly, while the damage area on the back side increases very rapidly, especially, when the impact energy is greater than 2J. The reason is that the increasing flexural moment induced by the impact force may cause debonding and cracking over a large area, due to the low bonding strength between the coating and the laminate, as well as the weak fracture toughness of the SiC coating.

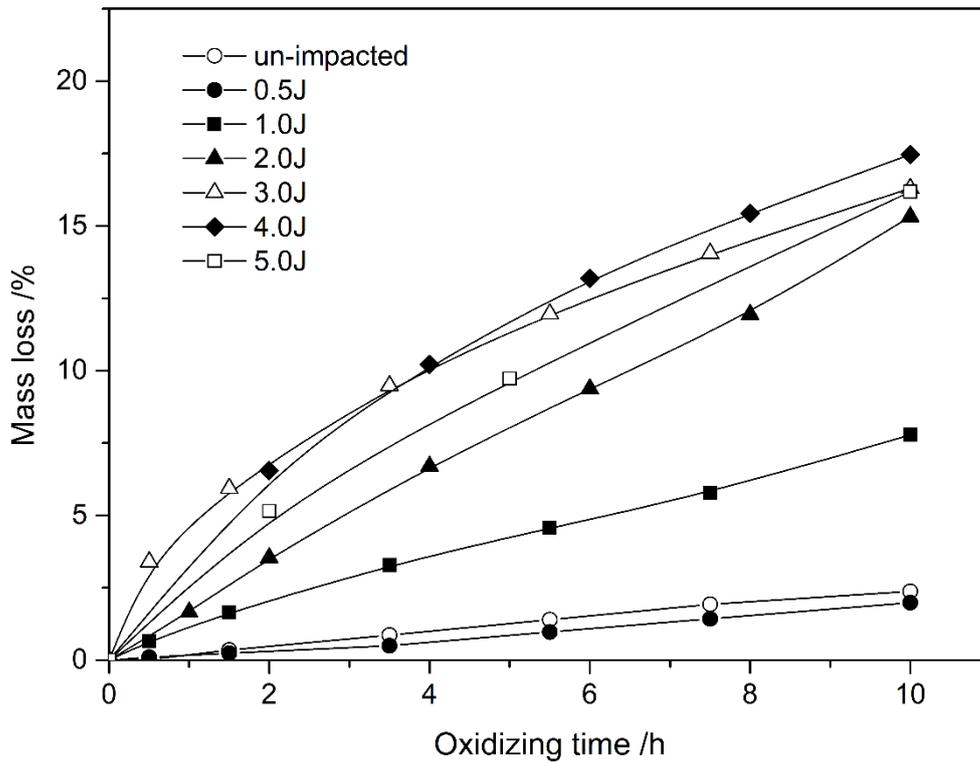
Fig.6. Isothermal oxidation curves of SiC coated C/SiC in wet oxygen atmosphere at 1300°C

The isothermal oxidation curves of the as-received and impacted SiC coated C/SiC in wet oxygen at 1300°C are shown in Fig. 6. For all specimens, increasing the oxidizing time increases the mass loss. Several chemical reactions are involved in the post-impact oxidation tests in the oxygen-water vapor mixture at 1300°C, which are [18,19]:

The chemical reactions 5-7 involve the consumption of the carbon phase and result in mass loss and the degradation of mechanical performance. The reactions of SiC with H<sub>2</sub>O and O<sub>2</sub> (Equation 8-9) lead to a mass increment. However, since the reactive velocity of carbon is much higher than that of SiC, the weight of C/SiC decreases with the oxidizing time.

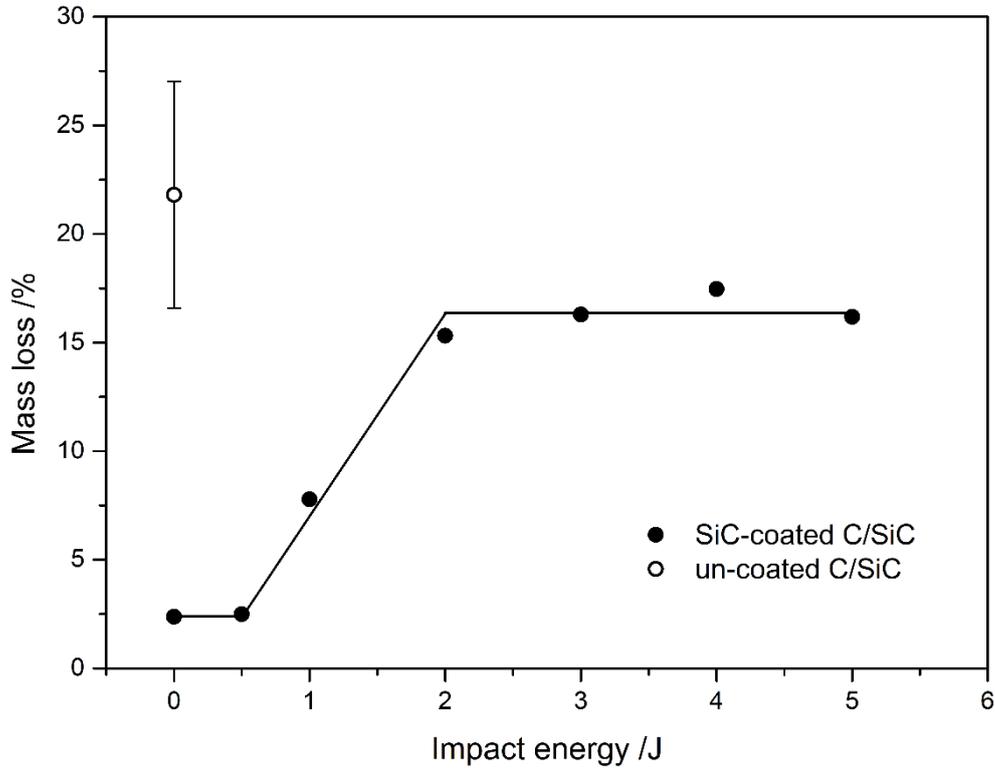
Fig.7. Influence of impact energy on mass loss after 10h oxidation

Fig.7 illustrates the influence of the impact energy on the mass loss of C/SiC after being oxidized for 10 h. As a comparison, the mass loss of untreated uncoated C/SiC is also indicated in Fig.7. The original unimpacted coating plays an excellent role in preventing oxidation of the carbon phases. The oxidizing gases can only enter the internal area through narrow cracks in the coating at a very low diffusive velocity, so oxidation of the carbon phases occurs very slowly. The resulting mass loss is therefore only 2.38 %. With the increasing impact energy, the evolution of mass loss can be divided into three intervals: (a) From 0 to 0.5 J, the effect of the impact appears to be very limited. The mass loss is only 2.49 % when the impact energy is 0.5 J, nearly the same as the unimpacted specimen. (b) From 0.5 J to 2 J, the mass loss shows a significant rise from 2.49 % to 15.32 %. (c) From 2 J to 5 J, the mass loss remains almost unchanged and close to the mass loss of uncoated C/SiC, which is  $21.81 \pm 5.22$  %.

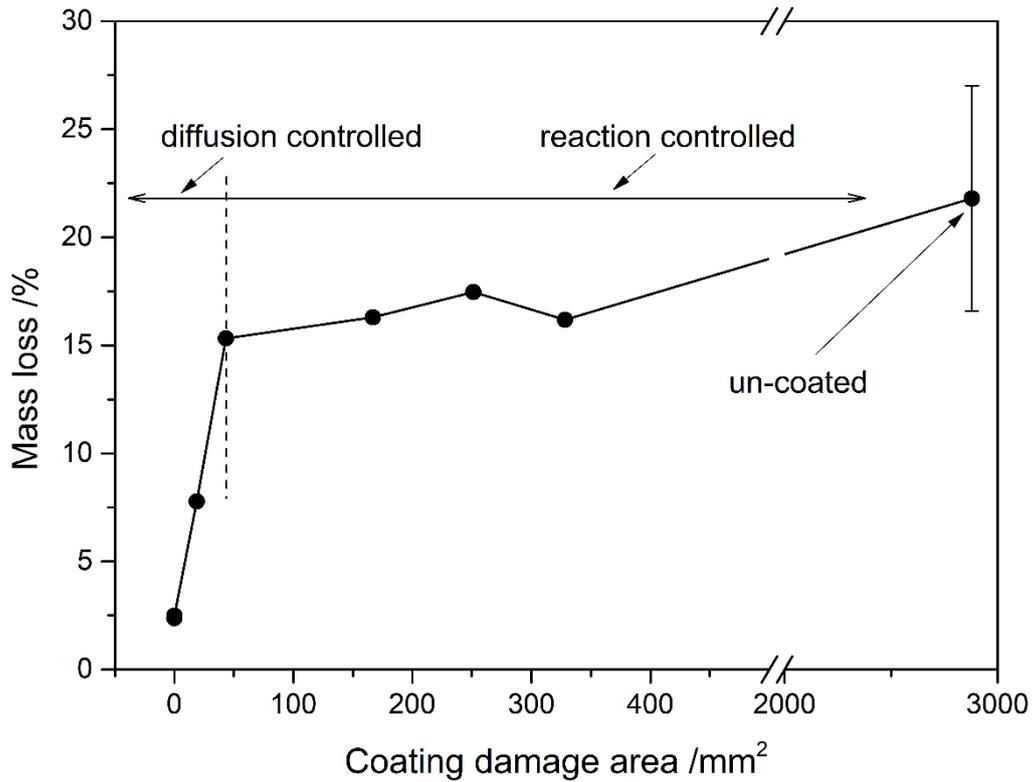
Fig.8. Relationship between mass loss and coating damage area

It is easy to understand that the oxidation behavior of C/SiC depends on the coating damage conditions. Fig.8 shows the relationship between the mass loss and the coating damage area. For the uncoated specimen, the coating damage area is defined to be twice that of the surface. Although a larger coating damage area allows more of the corrosive atmosphere to diffuse into the C/SiC, the mass loss doesn't always increase with the coating damage area. It is found from Fig.8 that the effect of coating damage on oxidation behavior has two distinct stages. When the coating damage is less than 50 mm<sup>2</sup>, the oxidation rate significantly increases with the coating damage area. In this case, oxidation depends primarily on the rate of diffusion, i.e. the oxidation behavior is diffusion controlled. When the coating damage area is larger than 50 mm<sup>2</sup>, the coating damage area has little effect on the oxidation behavior. Since oxygen can diffuse into the internal area freely, the oxidation of C/SiC becomes reaction controlled.

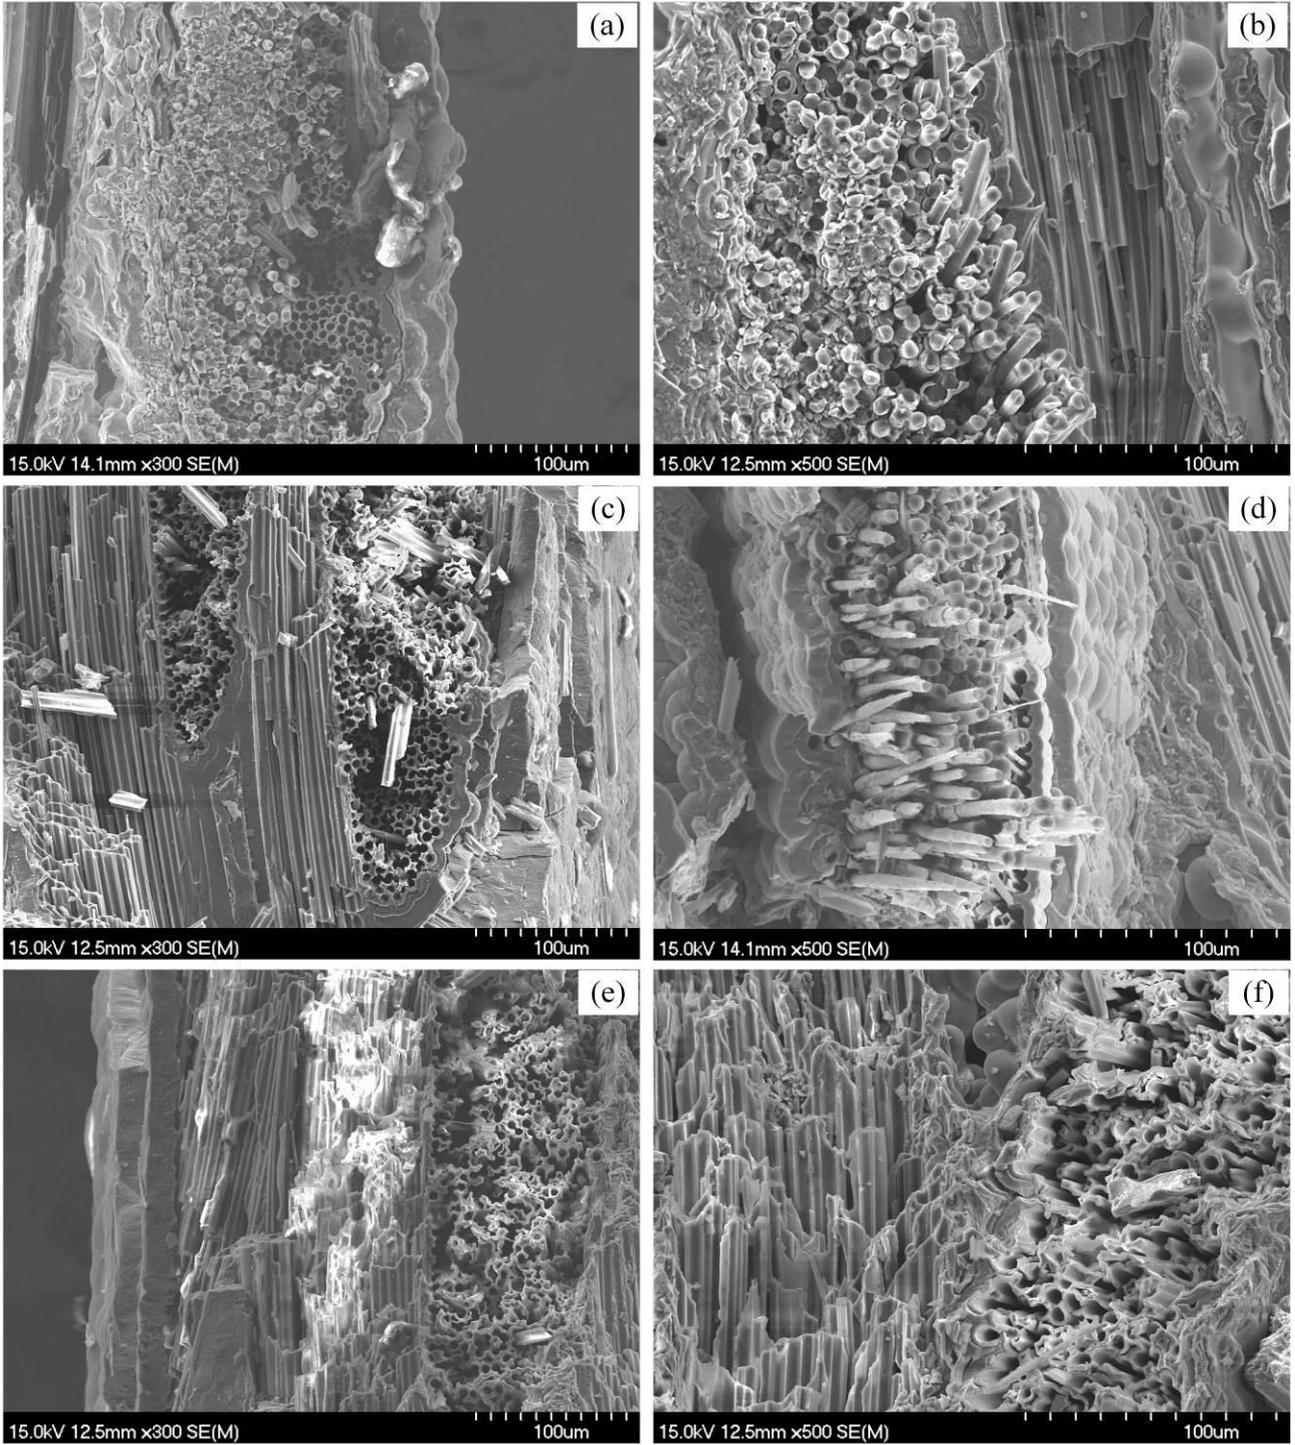
Fig. 9. Fracture surfaces near the coating and at interior of SiC-coated 2D C/SiC after impact and oxidation: (a) and (b) 0.5J, (c) and (d) 1J, (e) and (f) 5J.

Mass loss of C/SiC is the result of the oxidation of carbon fibers. Fig. 9 shows the SEM microstructure of fracture surfaces. It can be seen from Fig.9 that the extension of the oxidation of carbon fibers is greatly different under different impact energies. For the 0.5J specimen, the oxidation occurs locally, with only a few fibers in the first ply next to the SiC coating becoming oxidized (Fig. 9(a)). Some short fiber pull-out in the central region may be observed, and the fiber tips are round, which indicates that the internal fibers are maintained in their original condition (Fig. 9(b)). For the 1J specimen, carbon fibers near the surface were completely oxidized extensively and only SiC tubes were left (Fig. 9(c)). However, in the central area, it was deduced from observing some thin and sharp pull-out fibers (Fig. 9(d)) that the fibers were partially slightly oxidized. For the 5J specimen, the carbon fibers are nearly totally oxidized in the area near to the surface (Fig. 9(e)), as well as in the central region (Fig.9(f)).

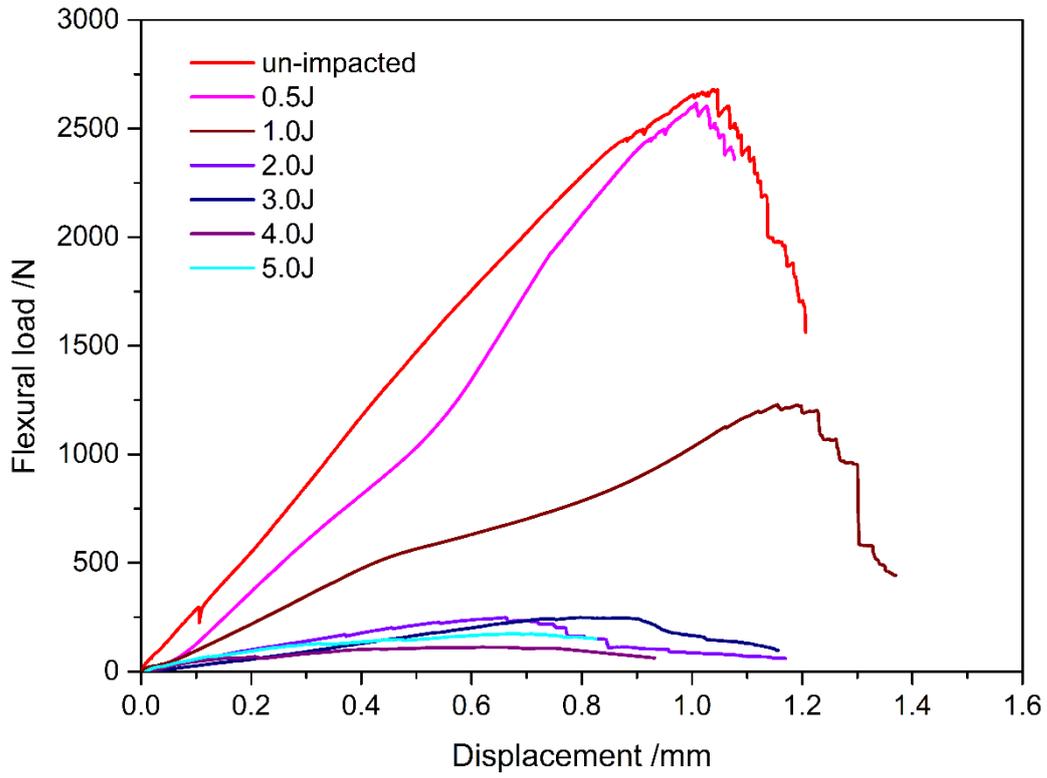
Fig. 10. Flexural load-displacement curves of oxidized C/SiC specimens.

The flexural load-displacement curves of the oxidized C/SiC are shown in Fig. 10. As the main load-carrying phase, the oxidation of carbon fibers will inevitably lead to a degradation in the mechanical properties of the material. The mass percentage of carbon fibers can be calculated by:

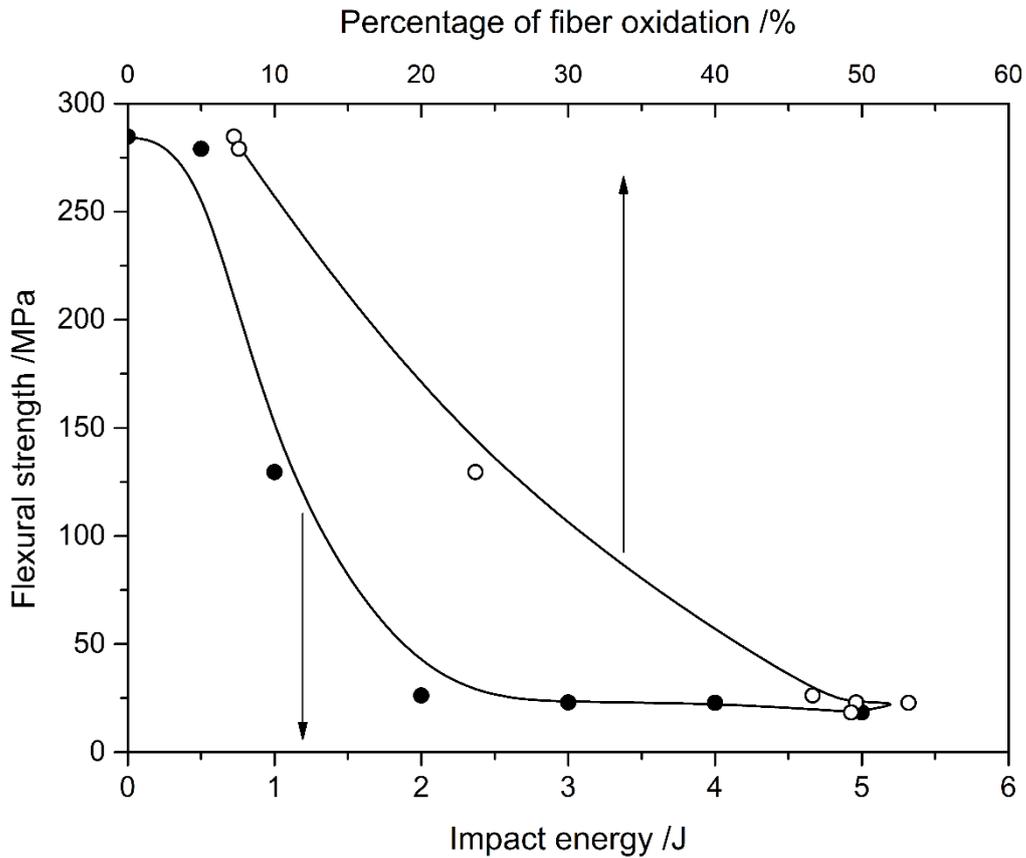
Fig. 11. Relationship of the residual flexural strength with the impact energy and the percentage of fiber oxidation.

The percentage of fiber oxidation, flexural strength and the strength retention ratio of the oxidized C/SiC under the LVI at various impact energies are listed in Table 1 and illustrated in Fig. 11. For unimpacted and impacted cases under 0.5J, only about 7% of the fibers are oxidized. Less fiber oxidation means that the mechanical properties are largely maintained. The flexural strength is about 280MPa, which is 93% of the non-oxidized specimen. With the increase in the impact energy, more fibers are oxidized and the flexural strength decreases rapidly. If the impact energy is larger than 2J, half of the carbon fibers are oxidized. Since the oxidation process starts from the impact damage area, it is believed that the fiber preform around the impact contacting region has been totally destroyed. So, the flexural load is carried by the SiC matrix, and the strength retention ratio is less than 8%, indicating that coating totally loses its intended function.
