Residual Shear Strength of Clays in Landslides in Southern Britain

A Thesis submitted in partial fulfilment of the requirements of

Kingston University London

for the degree of Doctoral of Philosophy of Civil Engineering

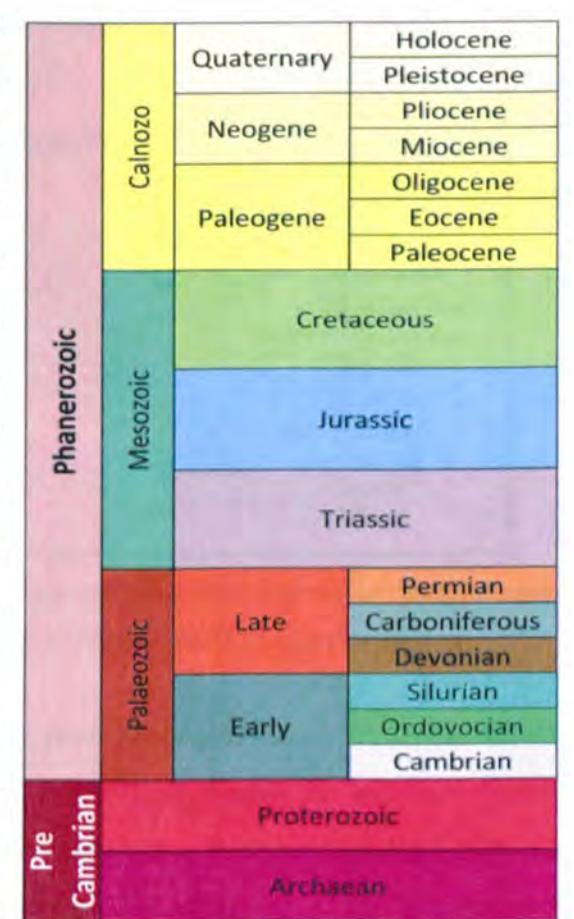
Figure 1-1: A simplified Stratigraphic column for Britain. Most of the stiff clays in which deepseated landslides formed, are found in the beds of the Upper Carboniferous, the Triassic and especially in Jurassic, Cretaceous and early Tertiary. Britain generally, and south east England in particular, has very low relief. In south east England, the gently folded strata create simple structures which include two basins, the London Basin and the Hampshire Basin separated by a dome known as the Weald.

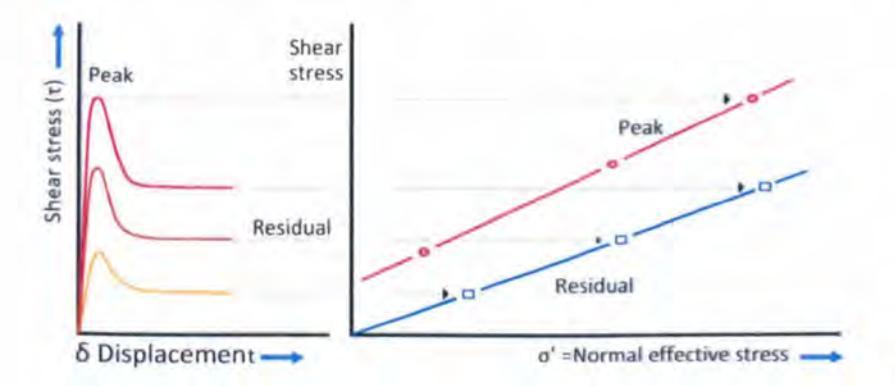
Figure 1-3: Graph is idealised to show development of a residual shear strength envelope from a series of individual tests on soil specimens and the equivalent peak strength.

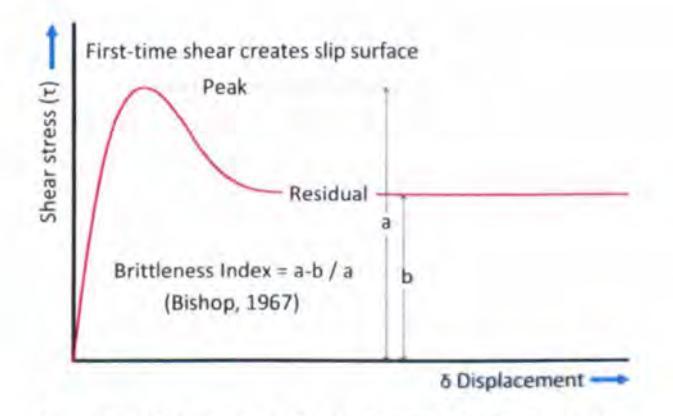
Figure 1-4: Definition of Brittleness and Sensitivity Index

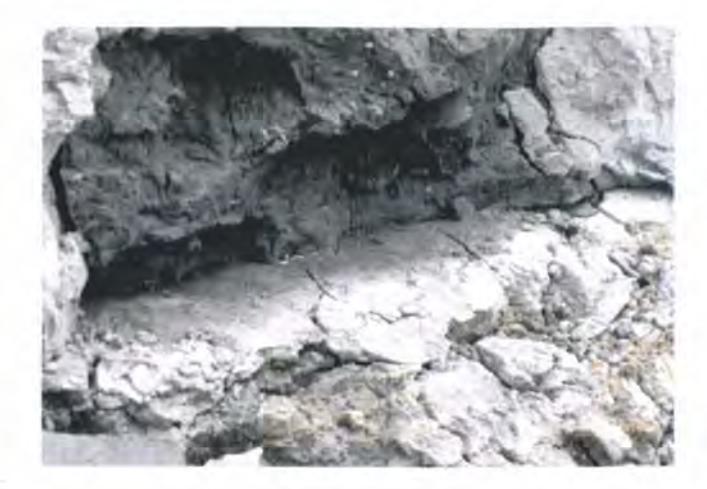
Figure 1-5: An example of a shear surface from a shallow landslide at Barton on Sea (Barton D Zone).

The **shear surface**, which also sometimes termed a slip surface or basal shear, is a phrase which describes a thin zone in which differential movement in the ground takes place, as a result the residual strength is established. Hutchinson (1970) discussed the process and locations in which the rupture surface or slip surface of landslides in British Clays take place. Figure 1-5 shows an example of the slip surface which explored in the field at Barton on Sea in Hampshire.

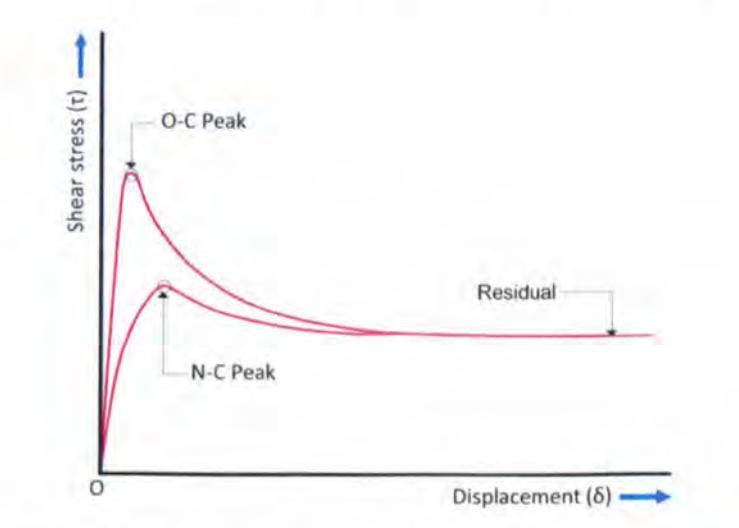
Figure 2-1: Simplified relation between normal and over consolidated clay (after Skempton 1964).

However, as geotechnical engineering was prior to that concerned with problems of the stability of unfailed slopes and foundations, research emphasis lay on the determination of peak strength properties. Henkel (1957) discovered that when the drained heavily over-consolidated clays fail, the shear strength diminishes fairly rapidly with increasing strain while the strain at failure is comparatively small (Fig. 2-1).

Skempton discussed the post-peak shear strength behaviour of clay in the drained condition. The post-peak drop in drained shear strength of overconsolidated clays occurs in two stages. First, at relatively small strain, the strength diminishes to the *fully softened* or *critical state value*, due to an increase in water content. Then, after much larger strain, the strength drops to the residual value, due to reorientation of platy clay minerals parallel to the direction of shearing. In normally consolidated clay, the post-peak drop occurs only due to particle reorientation (Ibid.) (Fig 2-1).

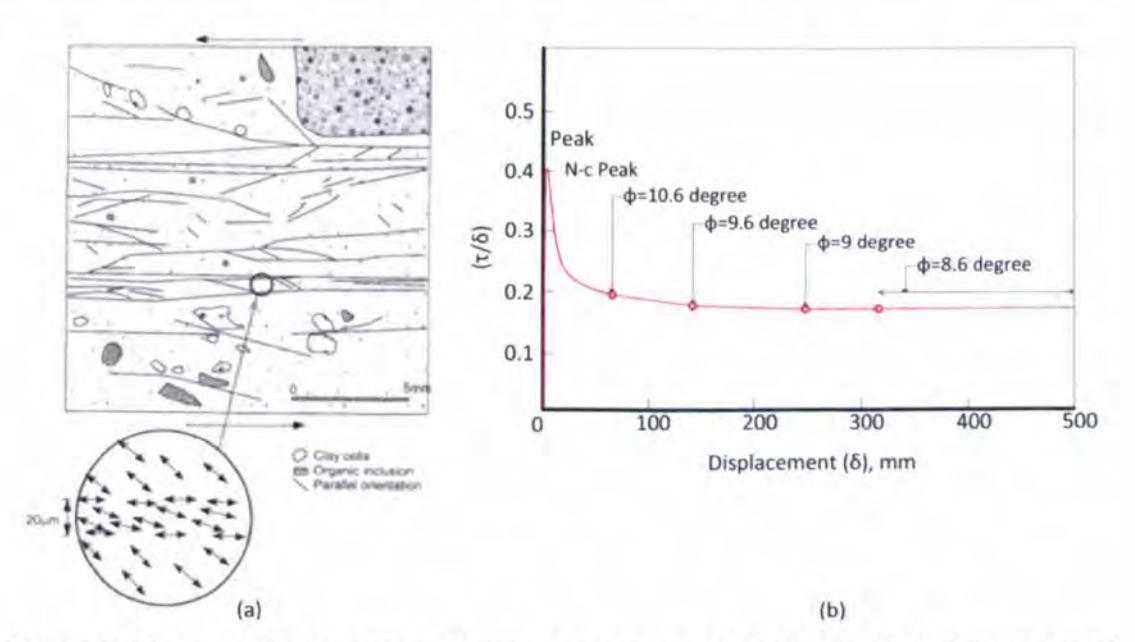
Figure 2-2: (a) Formation of multilayer slickenside after shear test (Skempton, 1964); (b) Variation of shear strength of soil with displacement (Skempton, 1985).

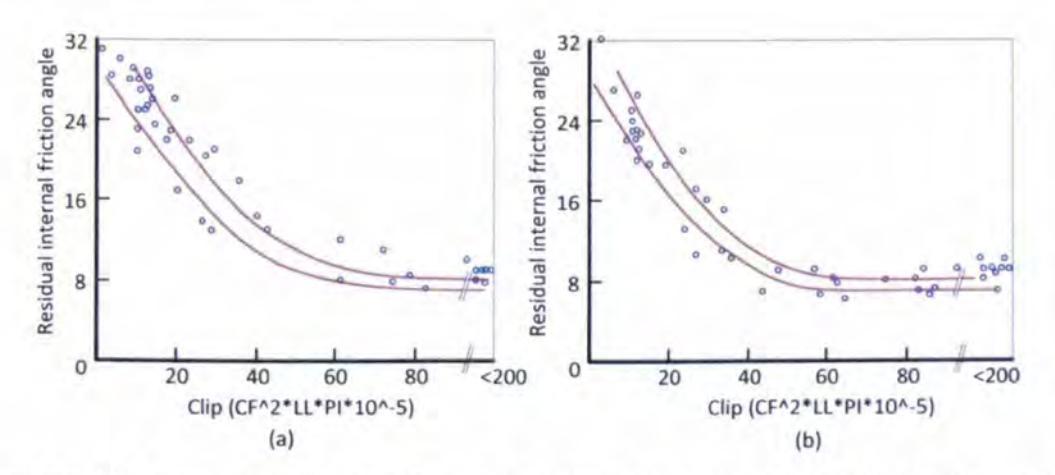
Figure 3-3: (a) Relationship between calip and residual friction angle using DSBT , (b) Relationship between calip and residual friction angle using RST (after Colotta et al., 1989).

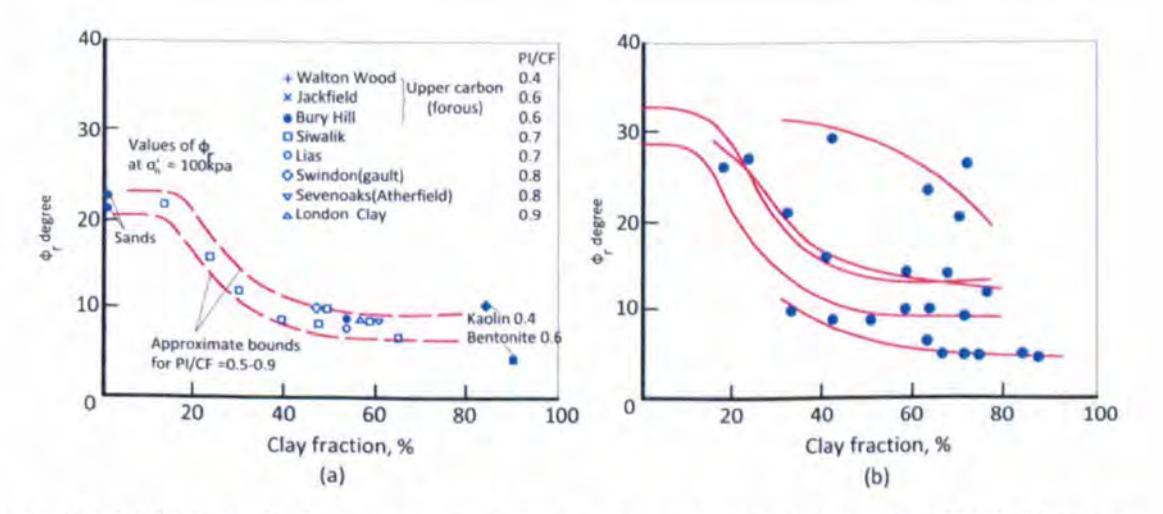
Figure 3-4: (a) relationship between residual friction angle and clay fraction (Skempton1985), (b) redrew the curve relationship of clay-fraction residual ϕ' by Mesri and Cepeda-Diaz (1986).

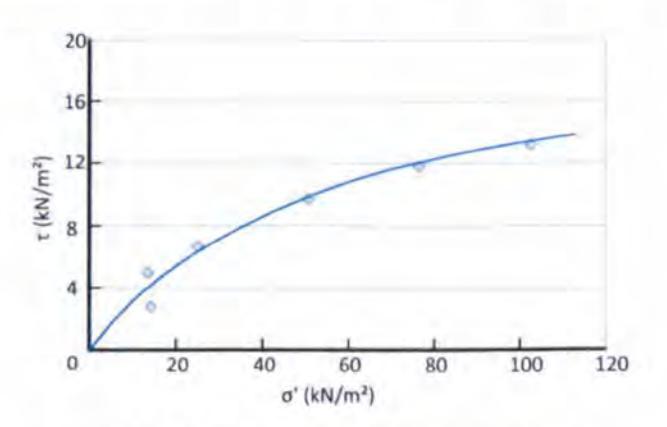
Figure 4-1: A curved residual strength envelope.

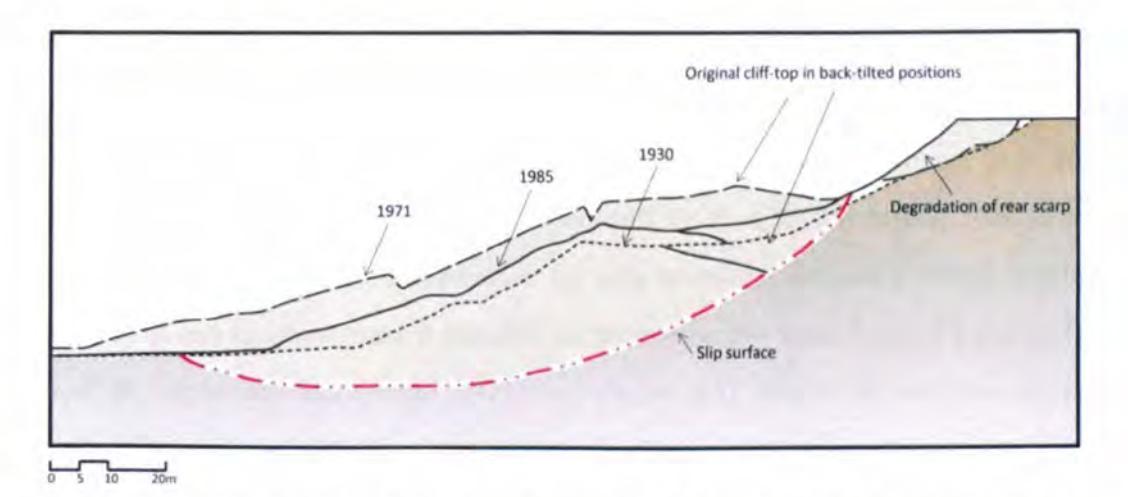
Figure 4-2: Example of different cliff profile after landsliding, Warden Point, Isle of Sheppey (after Dixon & Bromhead, 2002).

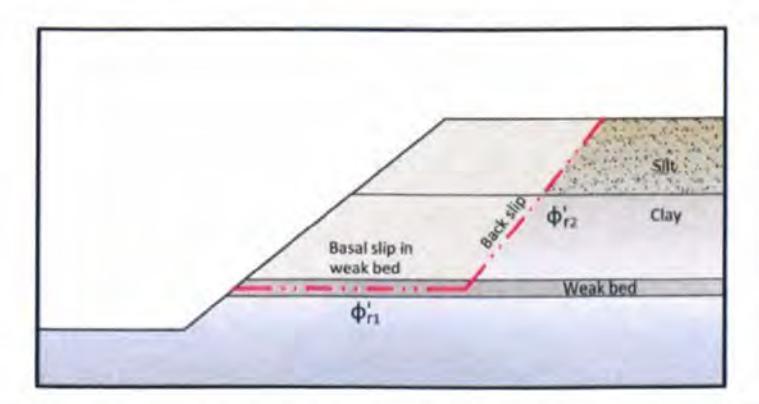
Figure 5-1: shows a simplified landslide with a bedding controlled segment, roughly based around the Barton cases. ϕ'_{r1} : represents the slipping through the weak clay & ϕ'_{r2} : represents the slipping through the strong clay (the back slip).

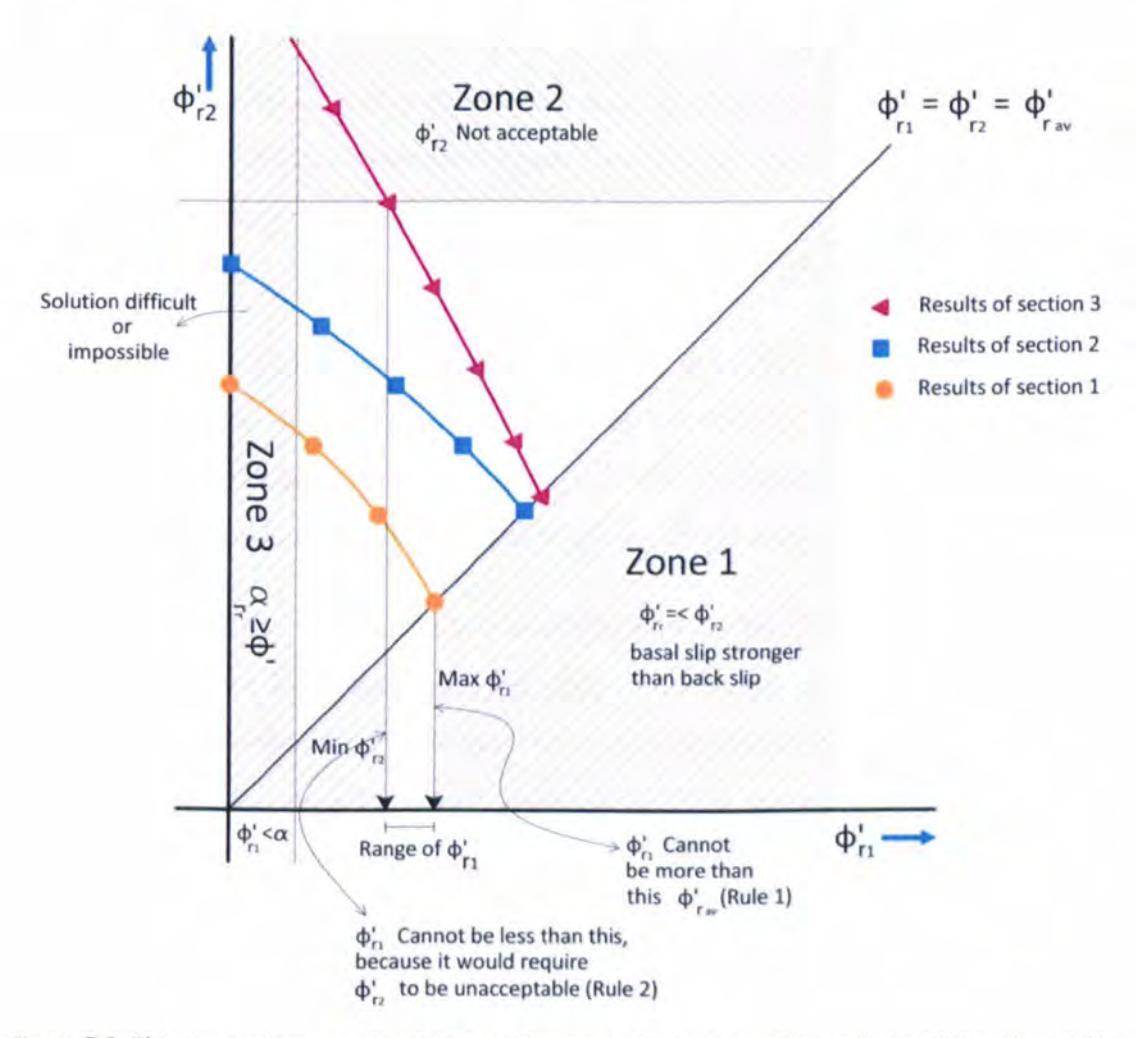
Figure 5-2: This graph shows results of ϕ'_{r1} vs. ϕ'_{r2} and the limitation and boundaries of the ϕ'_{r1} and ϕ'_{r2} . Rule1 and Rule2, as explained in the text, are shown on the horizontal axis.

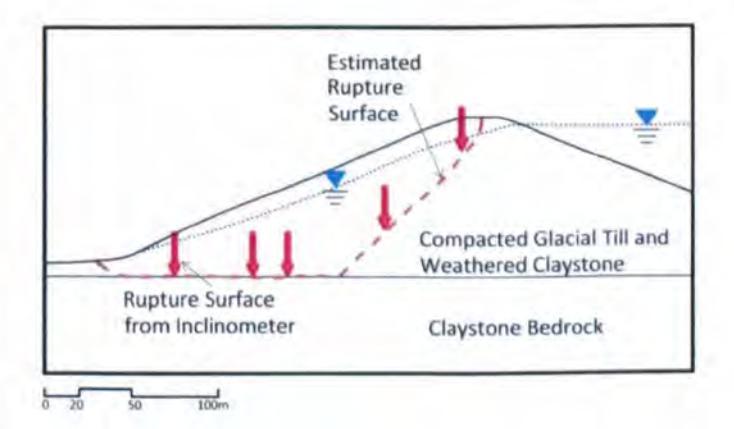
Figure 5-3: Cross section of Grandview Lake Dam with assuming rupture surface and Piezometric line (after Deschamps & Yankey, 2006).

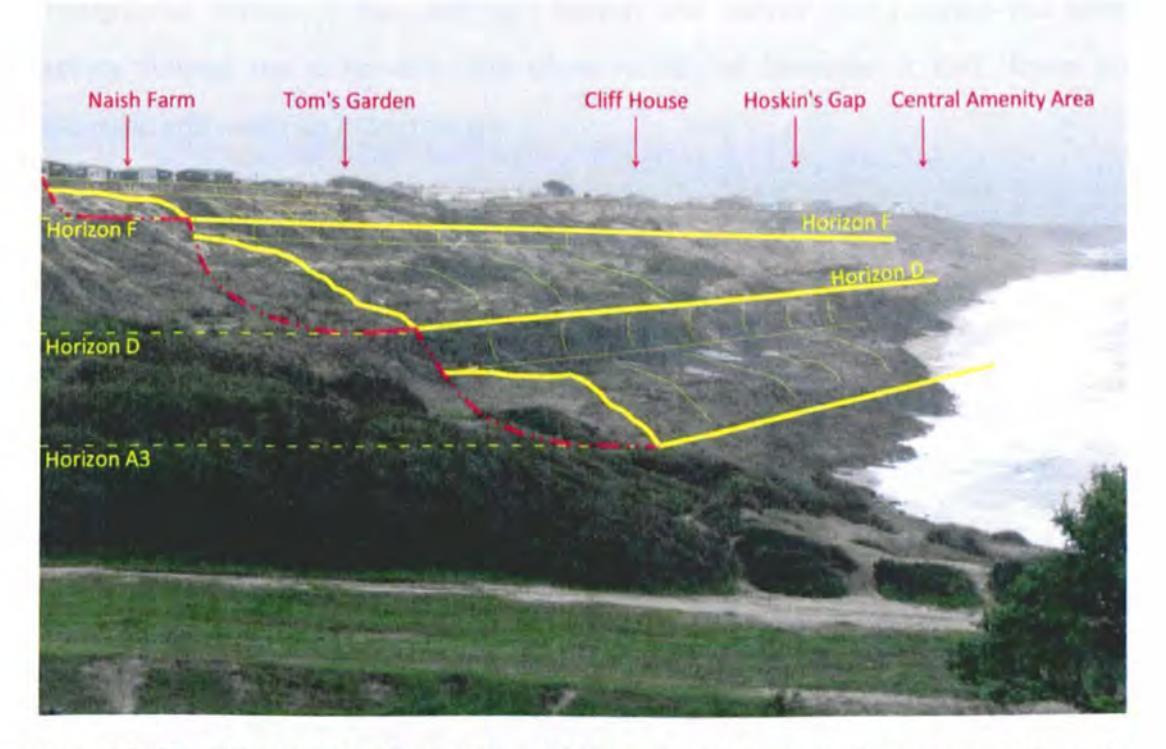
Figure 6-3: The photograph shows the view looking eastwards toward Cliff House, and shows the undercliff fronting the Naish Farm Holiday Estate in left and Tom's Garden in the middle and in the far right of photograph is landslide at Cliff House. The sketch illustrates the back scarp three benches, the upper and lower weak horizons, Zone F, Zone D and Zone A3, which dipping west to east are hosting the progressive transitional part of slips. The basal shear surface of the compound slides which is located along one of the preferred weak horizon is illustrated. It also shows slumping of the overlying scarp forms a colluvial bench above the preferred shear surface which is the characteristic mode of degradation of landsliding in Barton bed. The scarps are separated by colluvium which overlies the benches.

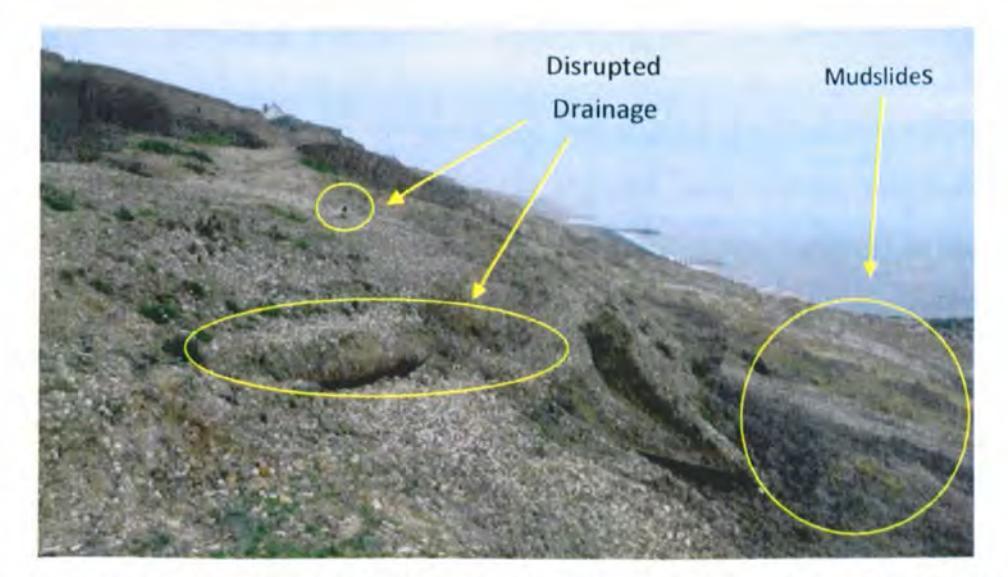
Figure 6-4: Barton on Sea Hoskin's Gap West area undercliffs, overturning and failure of sheet piles and drainage system resulting from sliding along shear surface within Zone F. The slide combined with loss of support seaward as result of toe erosion and caused reactivation of mudsliding.

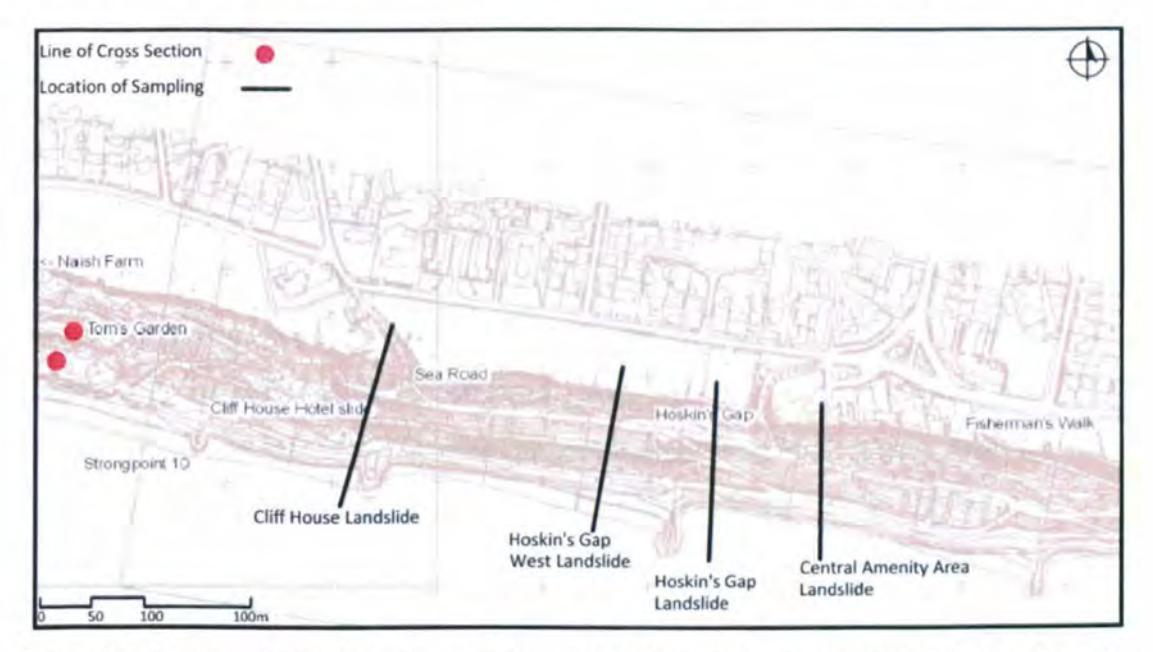
Figure 6-5: The map shows the study area, from Naish Farm to eastern outcrop of Barton Clay. The location of four cross sections used in back analysis and the location of sampling are illustrated. Samples are collected from slip surface exposure in F horizon Tom's Garden and in D horizon down of Naish Farm (after Garvey, 2007).

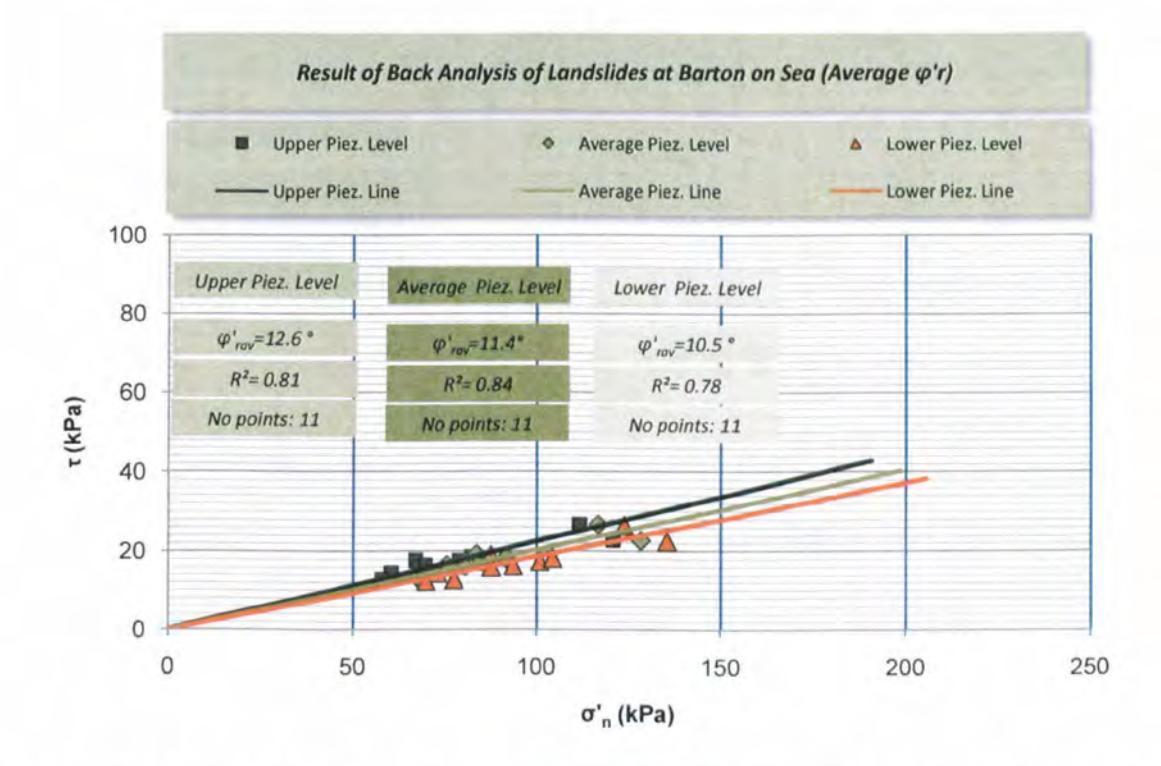
Figure 6-6: Results of back analyses show the average residual friction angle for different piezometric line as stated in Section 6.3.

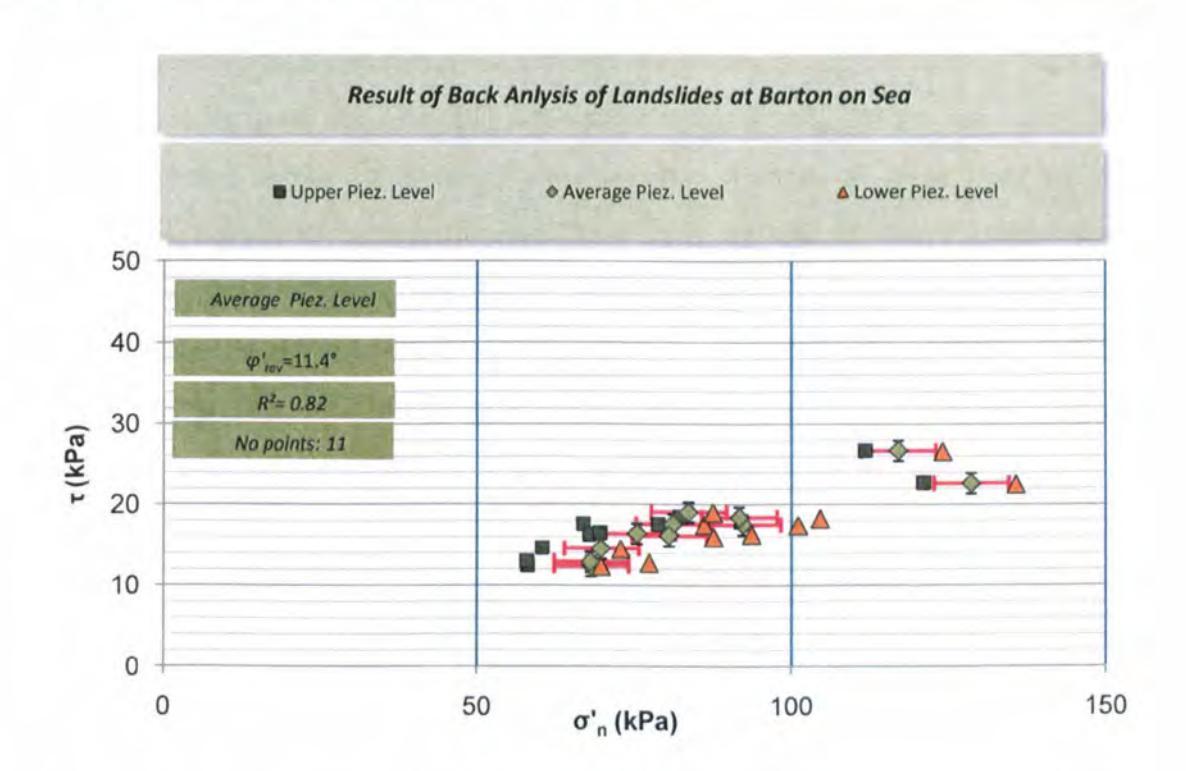
Figure 6-7: The error bars of the results of back analyses for different piezomtric level are shown in this graph. The error bars show the errors from the average residual friction angle which calculated for average piezomtric level.

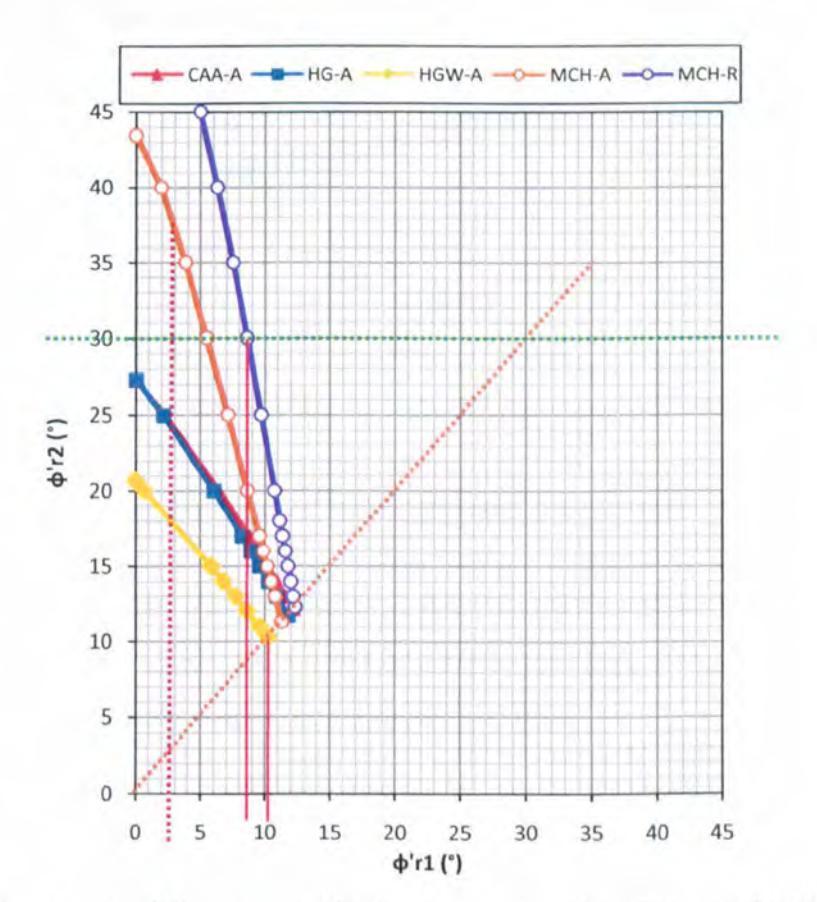
Figure 6-8: Shows how to define range of ϕ 'r1 for cross section of landslides at CAA, HG, HGW, MCH using Average and Real piezometric conditions. The narrow red lines show the range of ϕ 'r1.

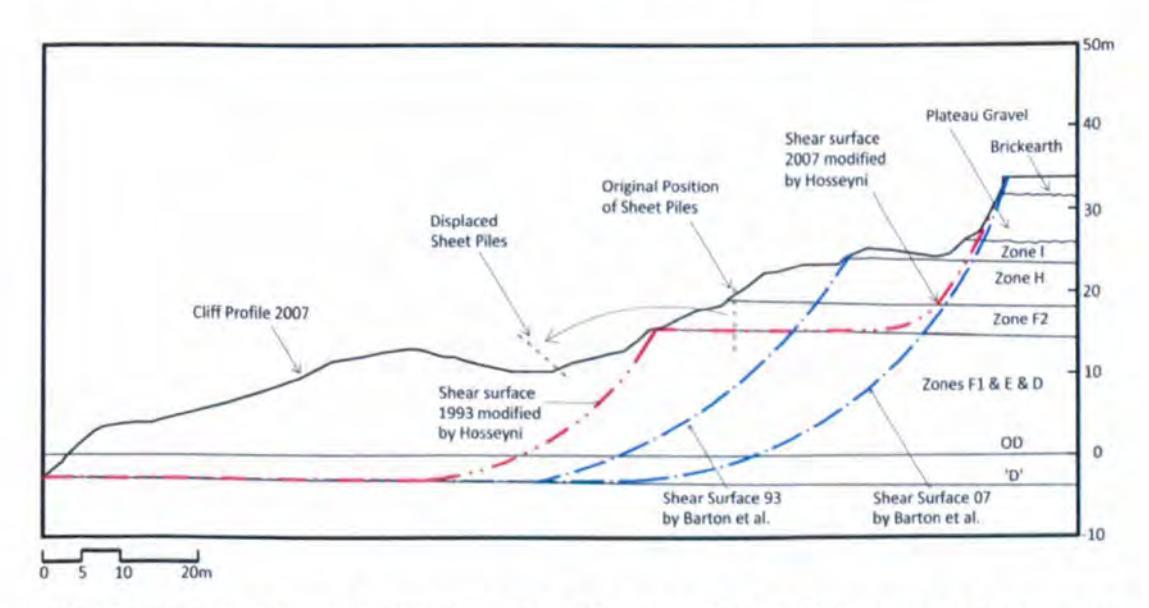
Figure 6-10: Geological section of Cliff House Landslide with cliff profile 2007. Barton et al. designated that deep movement taken place in Zone D. Evidence of the site and direction of displaced sheet pile indicate that the current topography of the area is the results of two separate slips in D horizon and F horizon. The former happens as result of toe erosion and continuous toward the cliff progressively along Zone D. This movement confirmed by the direction of displaced sheet piles. Subsequent movement take place in Zone F as a result of recession of the back scarp of the lower slips.

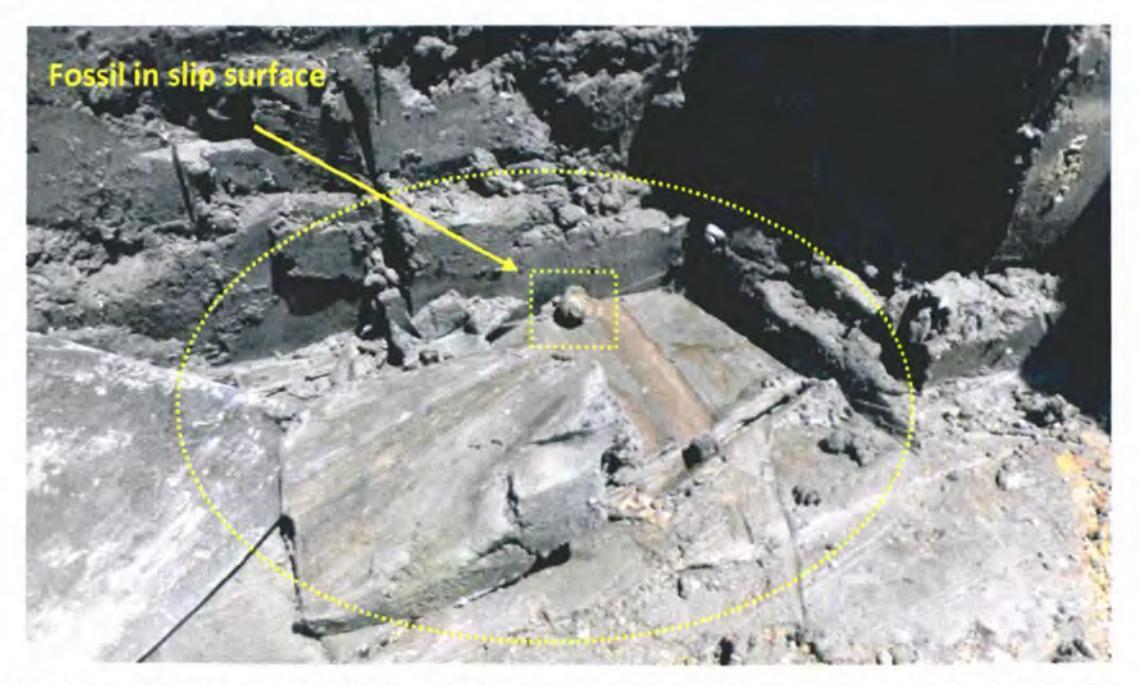
Figure 7-2: The polished slip surface which includes with brown staining is shown in the photograph. The slip surface is located along the D Zone and includes fossils.

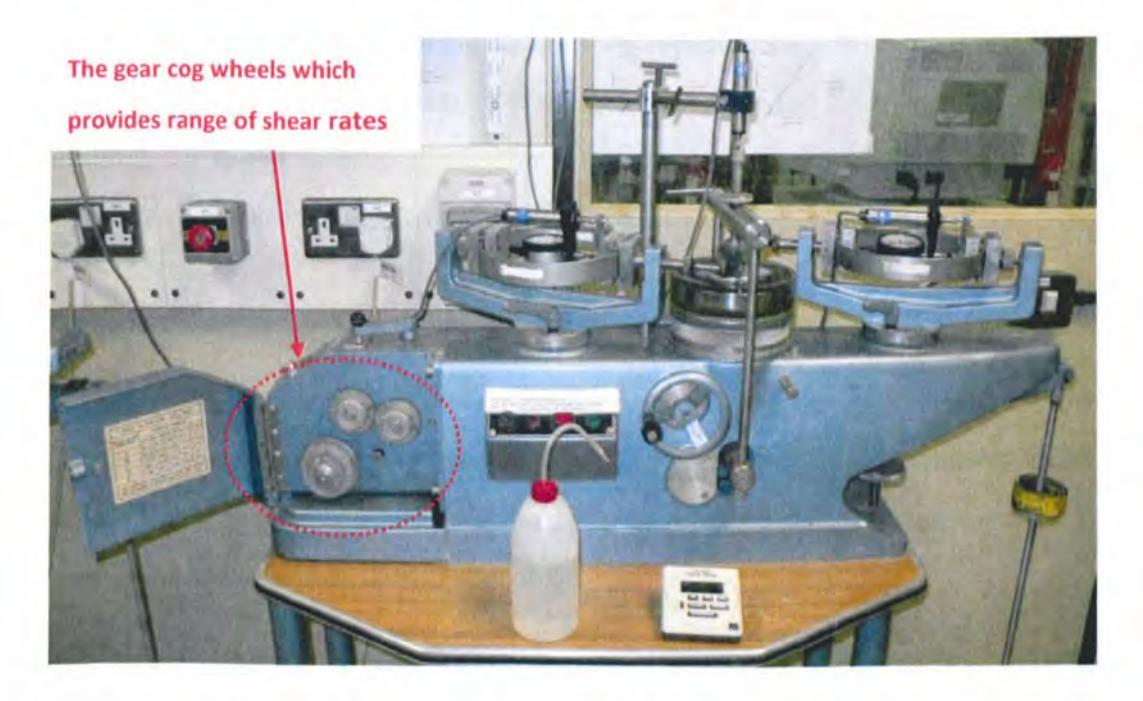
Figure 7-3: Bromhead ring shear apparatus, showing different parts, including: load hanger, proving rings, dial gauges, transducers, torque arms.

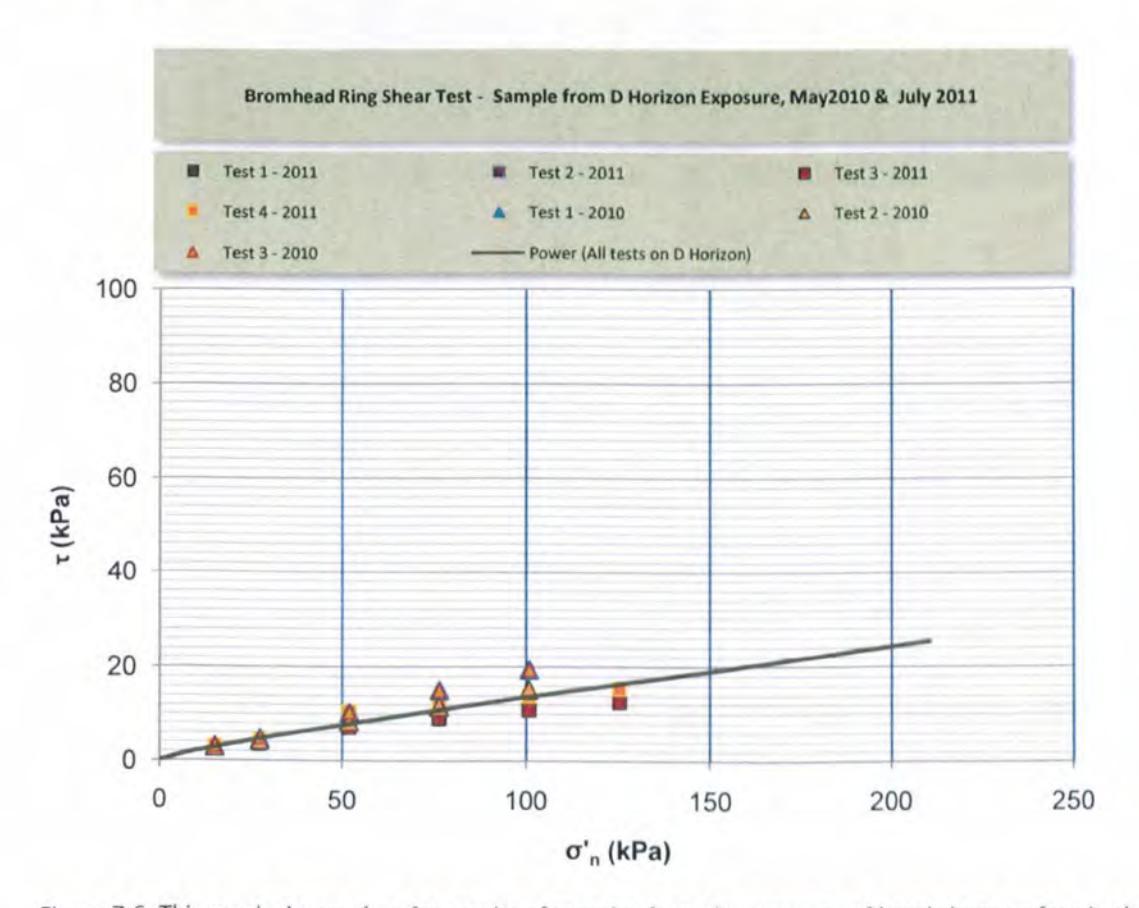
Figure 7-6: This graph shows σ'_n - τ for results of samples from the exposure of basal shear surface in the D horizon of Baron Bed. Four tests are carried out on the samples in 2011 and three on the samples in 2010. Locations of sampling are shown in Figure 7.5.

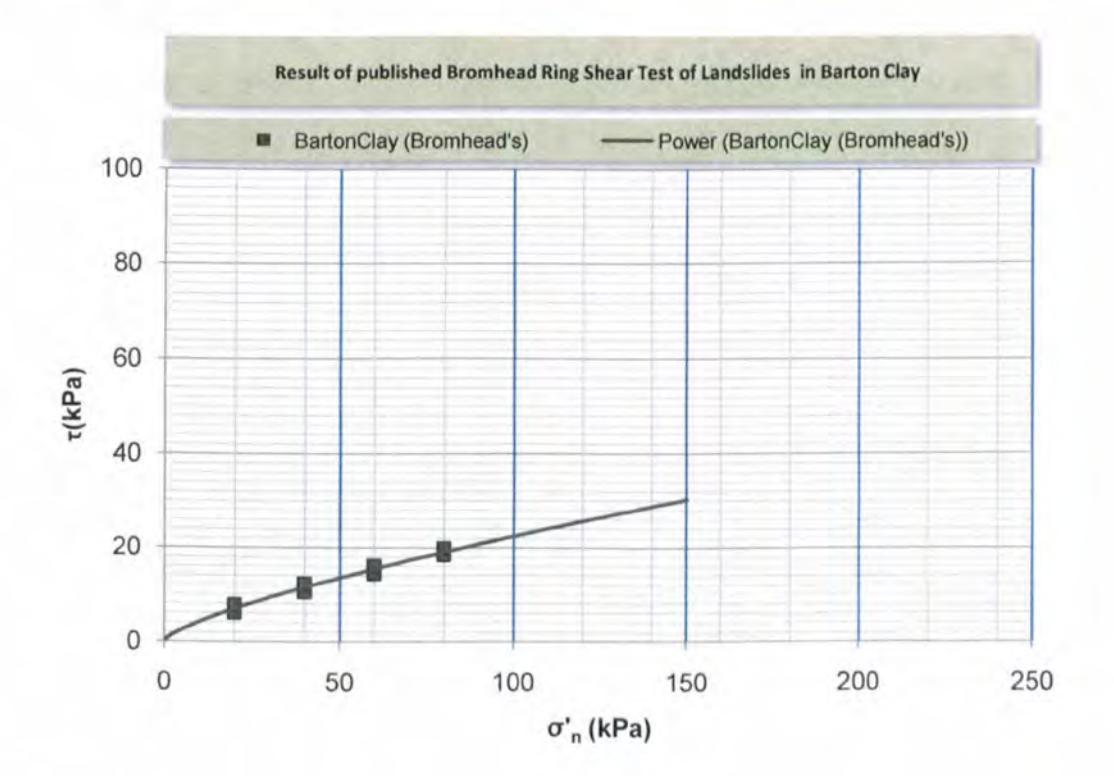
Figure 7-8: Results of the Bromhead ring shear tests plotted as values of effective normal stress versus shear stress for the dark chocolate brown seam and the immediately underlying D Zone of Barton Bed (after Barton et al., 2006).

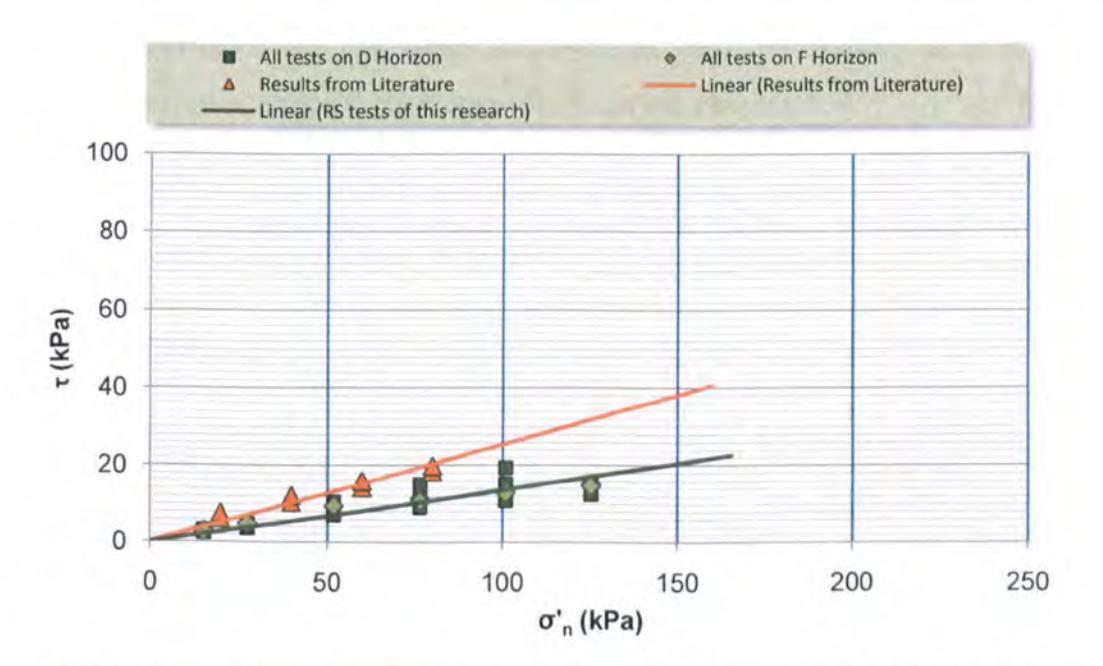
Figure 7-9: Results of the Bromhead ring shear tests on the samples from the landslides at Bartopn Sea are compared with published results using same apparatus.

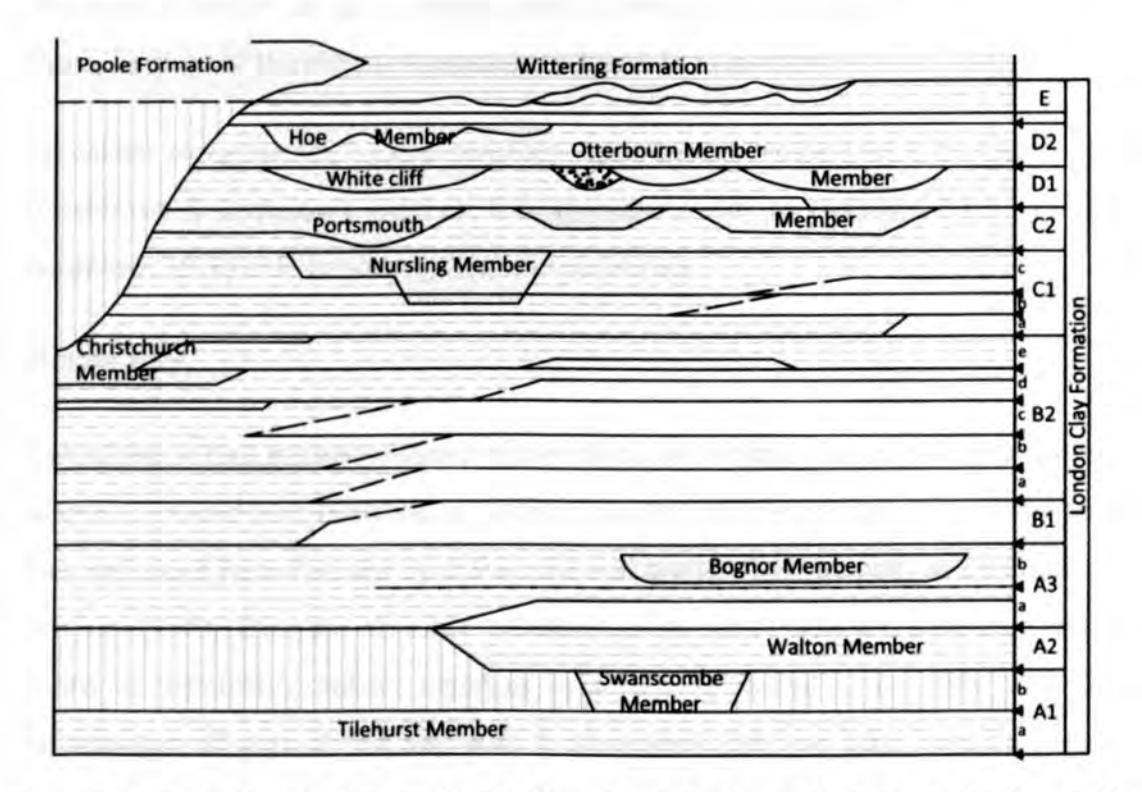
Figure 8-2: Lithostratigraphy of the London Clay Formation in the Hampshire Basin, the Lithology highly generalised (after King, 1991). It illustrates the major lithofacies and the relationship of the named lithostratigraphic units to the deposition sequences.

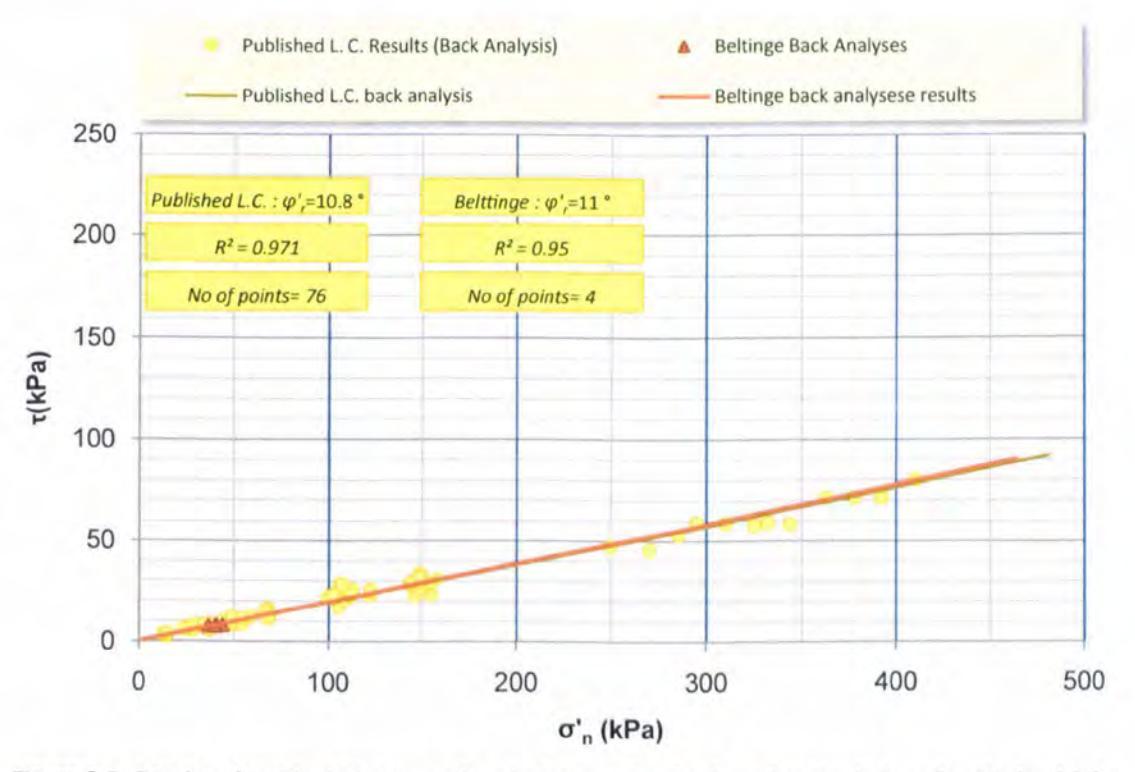
Figure 8-5: Results of residual friction angle calculation using back analysis technique for the landslides in London Clay at Beltinge. These results are compared with published data.

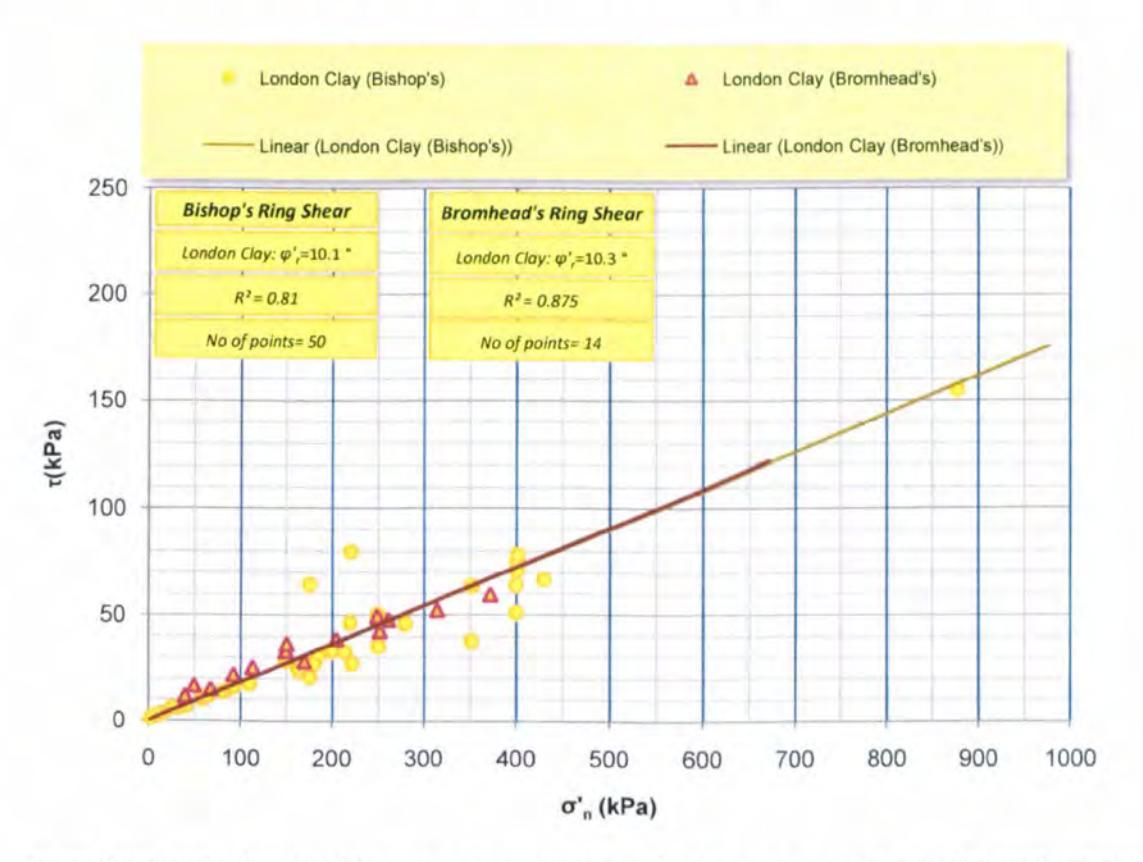
Figure 8-6: Results of residual friction angle measurement by ring shear apparatus (both Bromhead and Bishop devices) for the landslides in London Clay. The data come from the published data or extracted from published graphs.

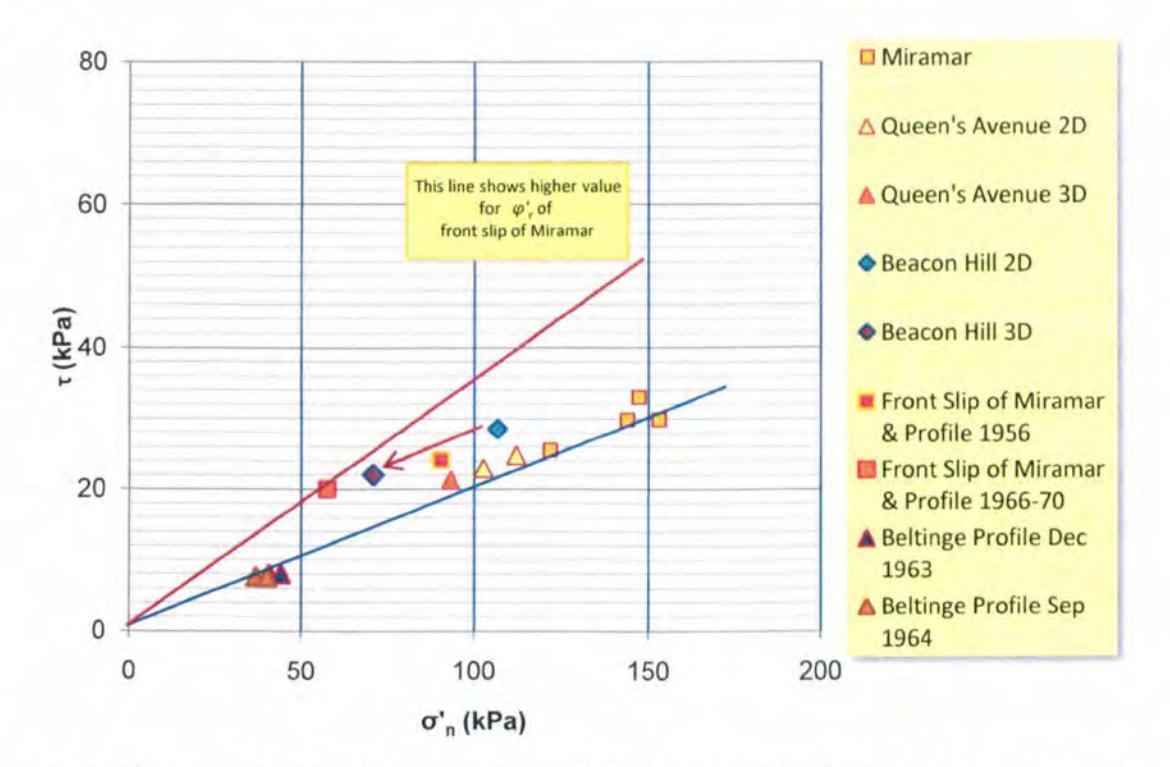
Figure 8-7: Result of back 2D and 3D back analysis of landslides at Herne Bay including the new analyses of this research. The red coloured arrow shows the drop of stresses of 2D analysis to the 3D analysis in Beacon Hill landslide.

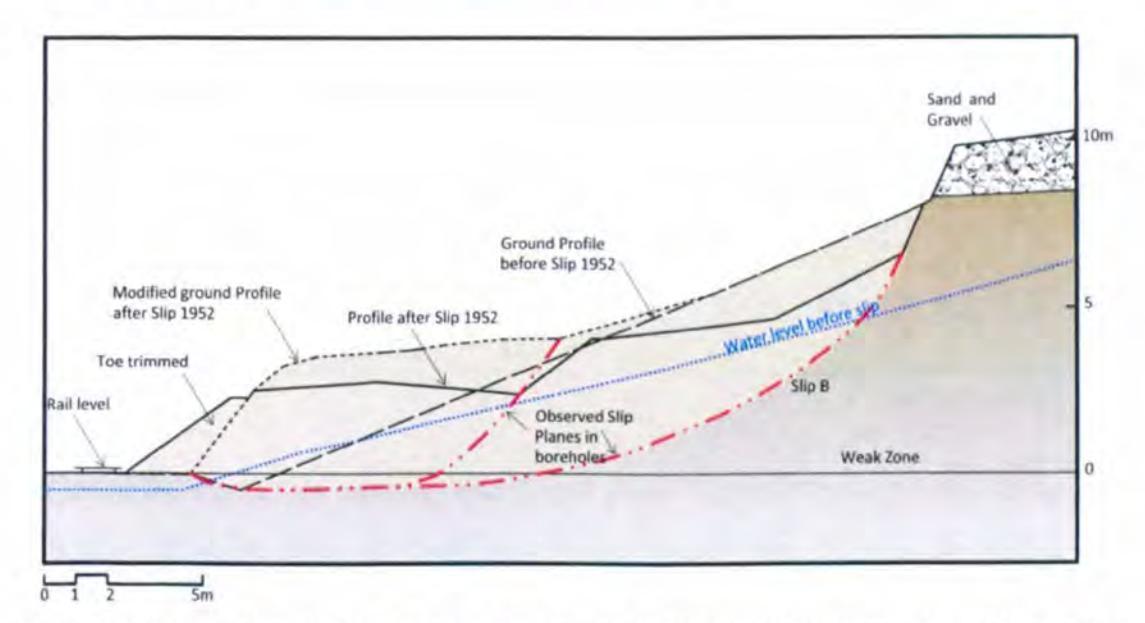
Figure 9-1: Section of landslide in London Clay cutting at Dedham (after James, 1970). The section illustrates the original ground profile after the cutting in 1840 and the ground surface profile before and after the slip in 1952. Water level was recorded in stand pipes after failure but slip surface was assumed from failure profile and boring results.
