Residual Shear Strength of Clays in Landslides in Southern Britain

A Thesis submitted in partial fulfilment of the requirements of

Kingston University London

for the degree of Doctoral of Philosophy of Civil Engineering

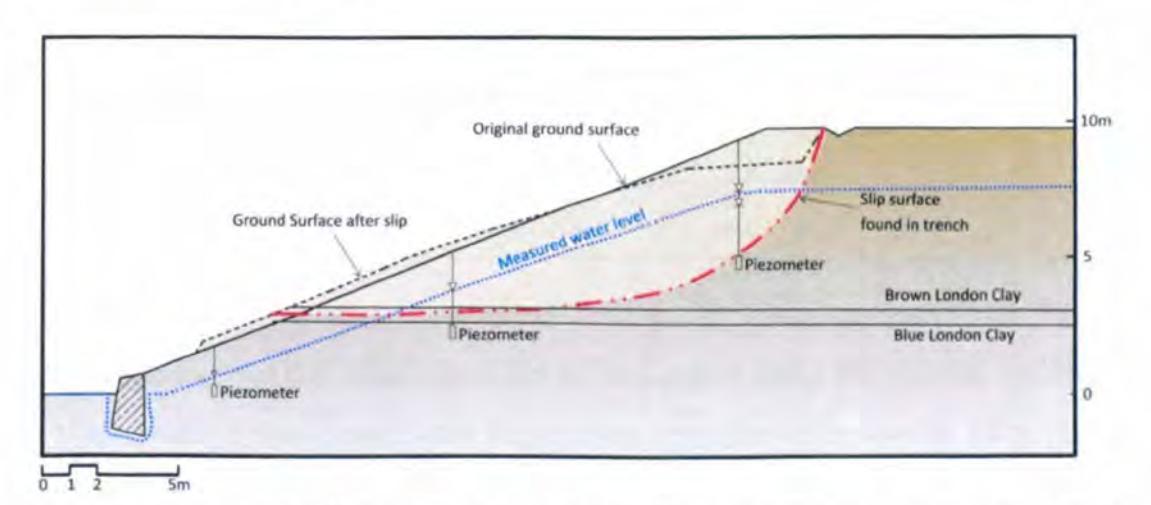
Figure 9-2: Section through Northolt cutting (after Henkel, 1957). The original ground surface profile after cutting 1938, the ground profile after slipping, location of piezometers and slip surface.

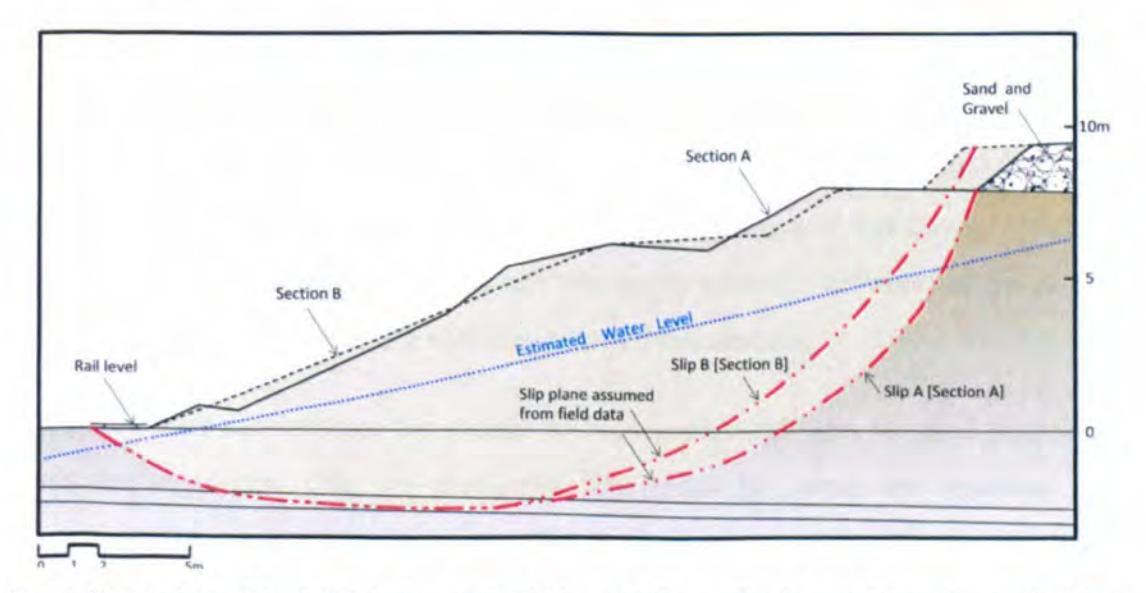
Figure 9-5: Section of landslide in the cutting in London Clay at Fareham in Hampshire Basin (after James, 1970).

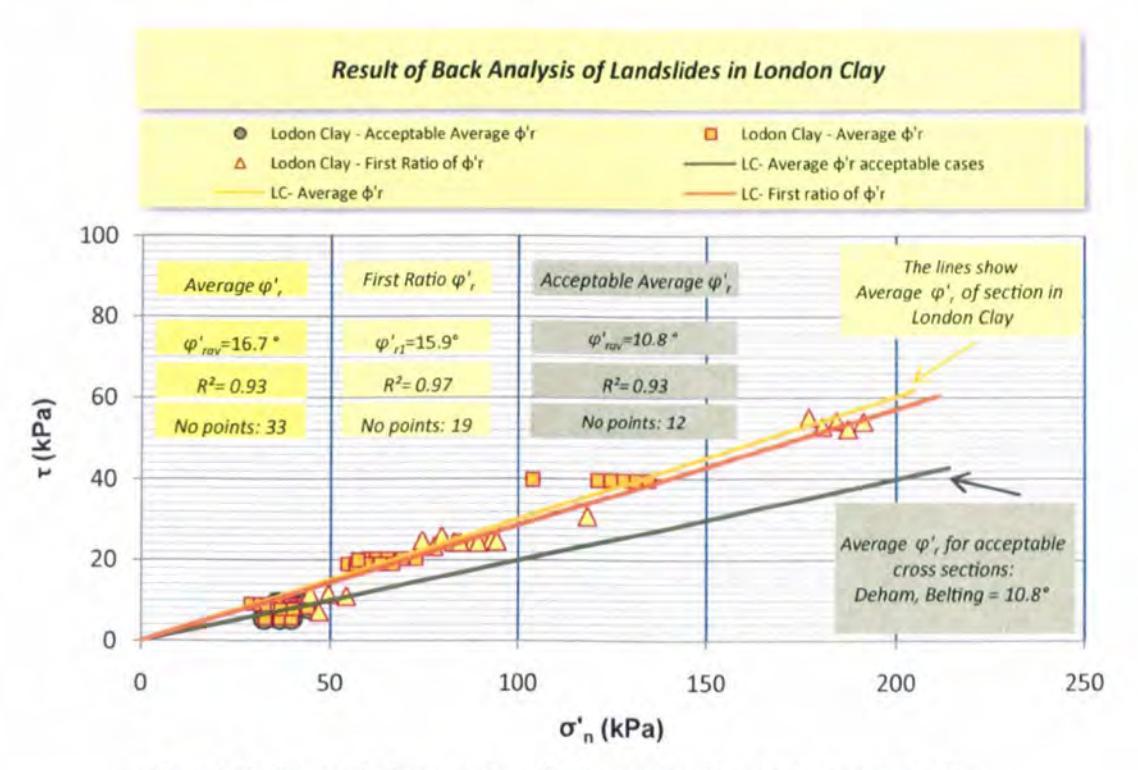
Figure 9-6: The graph show results of back analysis of landslides in London Clay.

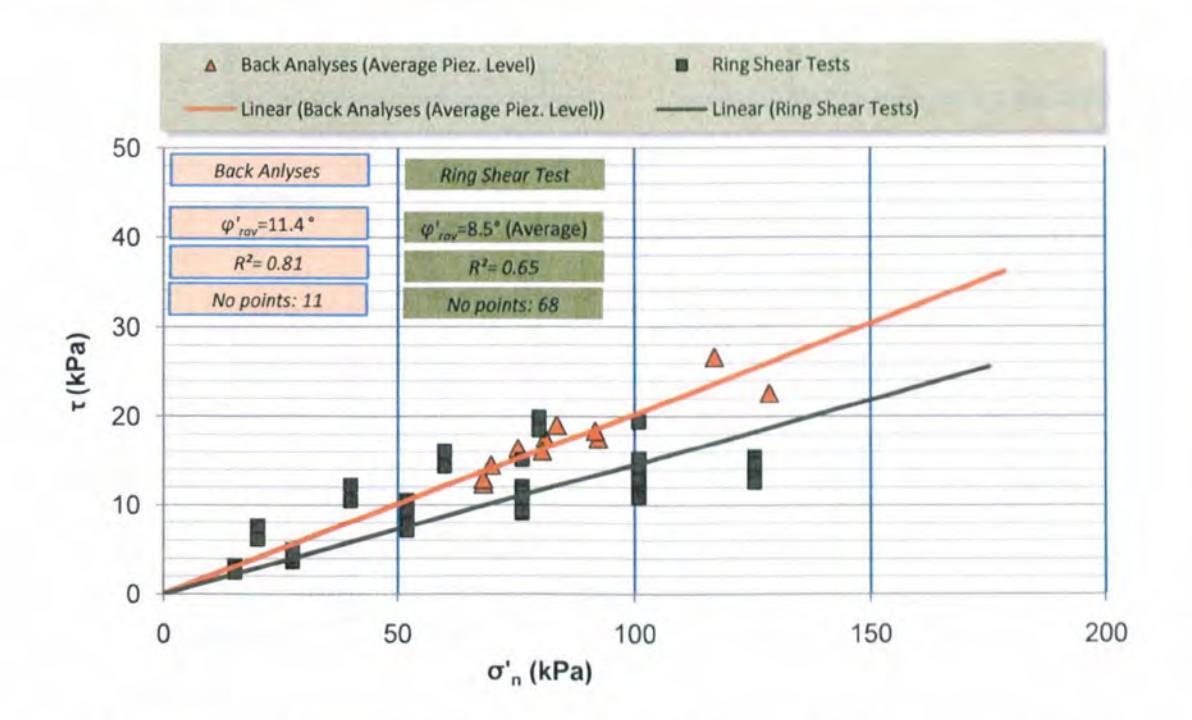
Figure 10-3: The graph compares results of back analysis and Ring Shear test of Landslides at Barton on Sea (This research and Literature).

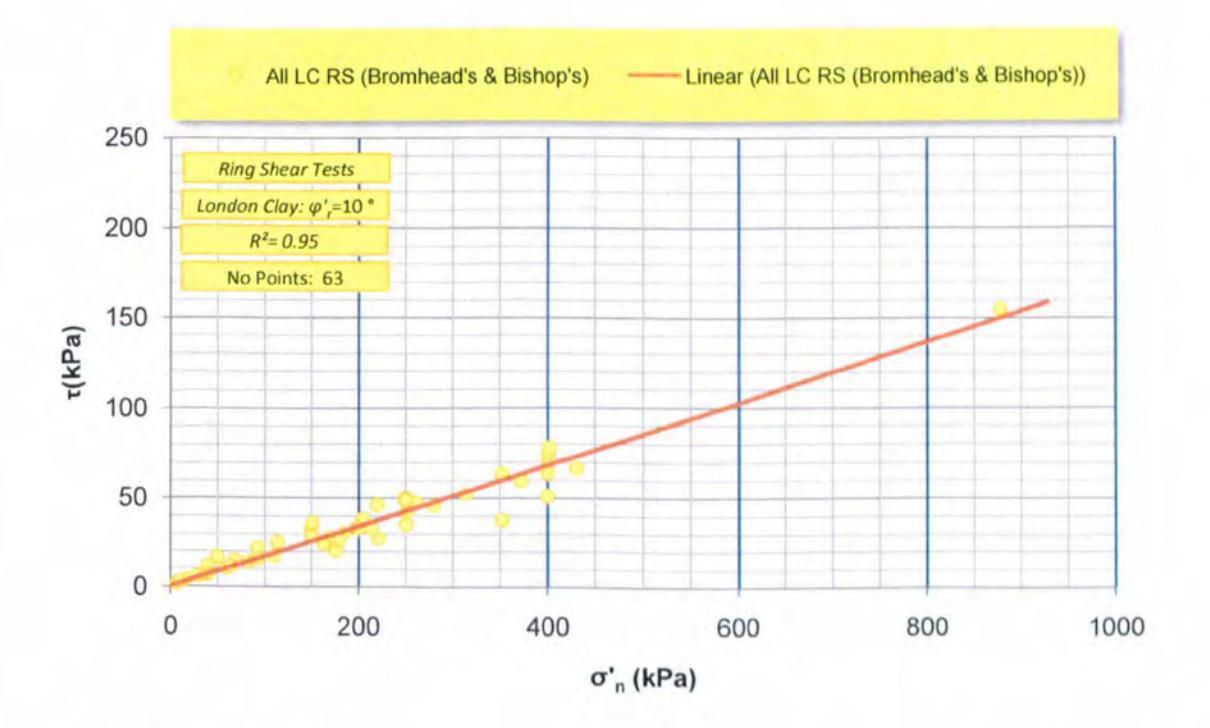
Figure 10-4: Results of published ring shear tests using Bromhead device and Bishop apparatus on the samples from London Clay.

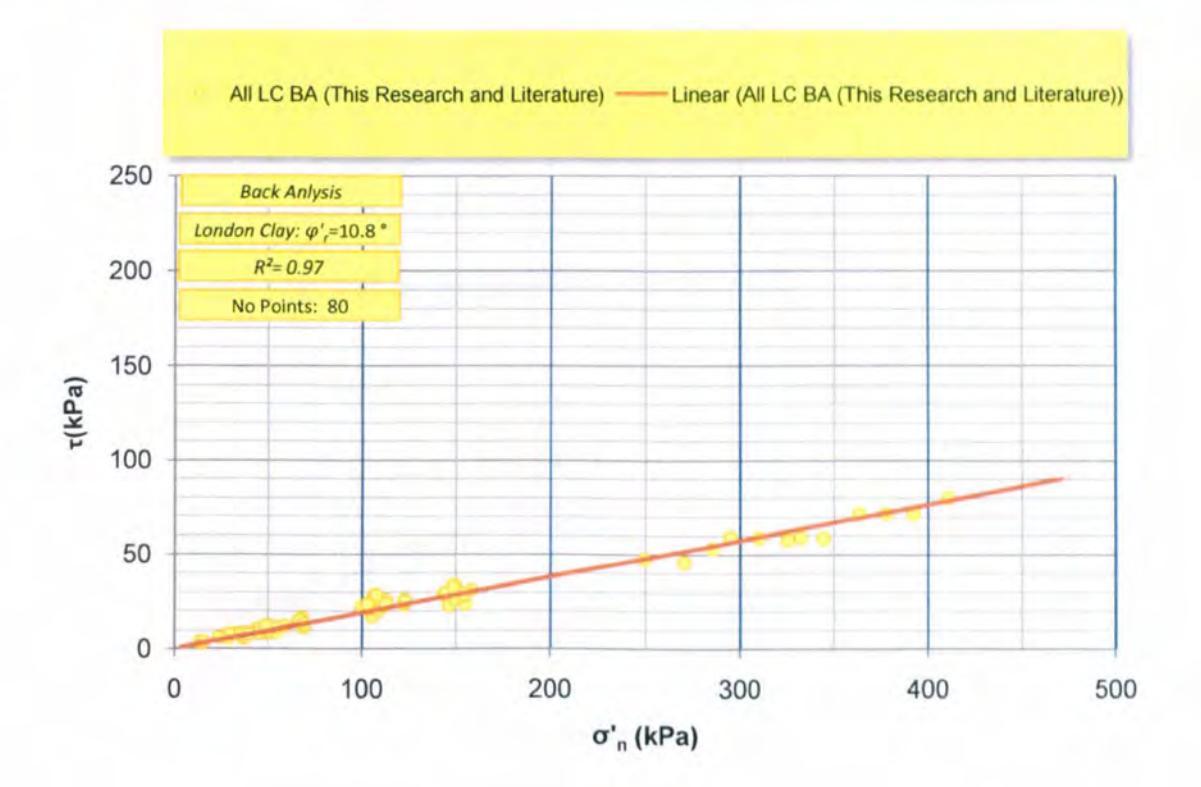
Figure 10-5: The graphs shows results of published back analyses on the cross sections of landslides and results of the acceptable cross section of this research (as stated in the previous chapters).

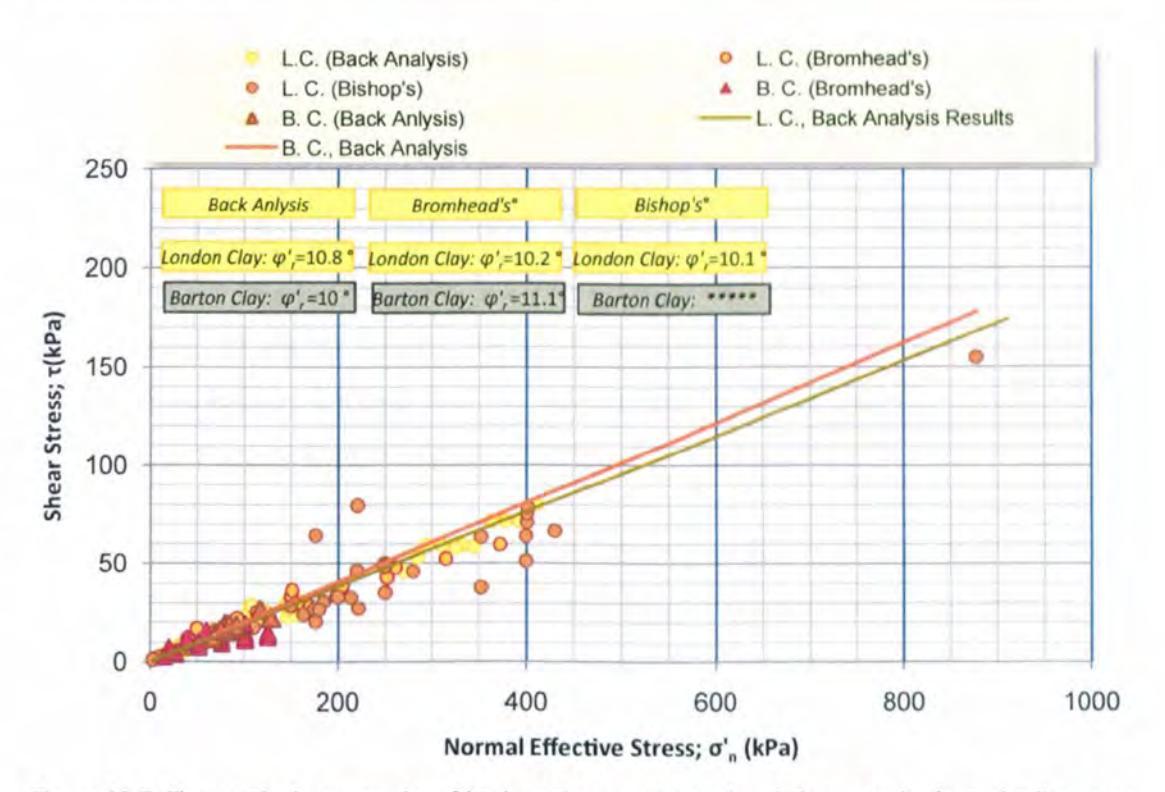
Figure 10-7: The graph shows results of back analyses and Bromhead shear results from the literature and the results of this research. It is also included comparison of those results and results of Bishop ring shear device from the literature.

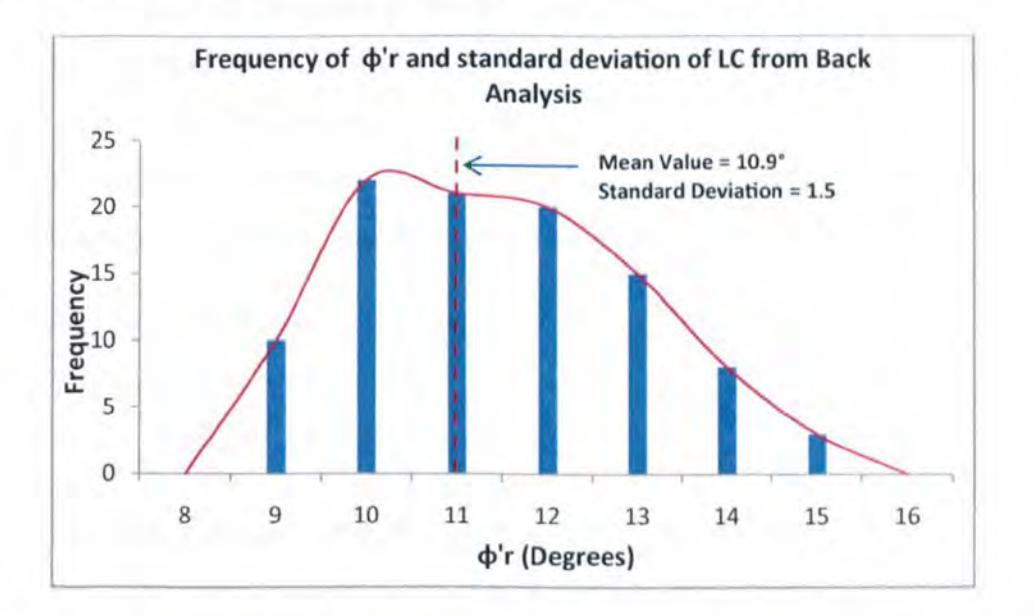
Figure 10-8: The graph shows the mean value and standard deviation of the published data from back analysis on the cross section of landslides in the London Clay.

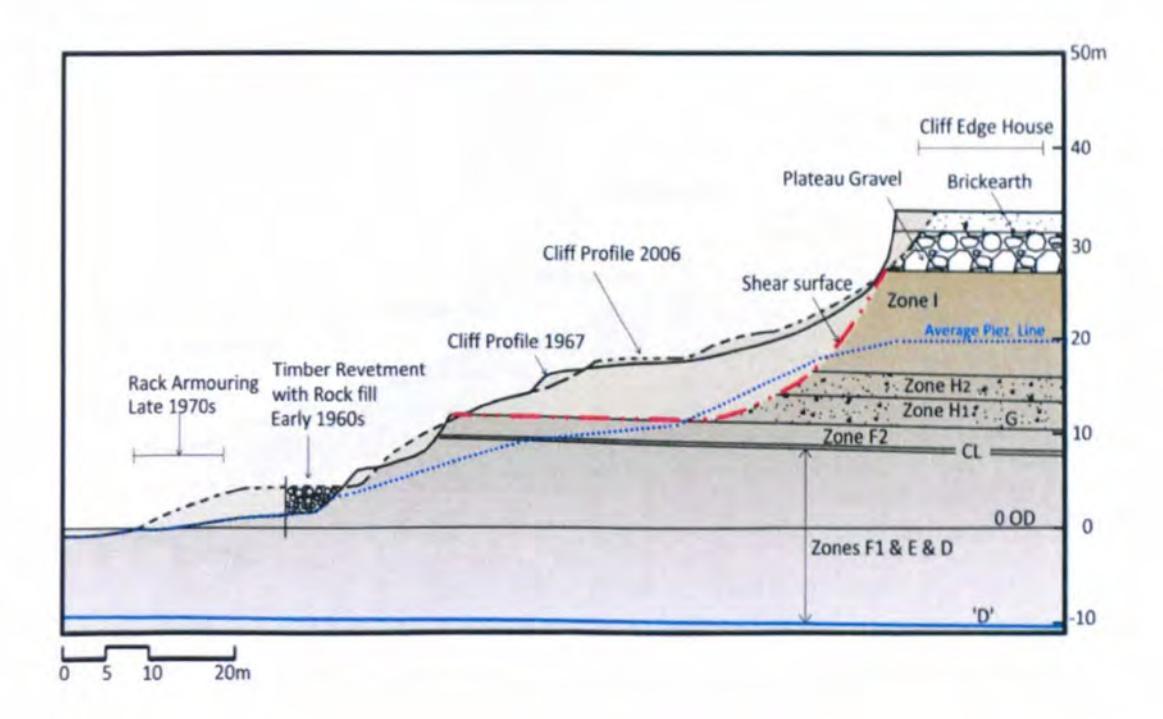
Figure A2: Cross section of the Hoskin's Gap Landslide with the cliff profiles of 1967 and 2006. The slip surface in 1960s which has been employed for back analysis is also shown.

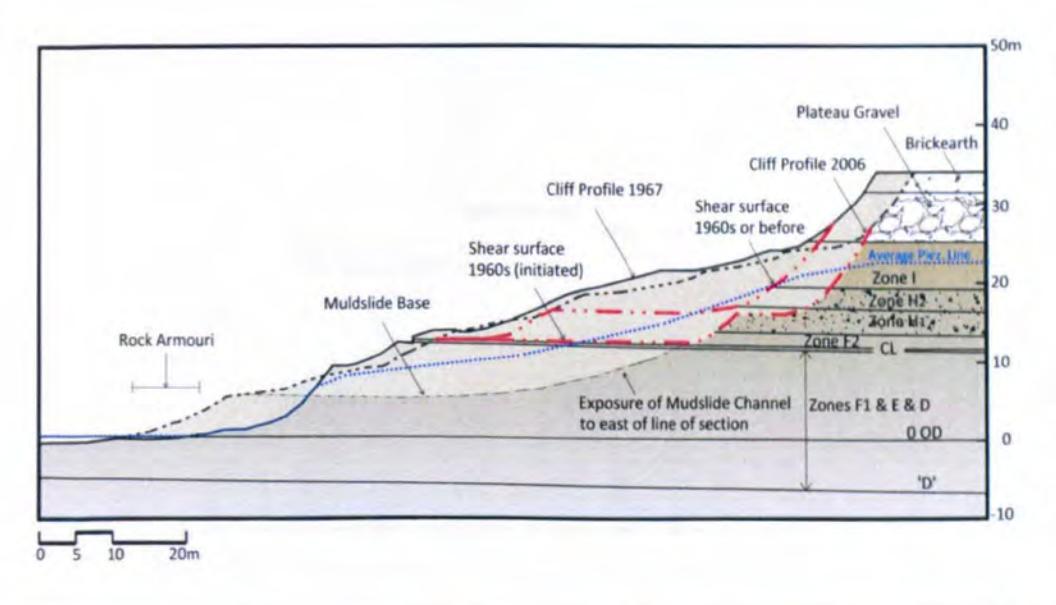
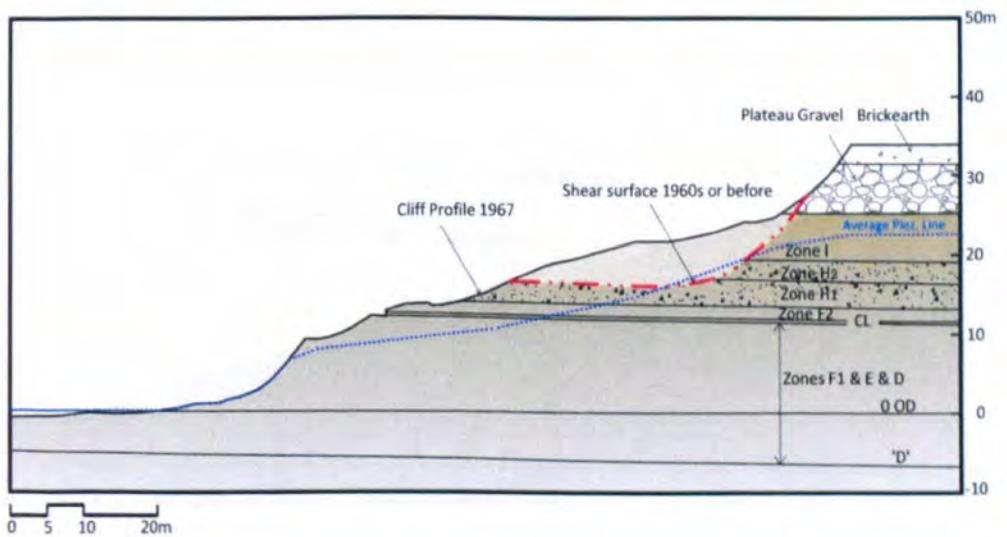
Figure A3: The cross section of the Hoskin's Gap West landslide by Barton and Garvey (2011) (the above figure. The below shows the selected slip surface of this cross section for back analysis. This section includes cliff profile of 1967 and slip slip surface prior to the stabilization works.

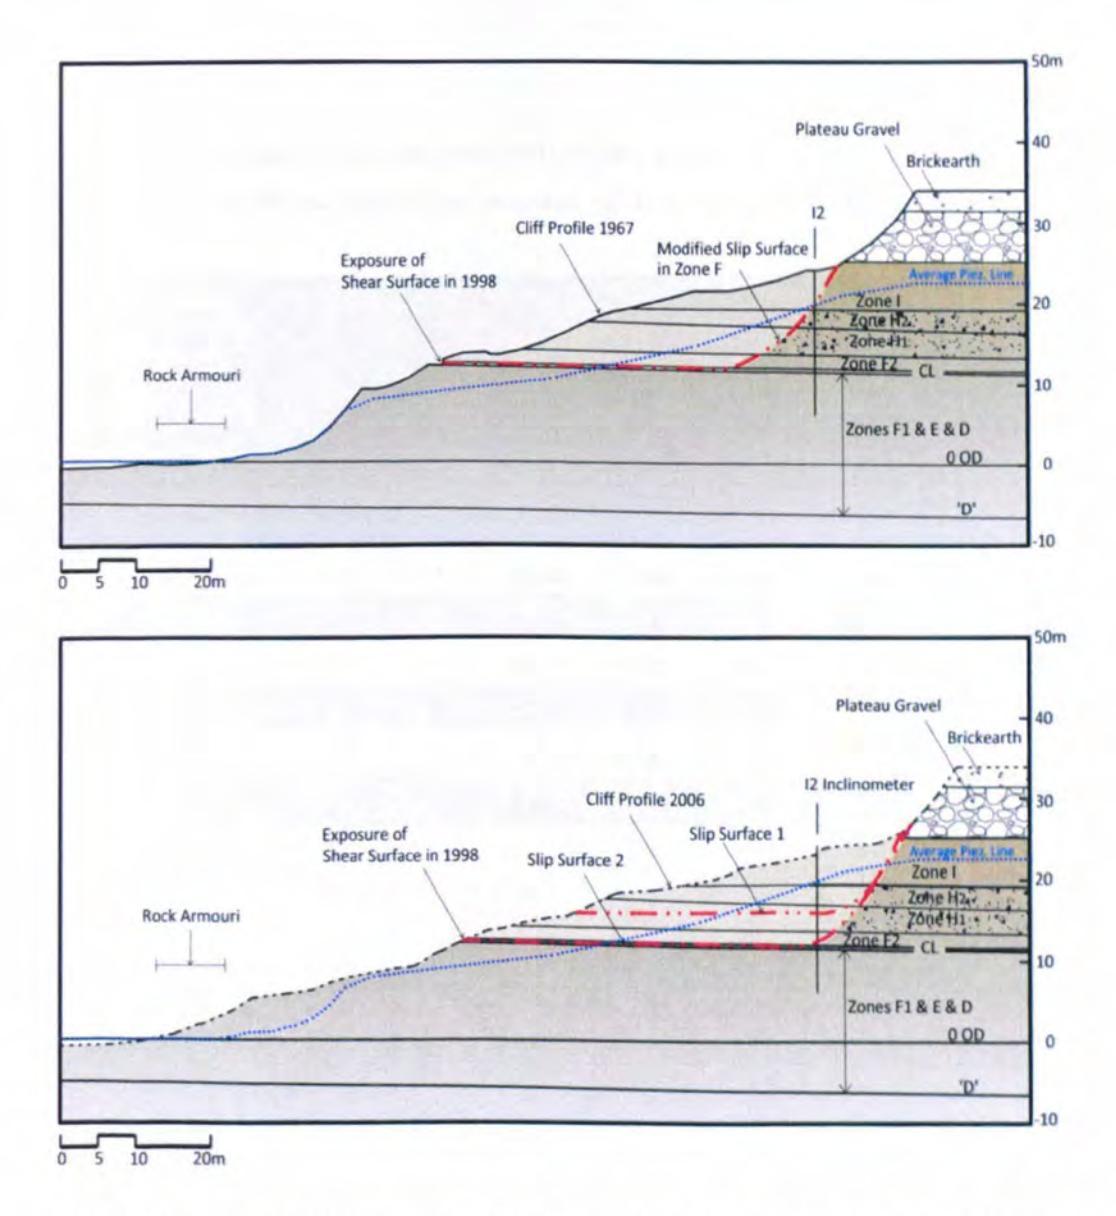
Figure A4: The modified cross section of Hoskin's Gap West which shows cliff profile in 1967 and 2006. The slip surface is modified into F Zone.

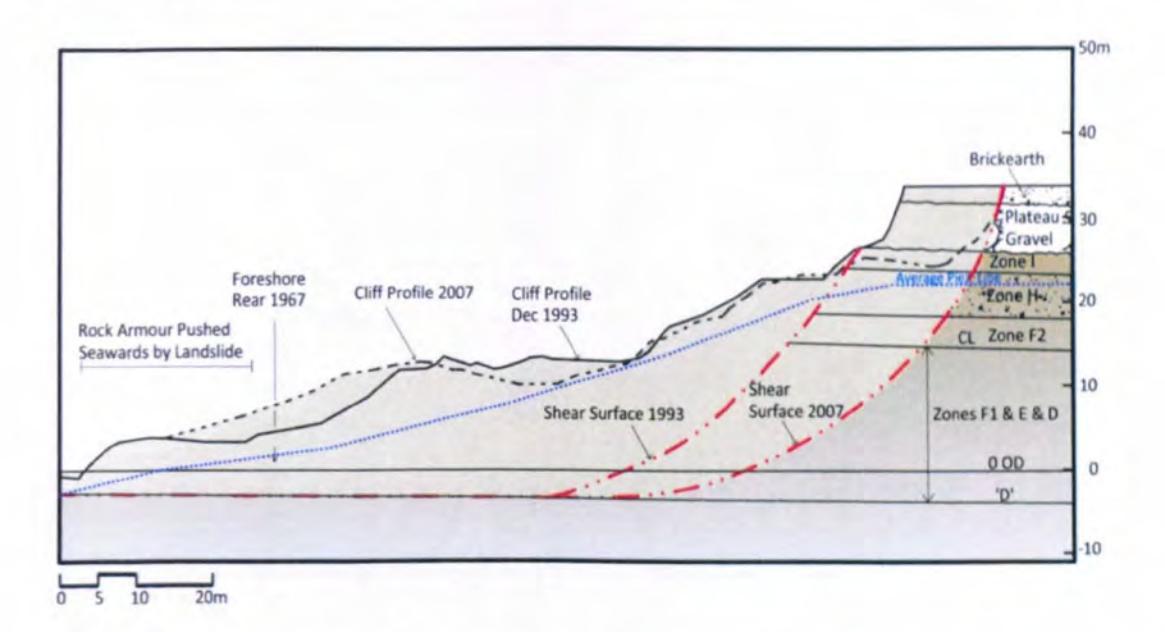
Figure A4: Cross section of Cliff House Landslide with cliff profile 1993 and deep-seated shear surface in Zone D by Barton and Garvey (2011).

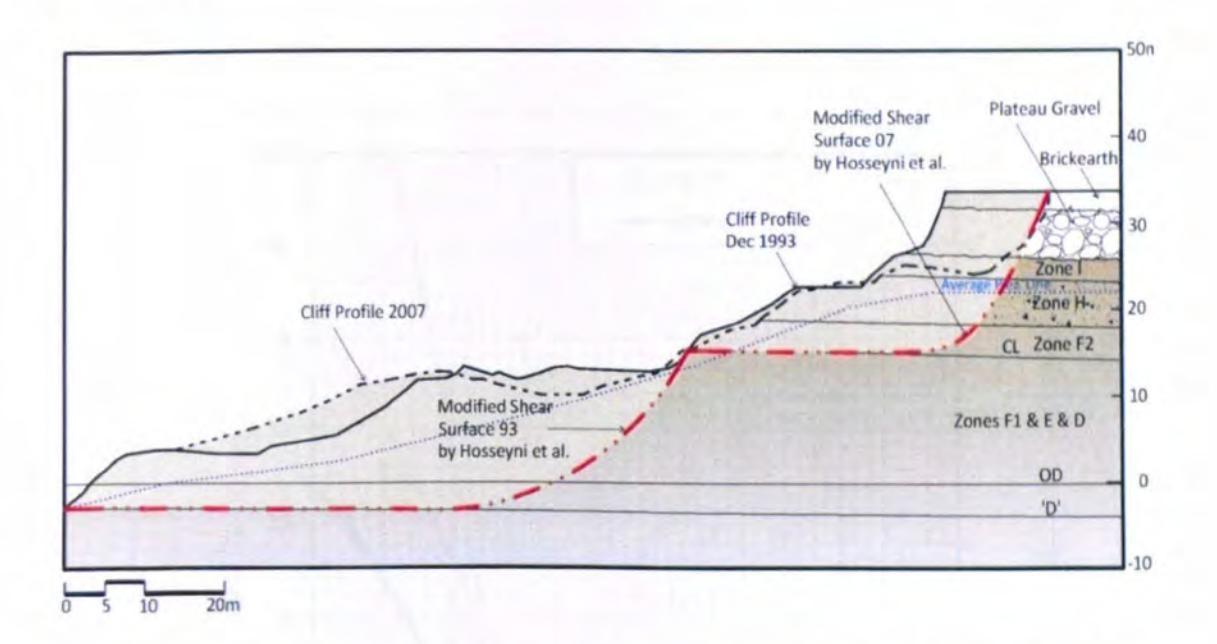
Figure A5: Modified cross section of landslide at Cliff House, showing cliff profile of 1993 and 2007. Two separate shear surfaces in D horizon and F horizon as discussed in Chapter 6.

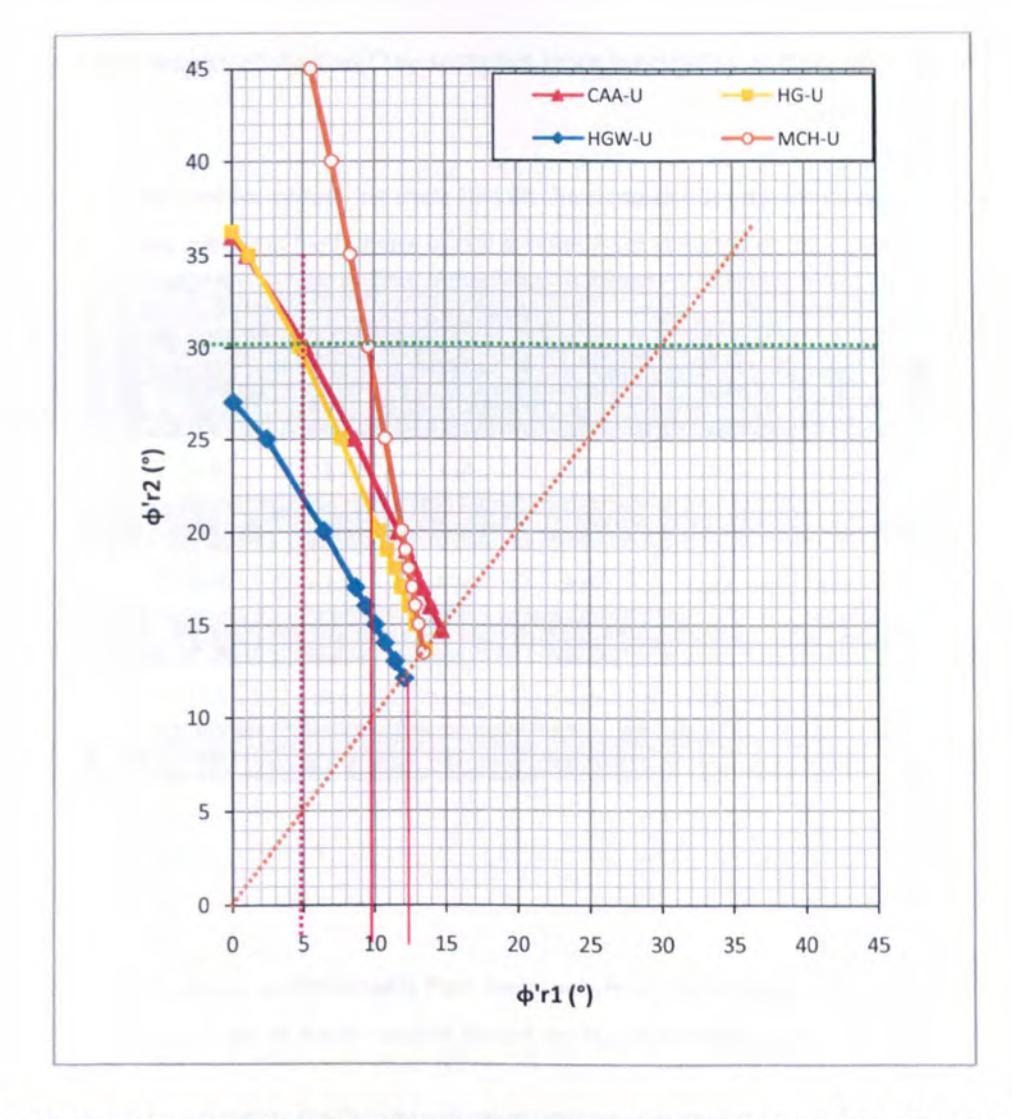
Figure A6: Shows how to define range of $\phi' r_1$ for the cross section of landslides at CAA, HG, HGW, MCH using Upper piezometric conditions (as explained in Section 5.2).

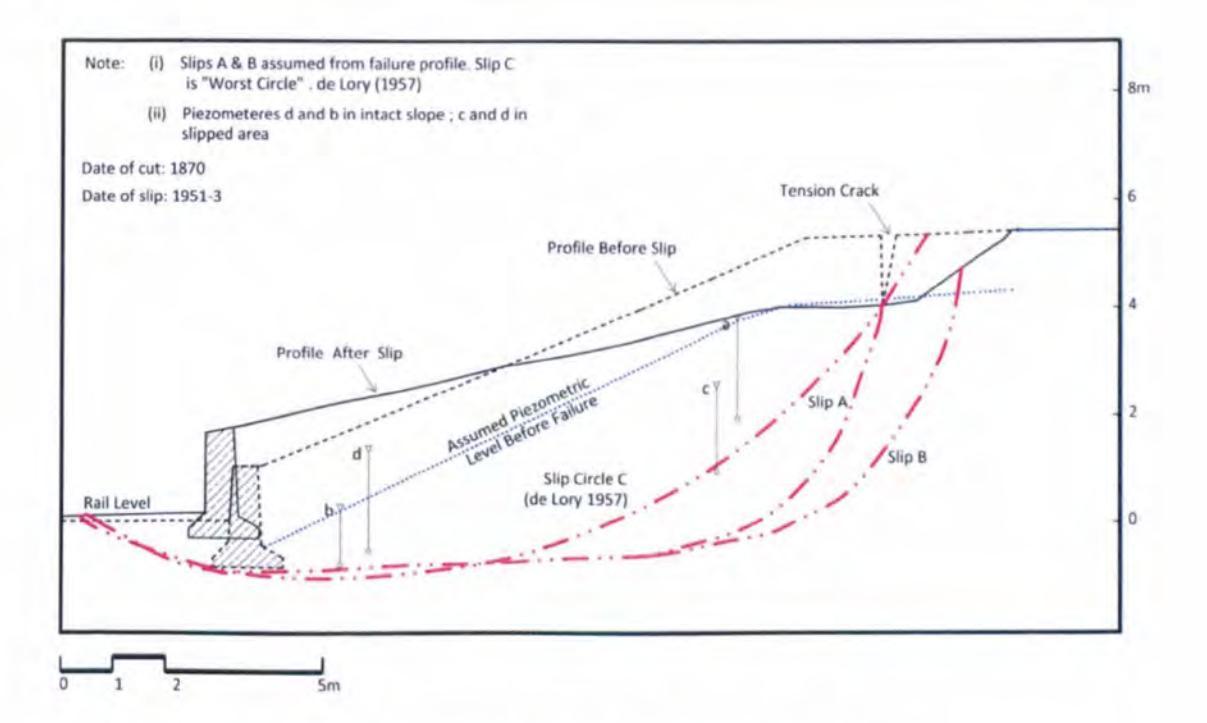
Figure C3: Cross section landslide at Upper Holloway by James (1970)

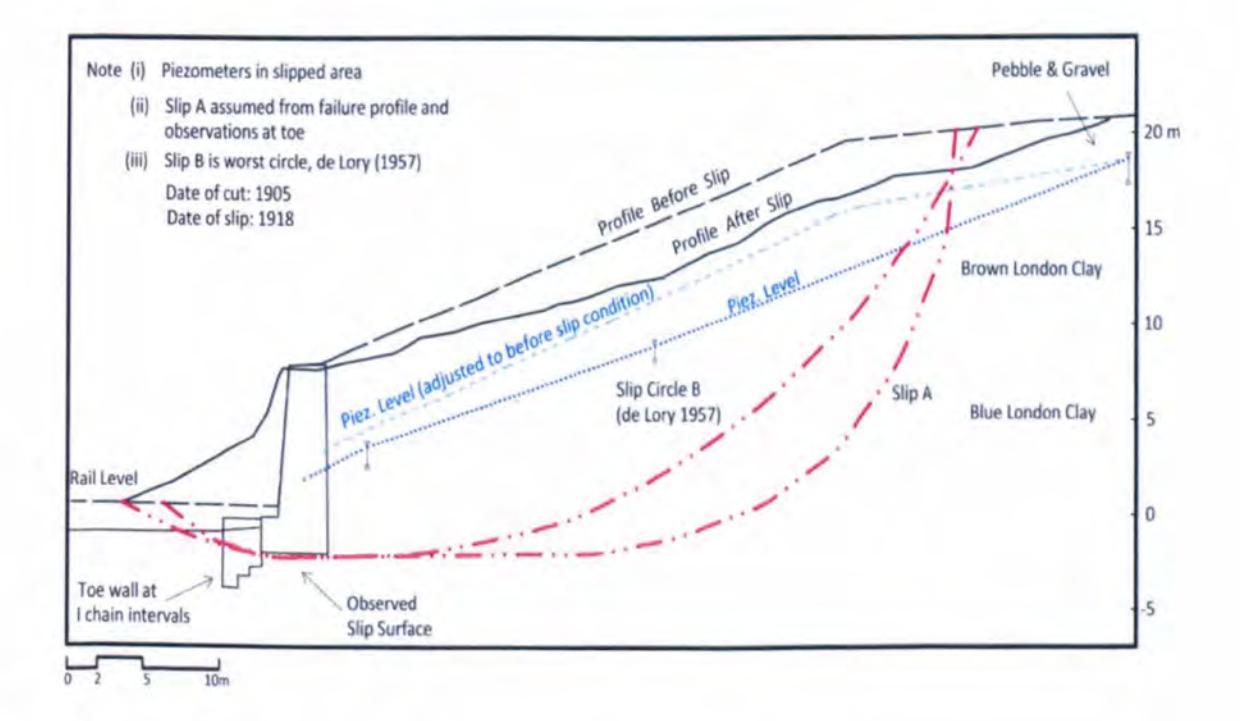
Figure C4: Cross section landslide at Wembley Hill by James (1970)

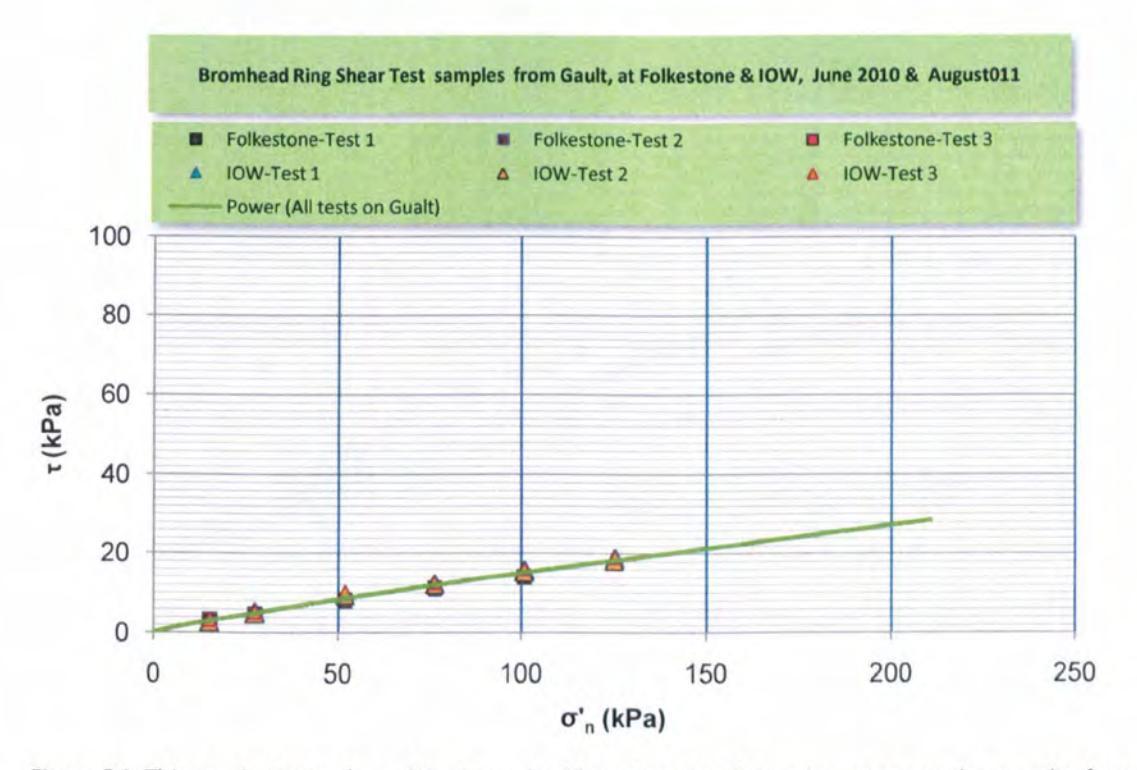
Figure D4: This graph shows σ'_n - τ of Gault resulted from Bromhead ring shear tests on the samples from the exposure of basal shear surface at Folkestone Warren and Isle of Weight

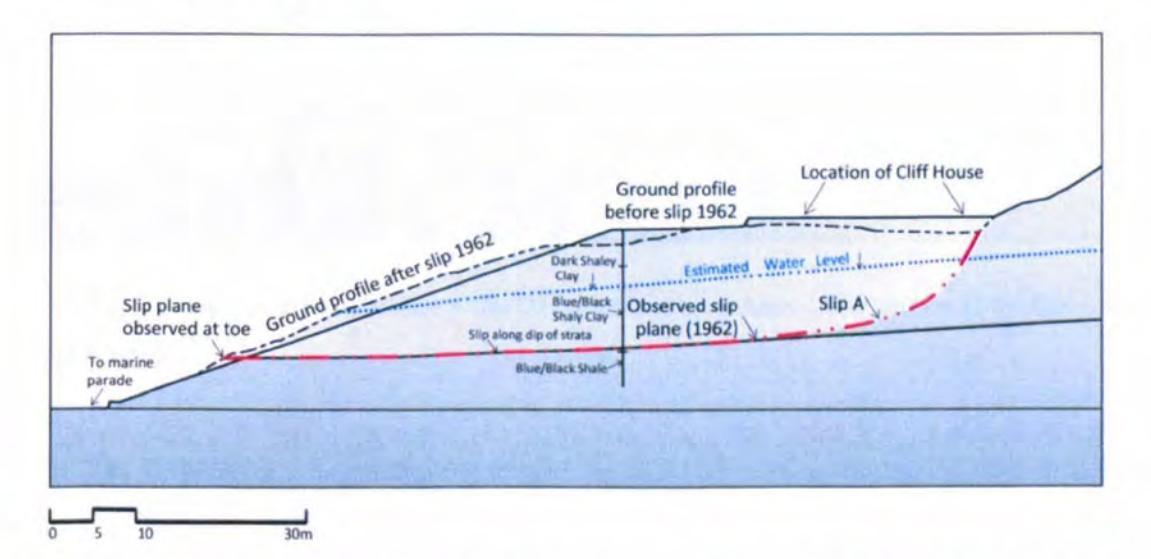
Figure E1: Cross section of the landslide in Lias Clay (Lower) in 1962 at Lyme Regis. Slip plane estimated from failure observation and boring results (After James, 1970).

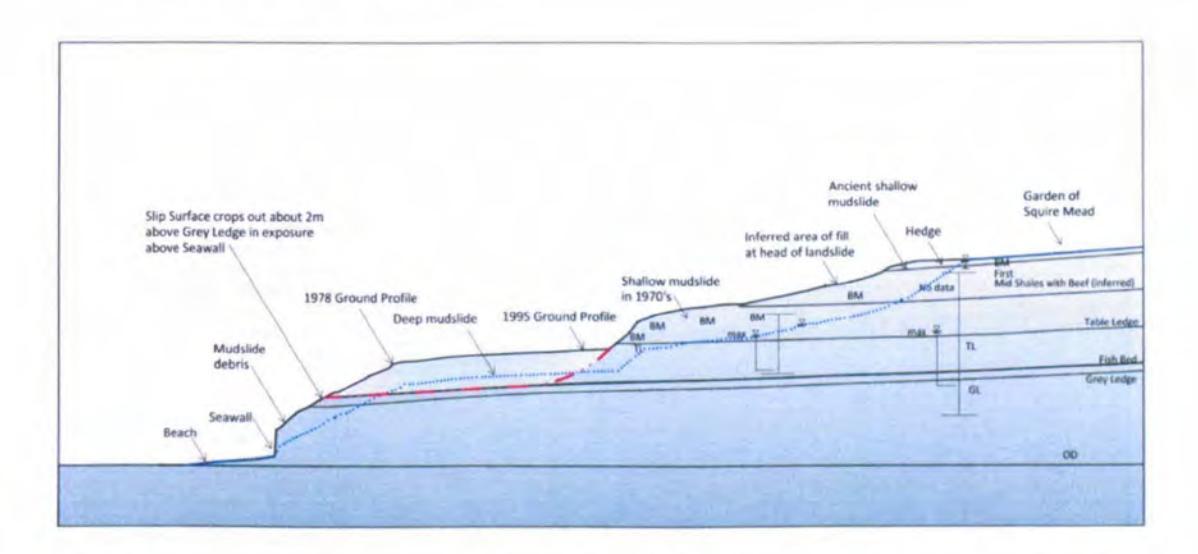
Figure E2: Cross section of the landslide in Lias Clay in 1978 at Lyme Regis. (After Section 12 by High-Point Rendel).

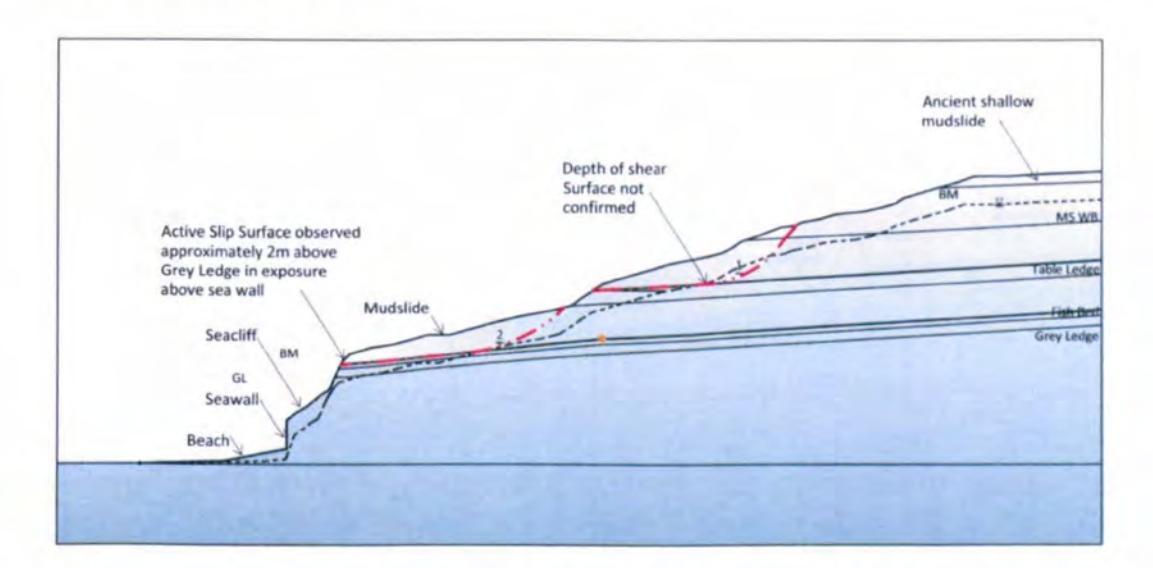
FigureE3: Cross section of the landslide in Lias Clay in 1995 at Lyme Regis. (After Section 10 by High-Point Rendel).

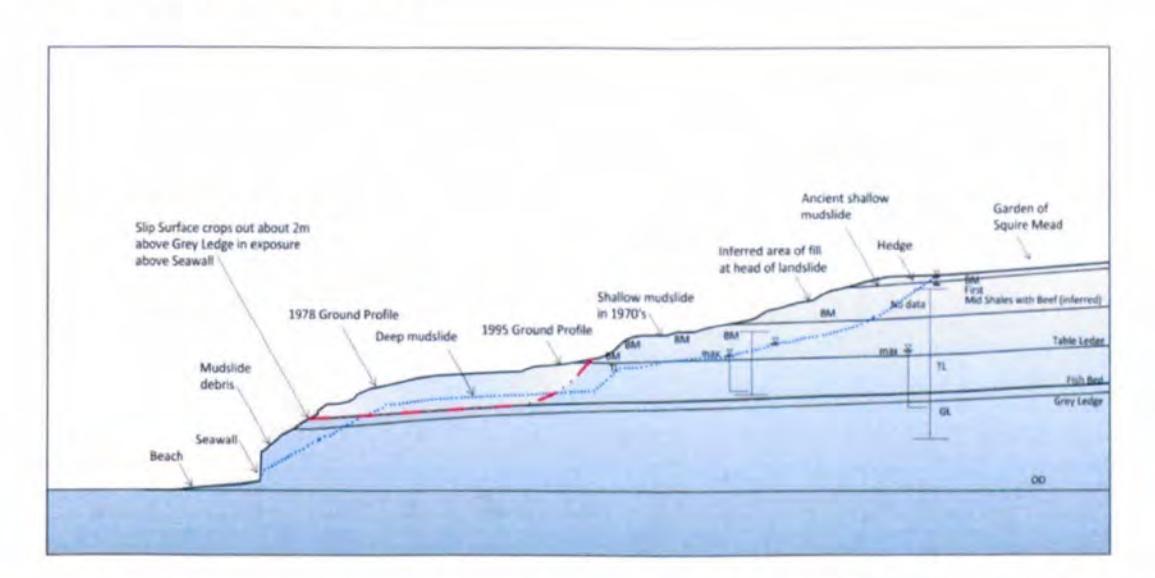
FigureE4: Cross section of the landslide in Lias Clay in 1995 at Lyme Regis. (After Section 10 by High-Point Rendel).

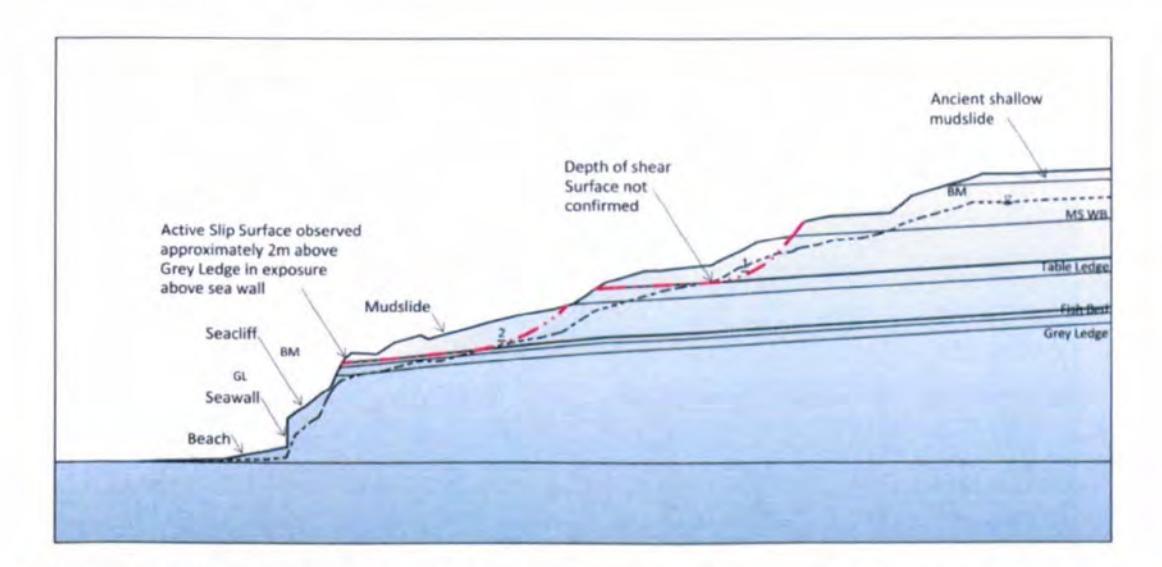
Figure E6: Cross section of the landslide in Lias Clay in 2007 at Lyme Regis. (After Section 10 by High-Point Rendel)

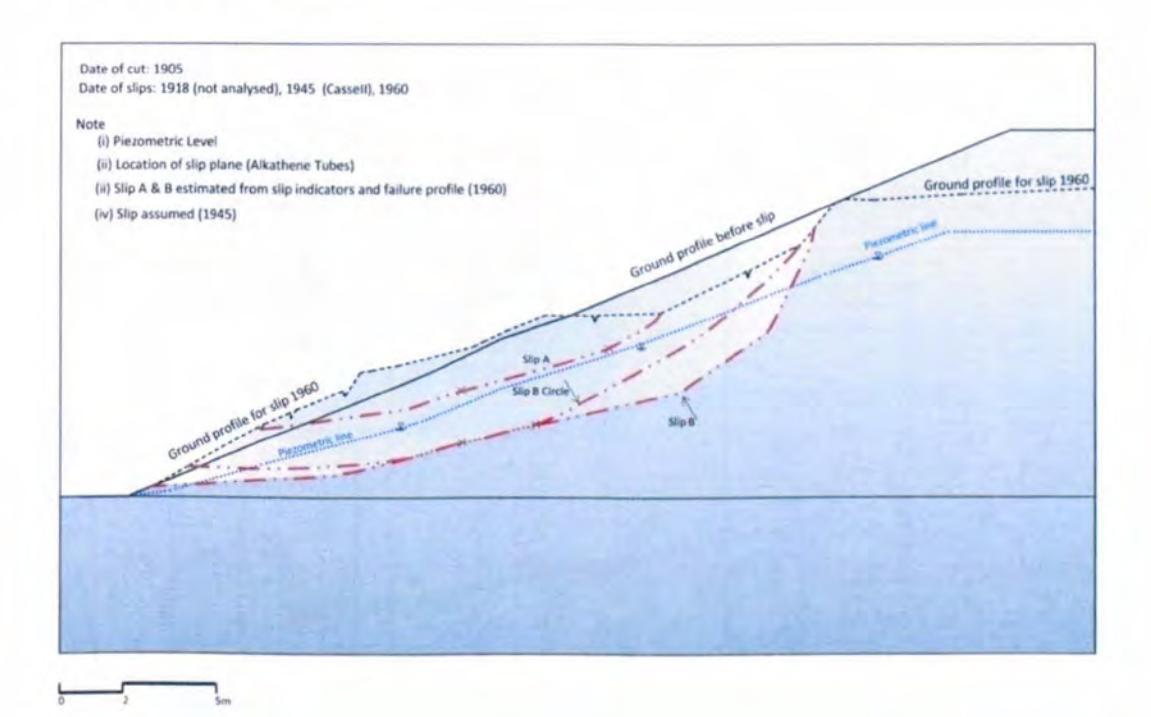
Figure E7: Cross section of the landslide in Lias Clay in 1960 at Toddington (After James, 1970).

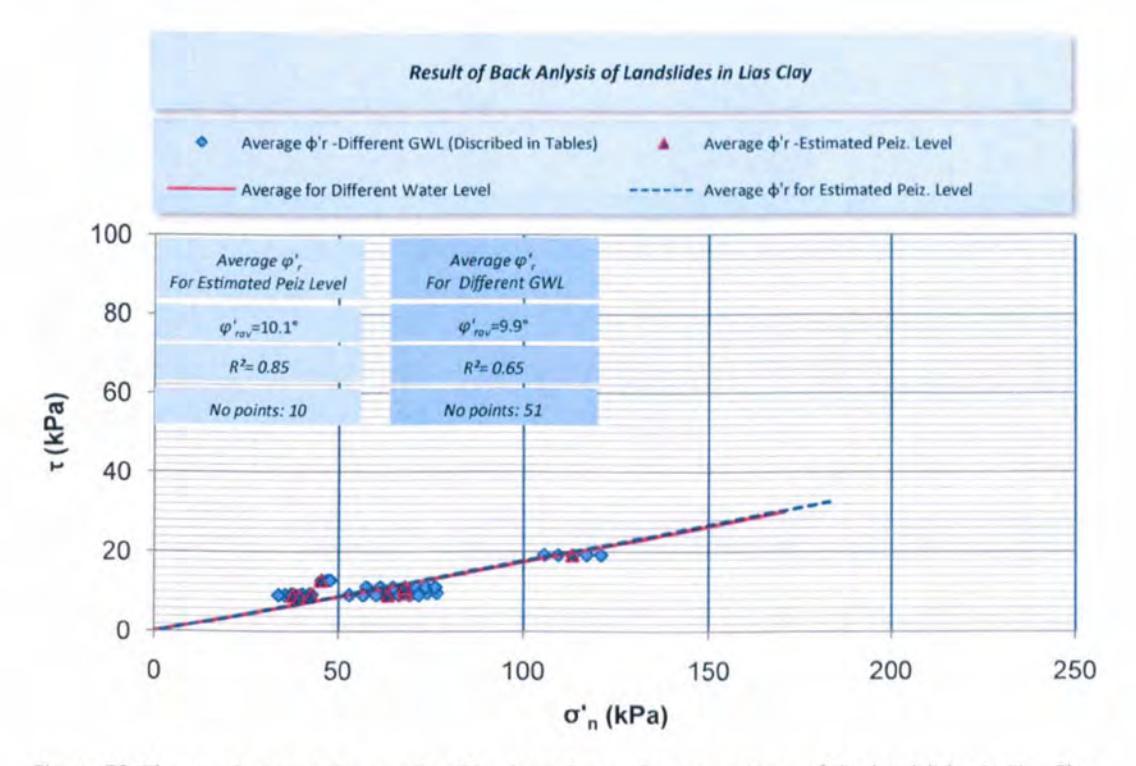
Figure E8: The graph shows the results of back analyses of cross sections of the landslides in Lias Clay (the above cross sections).

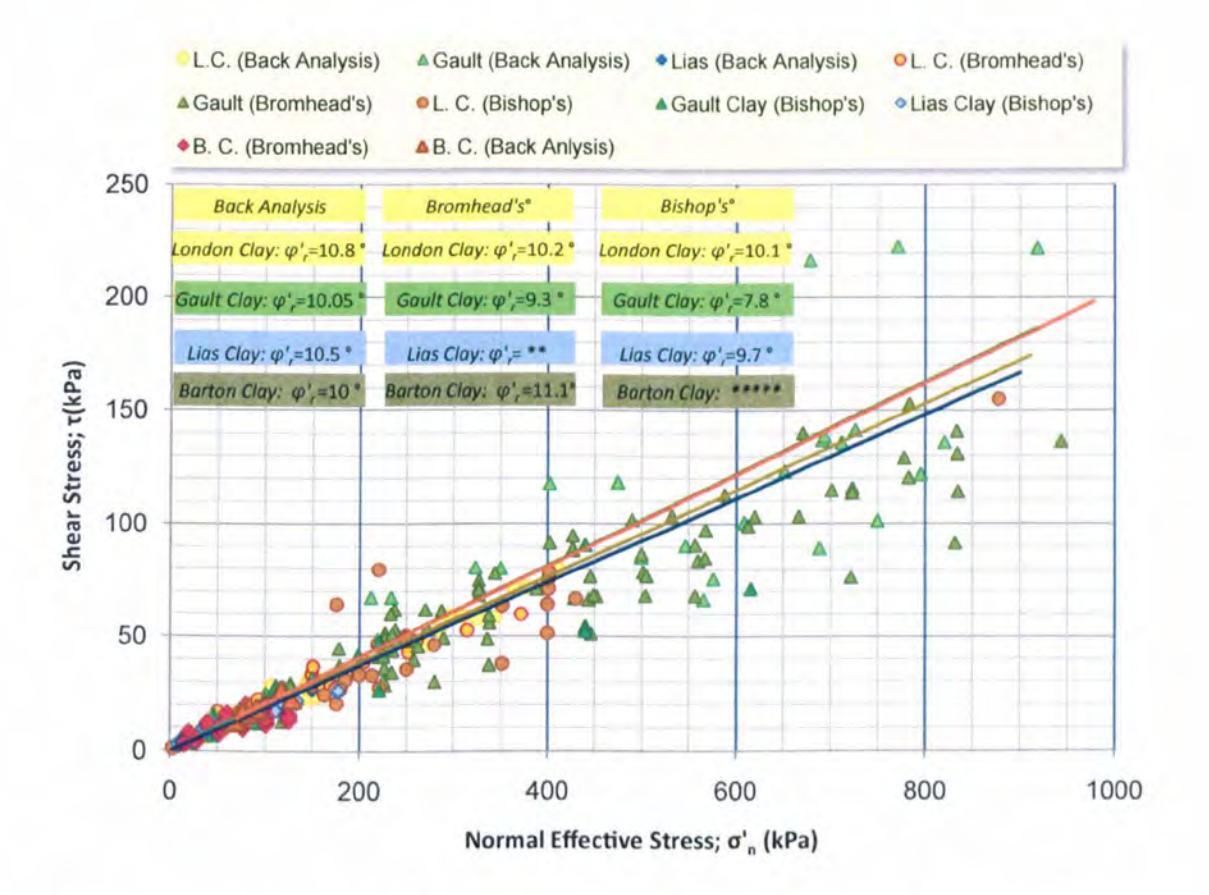
Figure F1: The graph compares the results of back analyses, Bromhead ring shear and Bishop ring shear apparatus of four British Clays (Barton Clay, London Clay, Gault and Lias). Value of residual friction angle of each clay is shown. The main outlier data points are those from the Folkestone Warren sections both (a) the minimum piezometric levels and (b) the after (or post) sliding profile (after the major displacement of 1915). Reflection on the groundwater conditions renders it highly improbable that this is a realistic interpretation of the piezometric levels operating. without those outliers, the four datasets are indistinguishable to the unaided eye on the graph.
