Residual Shear Strength of Clays in Landslides in Southern Britain

A Thesis submitted in partial fulfilment of the requirements of

Kingston University London

for the degree of Doctoral of Philosophy of Civil Engineering

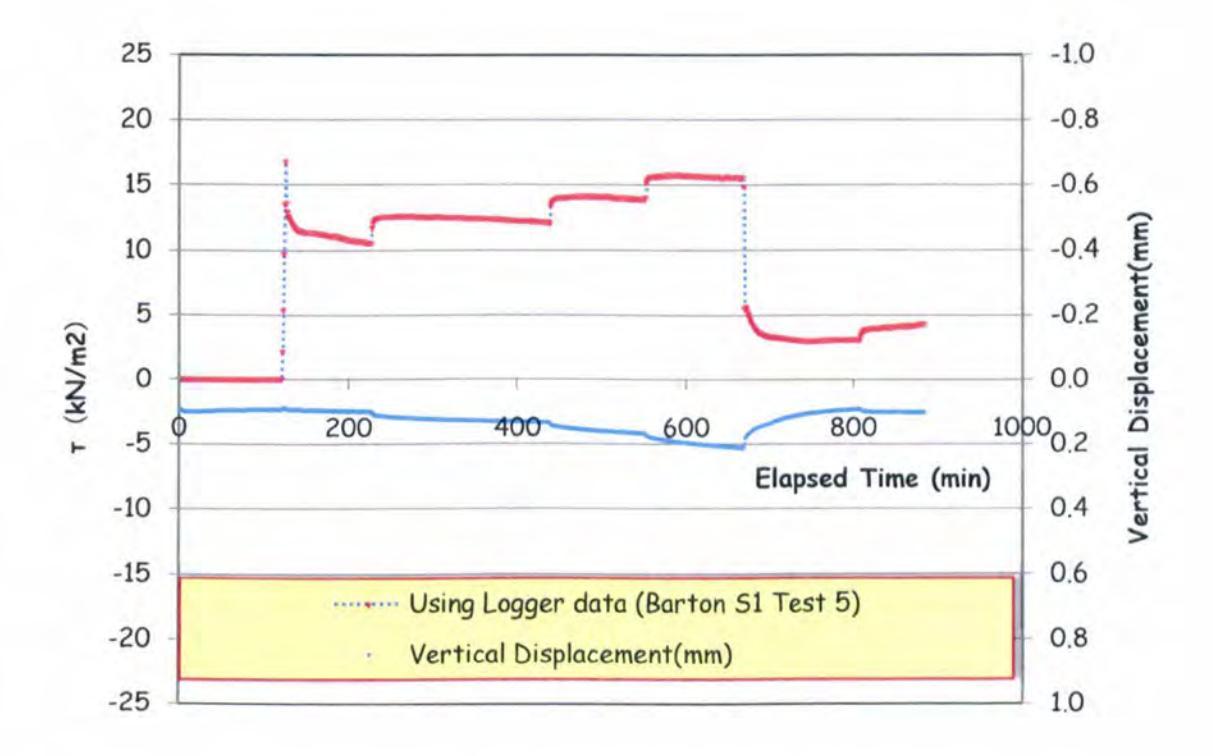
Figure G2: The graph shows results of ring shear test on the sample from the exposure of landslide in Zone F at Barton on Sea. Sample collected in 2010 as mentioned in the text. The Graph illustrates different stages of ring shear test using Bromhead ring shear apparatus including: consolidation and multi stage shearing under different normal stresses. The graph also shows displacement of the sample under different normal stresses (Blue coloured graph).
