Title: Post Occupancy Evaluation of social housing designed and built to Code for Sustainable Homes Levels 3, 4 and 5

Post Occupancy Evaluation of social housing designed and built to Code for Sustainable Homes Levels 3, 4 and 5

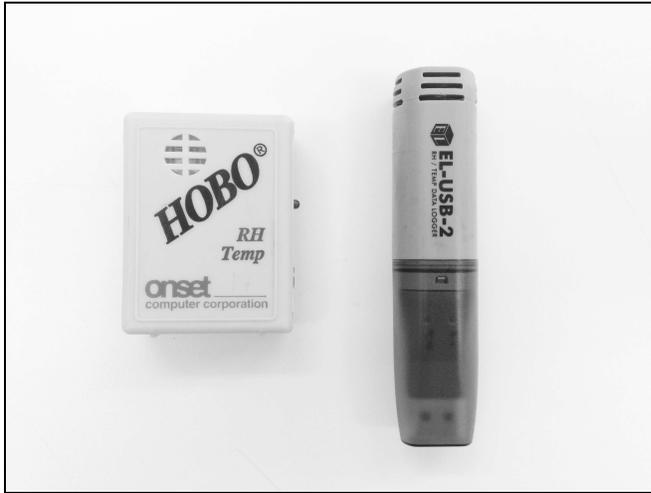
Figure 1: HOBO H8 and LASCAR EL-USB-2 dataloggers

The dwellings were monitored during the period 15th March 2013 to 14th March 2014 and during this period dataloggers were used to collect hourly readings of temperature and relative humidity in four locations in each dwelling: the living room, kitchen, bedroom and outside. Data was collected using a combination of HOBO H8 and LASCAR EL-USB-2 dataloggers, which are shown in Figure 1. HOBO H8 dataloggers have an accuracy of $\pm 0.7^{\circ}\text{C}$ at 21.0°C and $\pm 5.0\%$ RH. LASCAR EL-USB-2 dataloggers have an accuracy of $\pm 0.5^{\circ}\text{C}$ at 21.0°C and $\pm 3.0\%$ RH. In addition to this, during regular visits to each dwelling for the collection of data, gas, electricity and water consumption readings were taken, where possible, together with data from renewable energy generating systems installed at each location. Social surveys were also carried out at the start of the project, where the occupants were interviewed in order to assess how they use their homes. The basic specifications of the seven dwellings in this study are shown in Table 1.

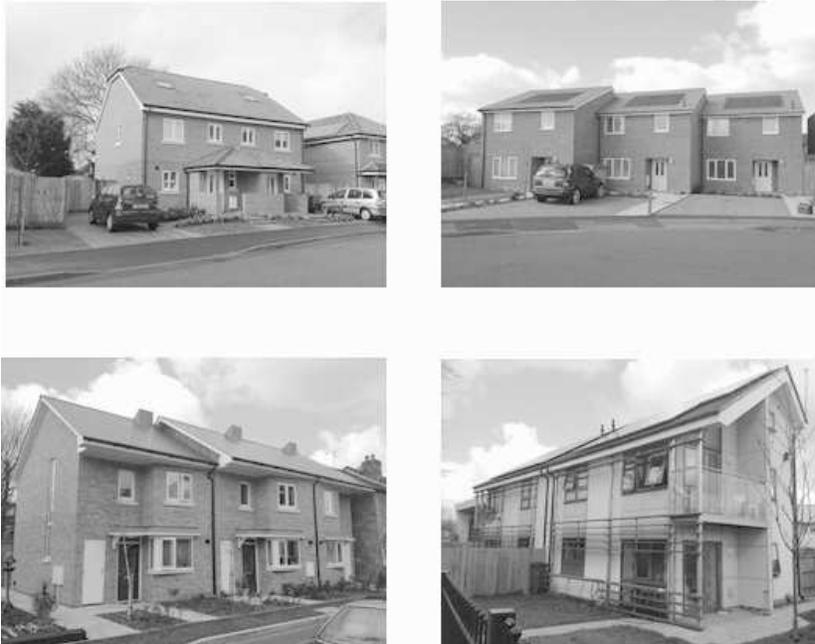
Figure 2: The dwellings, clockwise from top left, 39OB (Code level 3); 138NG / 139NG (Code level 4); 94SR/ 96SR (Code level 5); 249MR / 249aMR (Code level 5)

To ensure anonymity, the dwellings are given simple reference numbers and these are used throughout this paper. The table shows the basic dwelling unit configuration in terms of number of bedrooms and occupants, the floor area and the CfSH level. It also describes the fabric and building servicing strategy for each dwelling giving details of the technology installed into each home. Figure 2 shows the four dwelling types tested in this study.
